# **Arboricultural Assessment, Arboricultural Impact and Tree Protection Strategy Report**

**Boyne Greenway -  
Drogheda to Mornington,  
Co. Meath/Co. Louth**

| <b>Project No.</b> | TBOY001 | <b>Date</b> | 13/07/20 |
| <b>Project Name</b> | Boyne Greenway - Drogheda to Mornington | <b>Revision</b> | A |

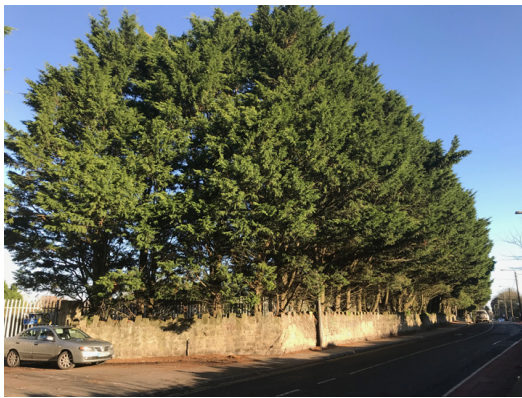
In the western section, for the first 130 meters of the survey area, a group of 61 Leyland cypress *Cupressus × leylandii* form a screen planting to former industrial grounds north (see image 2). These trees are of moderate landscape value and may have limited long-term potential due to poor root conditions from construction activity.

Image 2. Group of Leyland cypress screening former industrial grounds, 130 metre long.

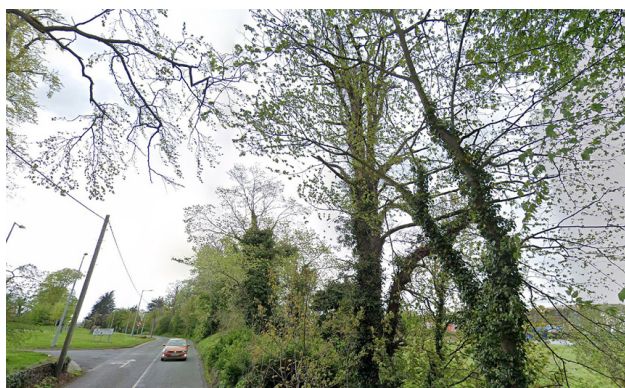
Located opposite Drogheda Grammar School in a dense roadside grouping (see image 3) are a mixture of mature horse-chestnut *Aesculus hippocastanum* and Sycamore *Acer pseudoplatanus* and younger self-seeded native/naturalised species Wych Elm *Ulmus glabra*, Sycamore *Acer pseudoplatanus* and Beech *Fagus Sylvatica*. Trees in this area constitute the greatest concentration of higher value specimens, in terms of variety, venerability and landscape value.

Image 3. Group of trees opposite Drogheda Grammar School.

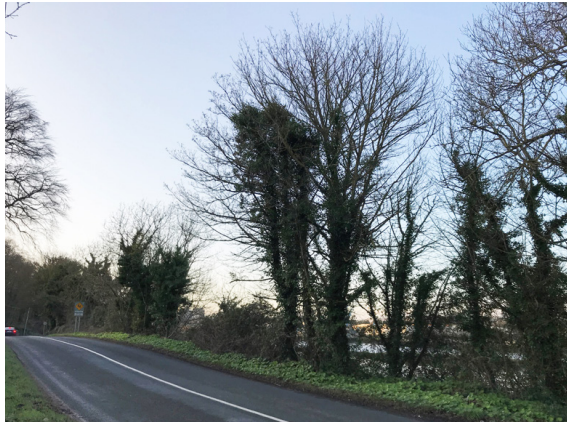
Along the central section of the surveyed area trees are located in close proximity (less than one metre) from the R150 roadside. The average quality of these trees are moderate to poor (B-C) with many being of drawn up form due to local competition (see image 4).

Image 4. Sycamore and ash along the R150 east of Mill Road.

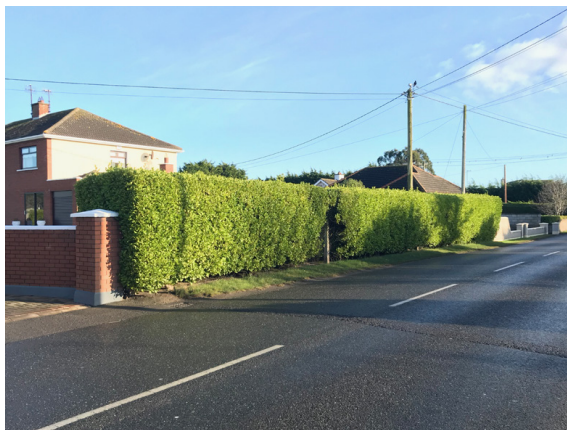
Image 5. Griselinia hedge in the residential area of Mornington.

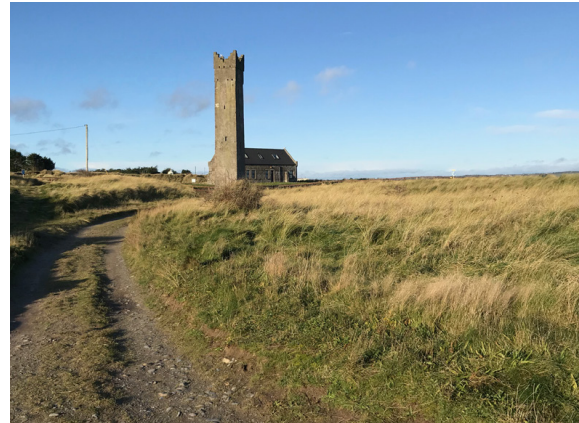
Image 6. Maiden Tower viewed near Mornington Bay Beach. Marram grass covers dunes with occasional dog rose, hawthorn and scrub ash.

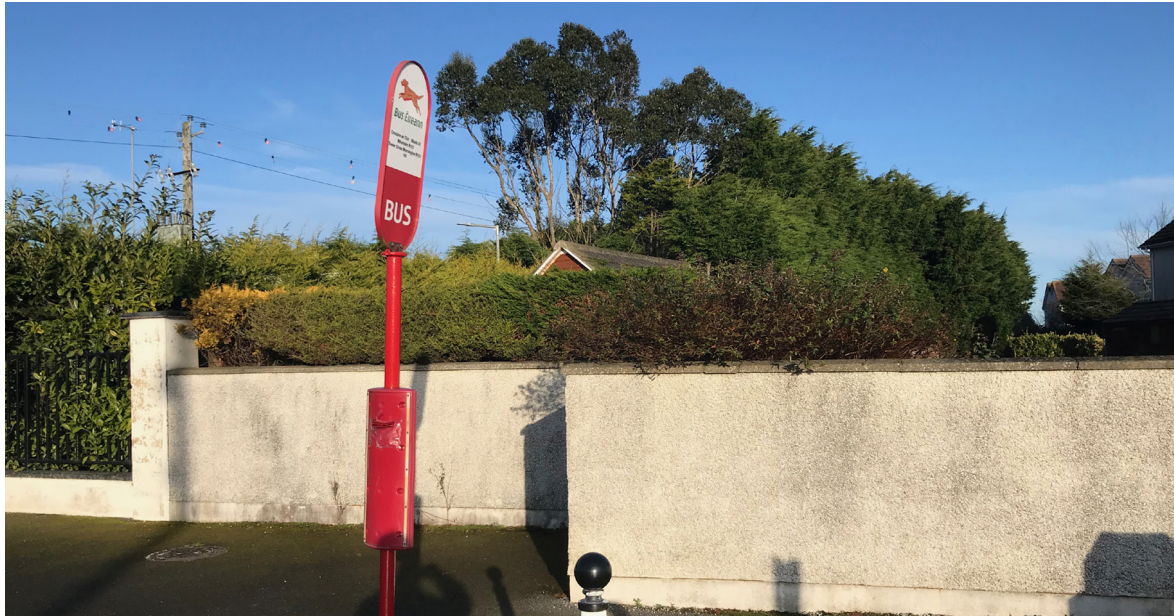
Image 7: Area A; *Crinodendron hookerianum* with Leyland hedge. Hedge 2 meter high and 4 metre long. Well maintained behind a 1.5 metre high pebbledash wall.

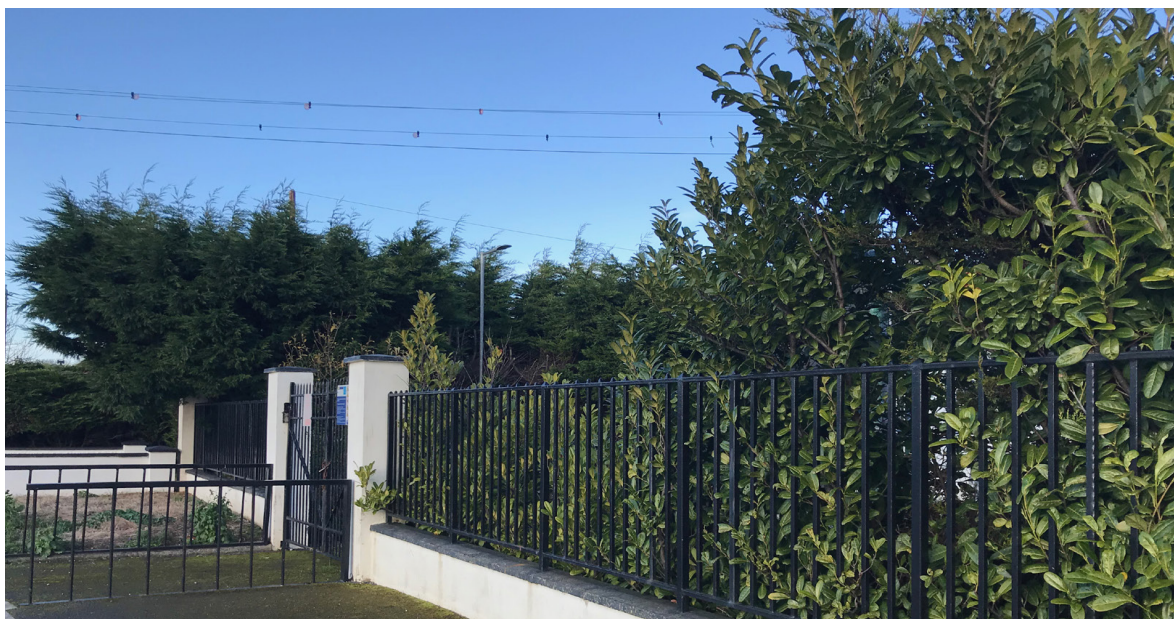
Image 8: Area B; *Laurel Prunus laurocerasus* hedge 1.5 metre high behind a metal fence screening a sewage pumping station.

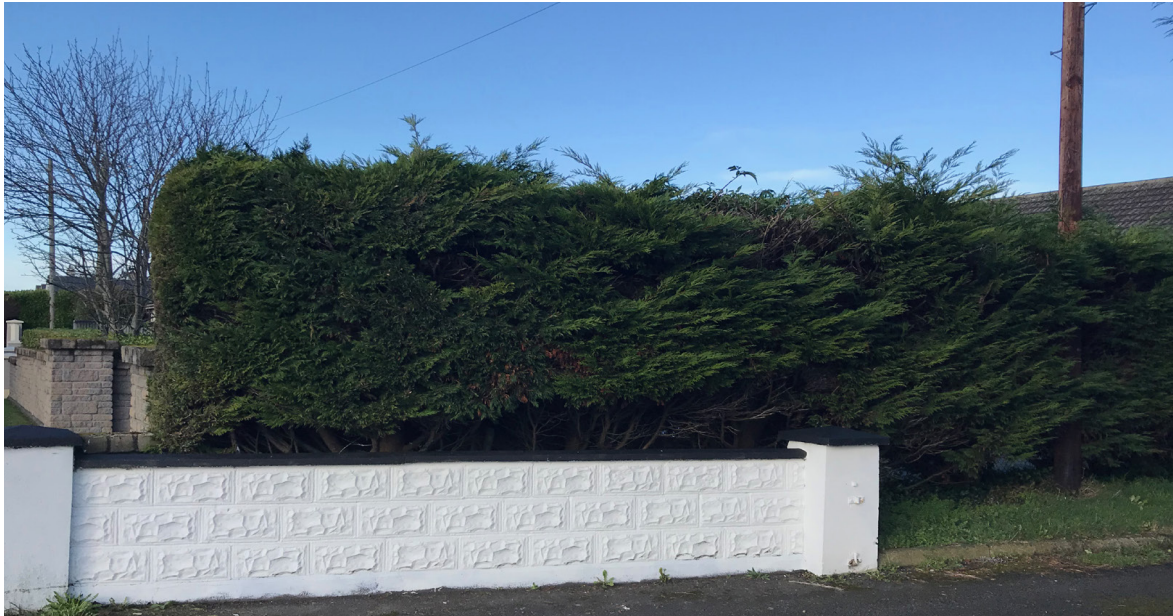
Image 9: Area C; A Leyland hedge 2.25 metre high in a line perpendicular to the roadway. Well maintained.

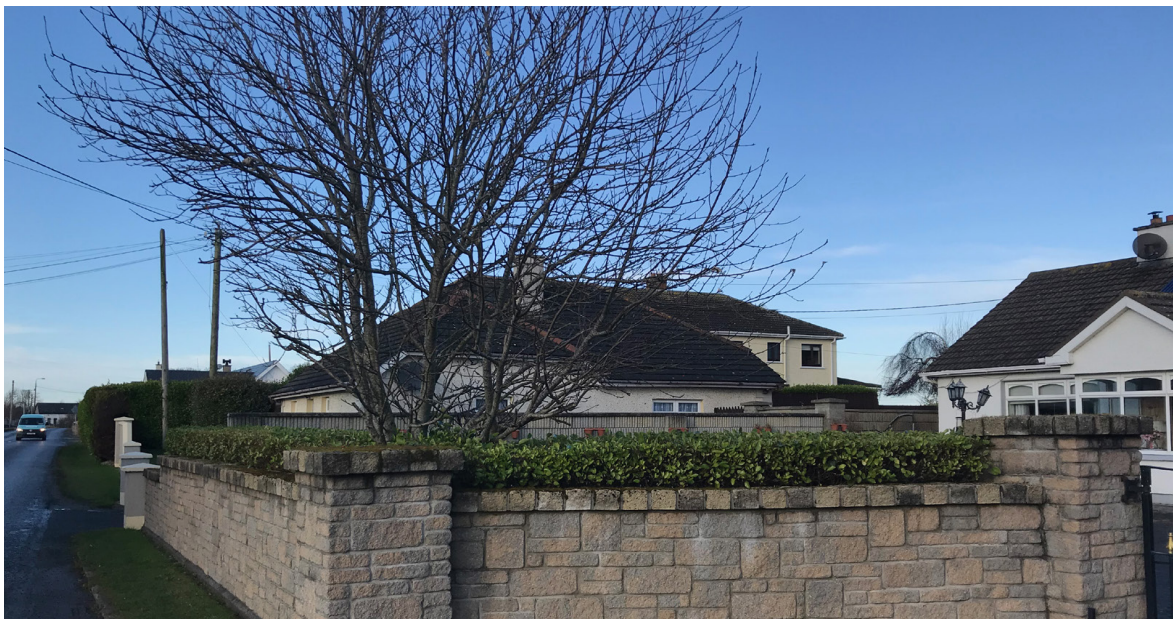
Image 10: Area D; Griselinia hedge 1.5 metre high behind a brick wall. Well maintained and vigorous. 9 metre long. Early mature Swedish whitebeam (#693) shown left.

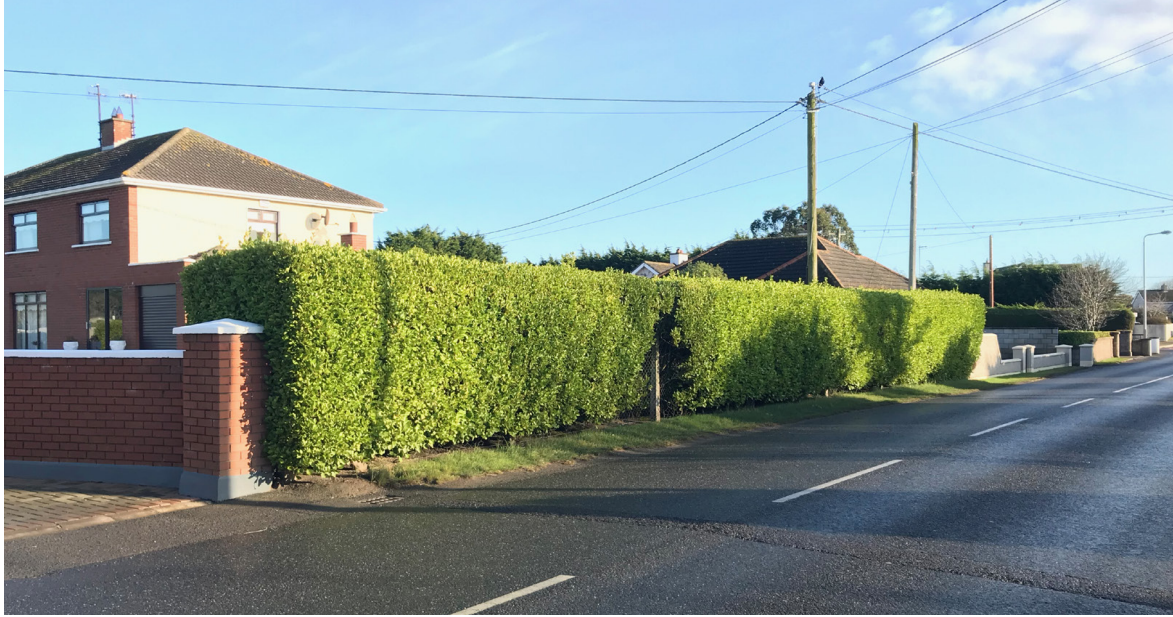
Image 11: Area E; Griselinia hedge 2 metre high behind a 1 metre high mesh wire fence. Well maintained. 23 metres long.

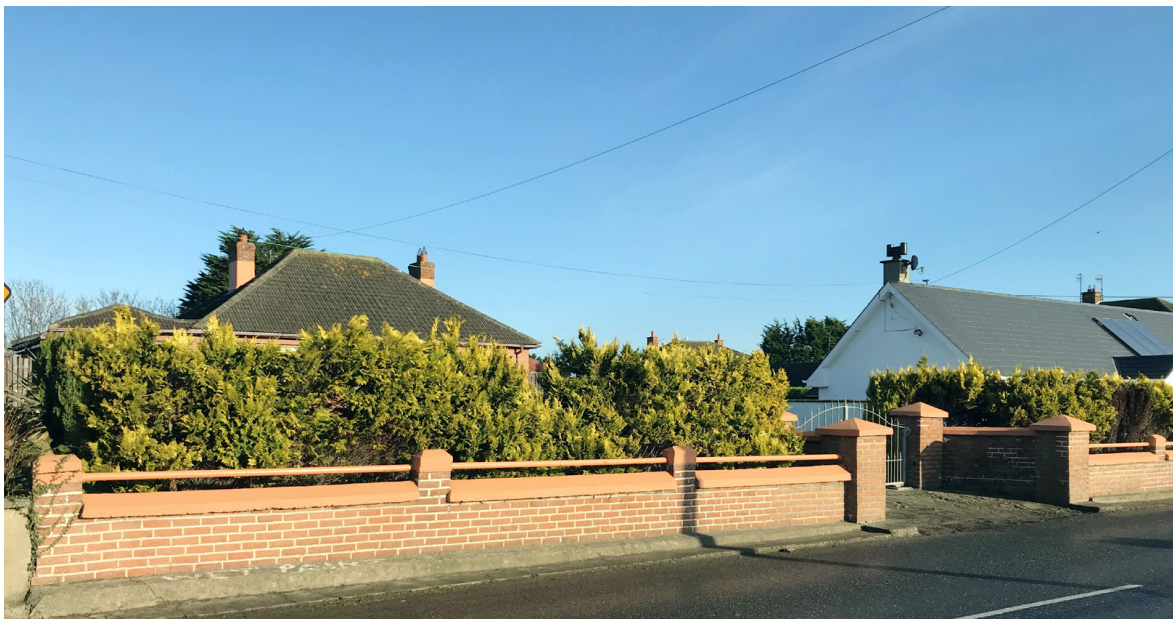
Image 12: Area F; Golden cypress (*Cupressus cv*) hedge topped to 1.75 metre high behind a low brick wall. Well maintained with no visible defects.

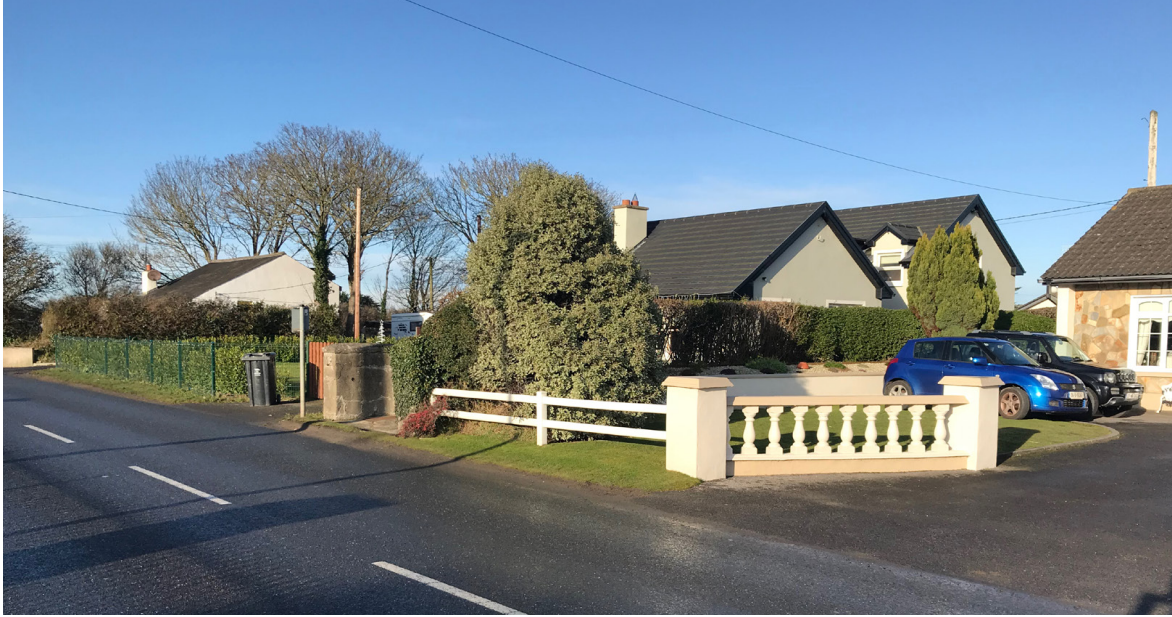
Image 13: Area G. 1.25 metre high privet hedge on eastern boundary of garden. Perpendicular to roadway. 2.5 metre euonymus cultivar, 1 metre from roadside. Well maintained.

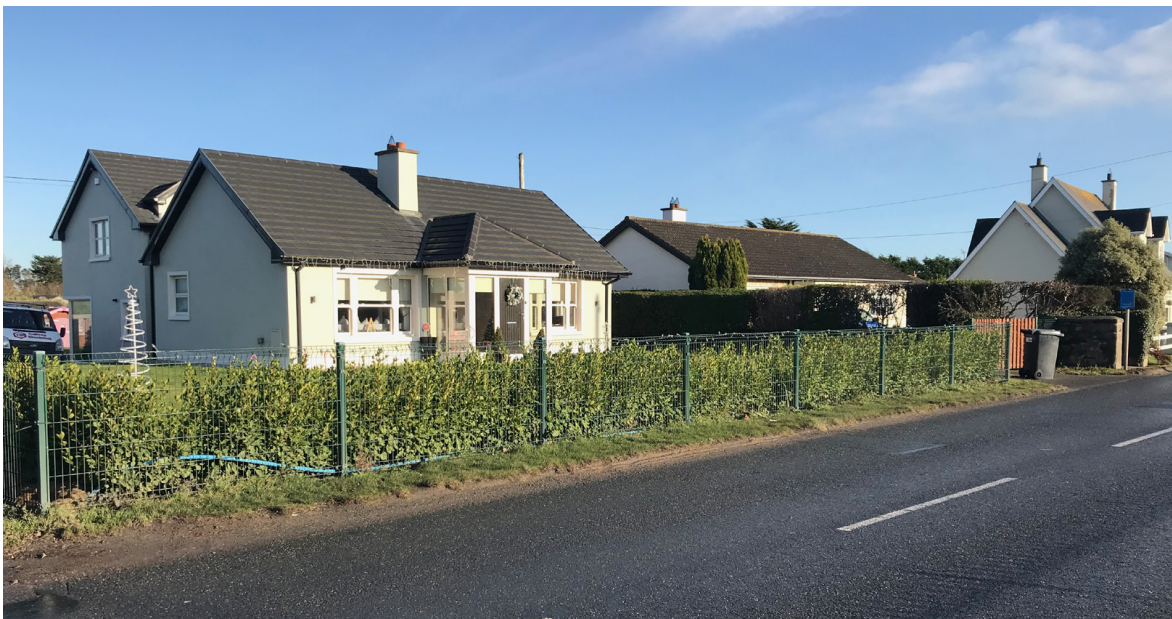
Image 13: Area H. Juvenile griselinia 0.5 high metre hedge. Recently planted for screening to residential property.

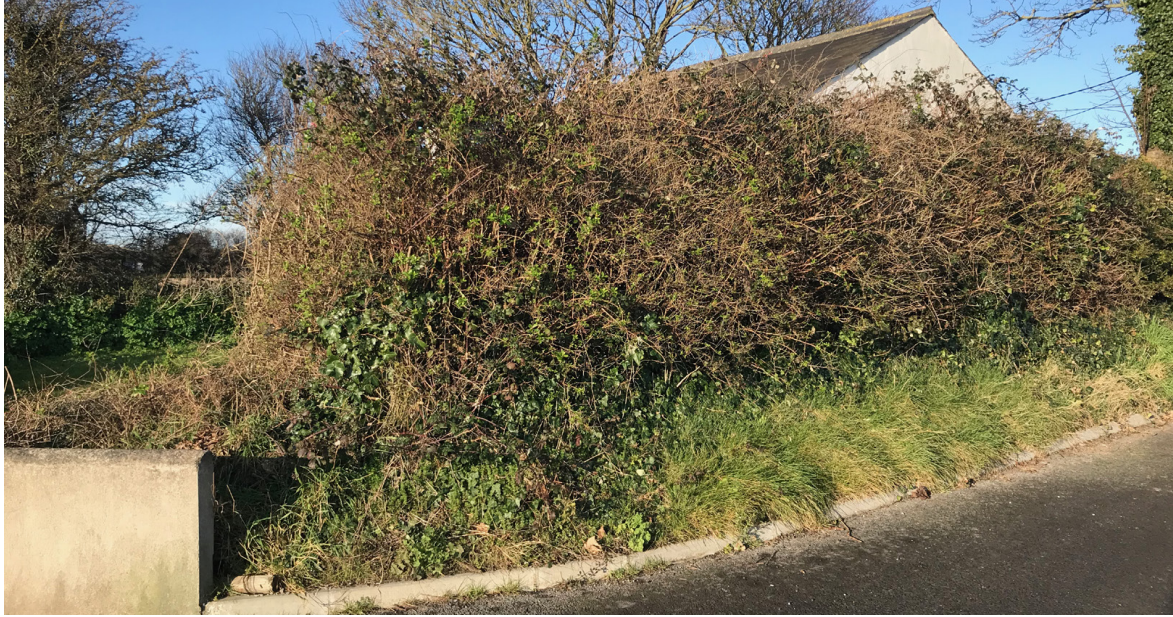
Image 14: Area I; Bramble hedgerow located on property on corner of R150 and North Lane. 2.25 metre high in a line perpendicular to R150. Well maintained.

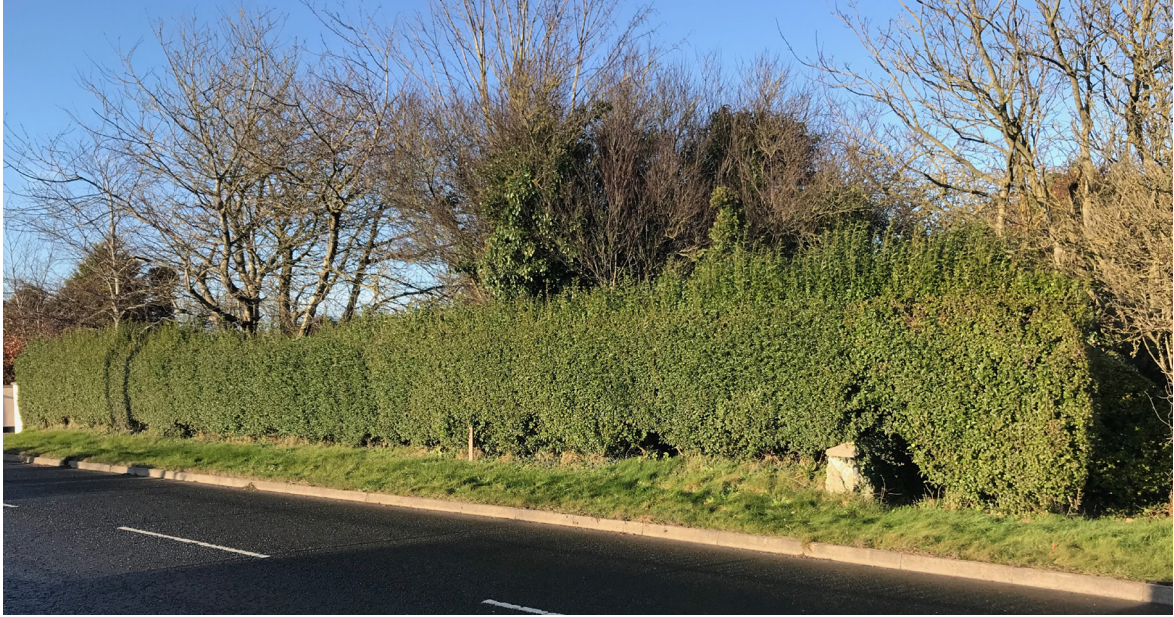
Image 15: Area J. Privet hedge 2 metre high. Well maintained. Set 1.75 metres from the roadside. Shown behind hedge are beech and cherry trees (#685, # 686 and #687).

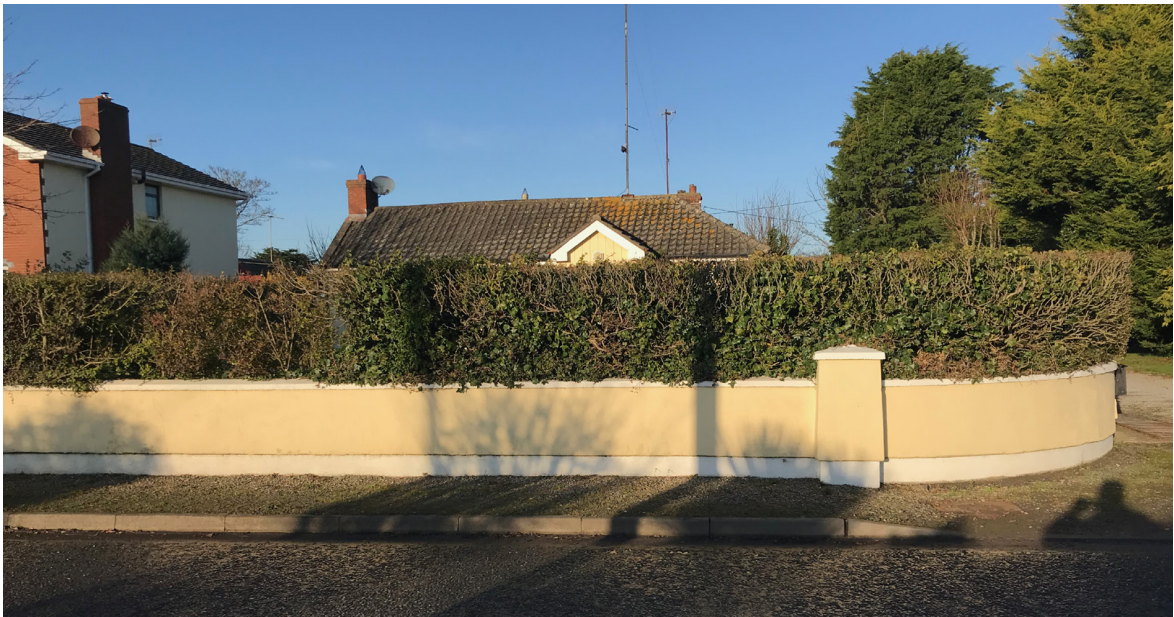
Image 16: Area K. Privet hedge 1.7m high behind a low stone wall. Gappy in places but well maintained.

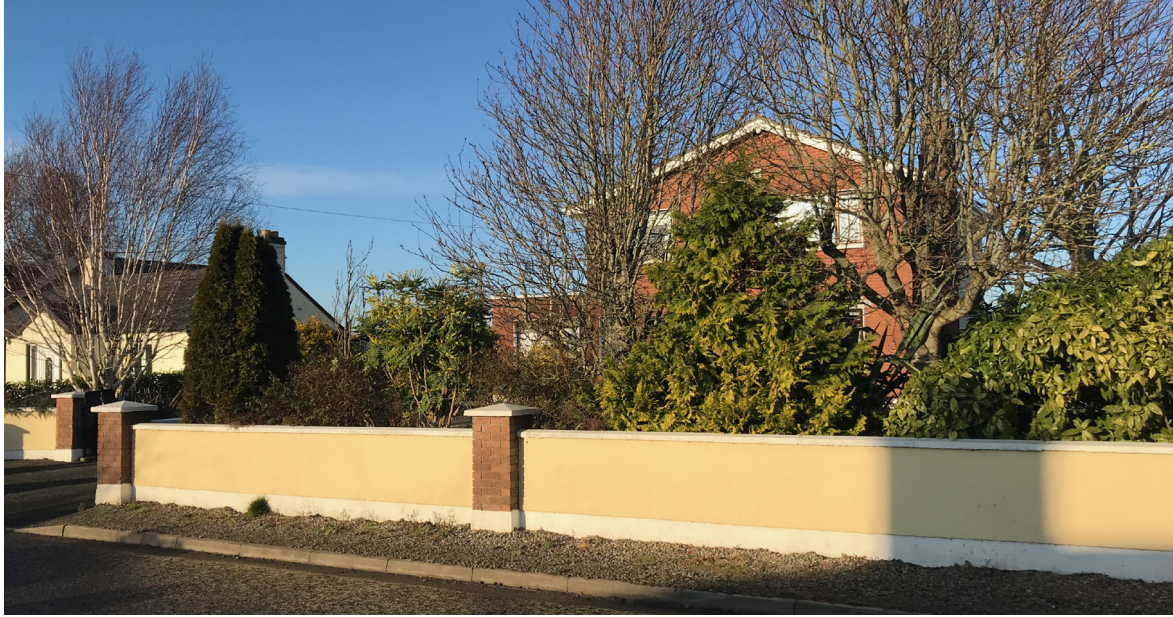
Image 17: Area L; Golden cypress (*Cupressus* cv), young birch (*Betula pendula*) and two young cherry (*Prunus* cv), behind a low stone wall.

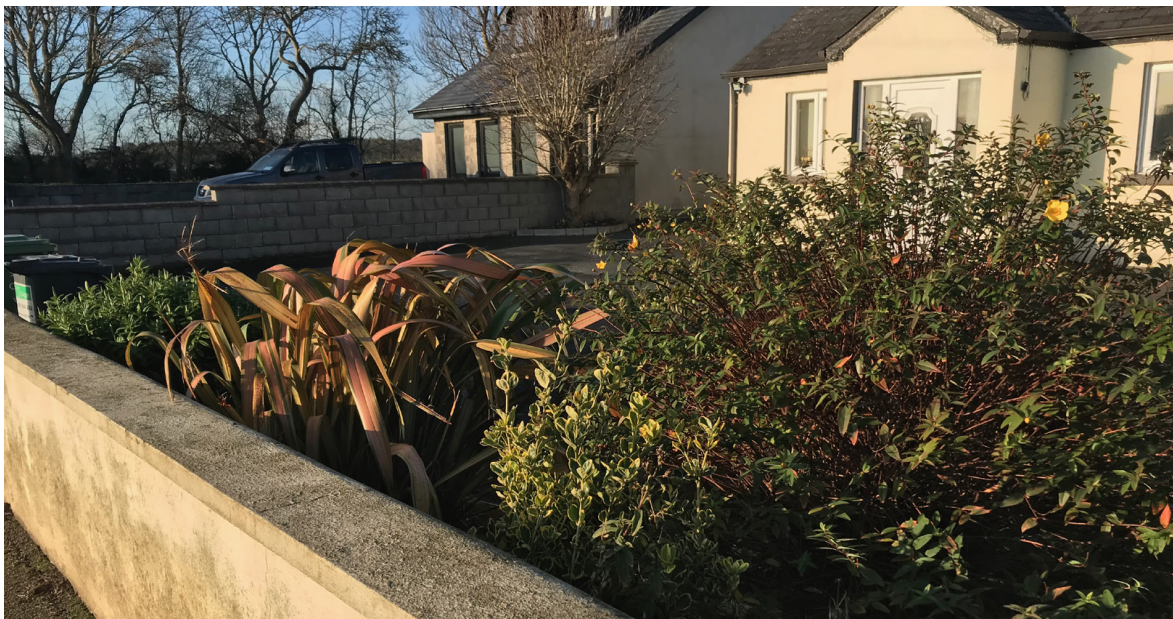
Image 18: Area M; Mix of shrubs (New Zealand Flax *Phormium* cv, *Euonymus* cv, Rose of Sharon) behind a low concrete wall.

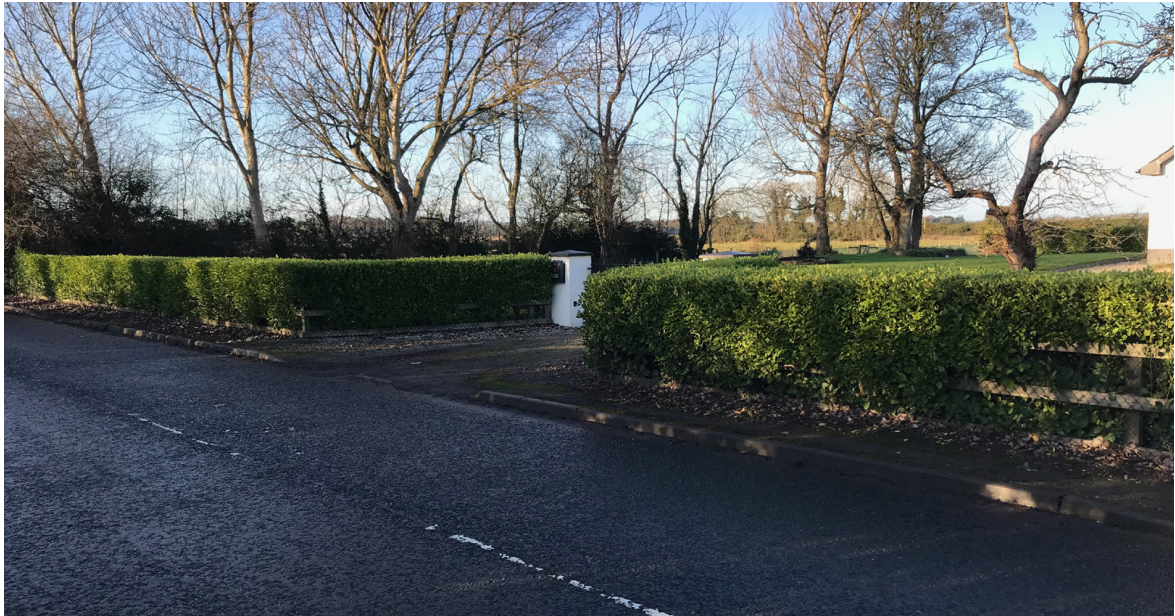
Image 19: Area N; Griselinia hedge 1 metre high. Well maintained. Located 0.5m from roadside and extending 35m long in front of the property.

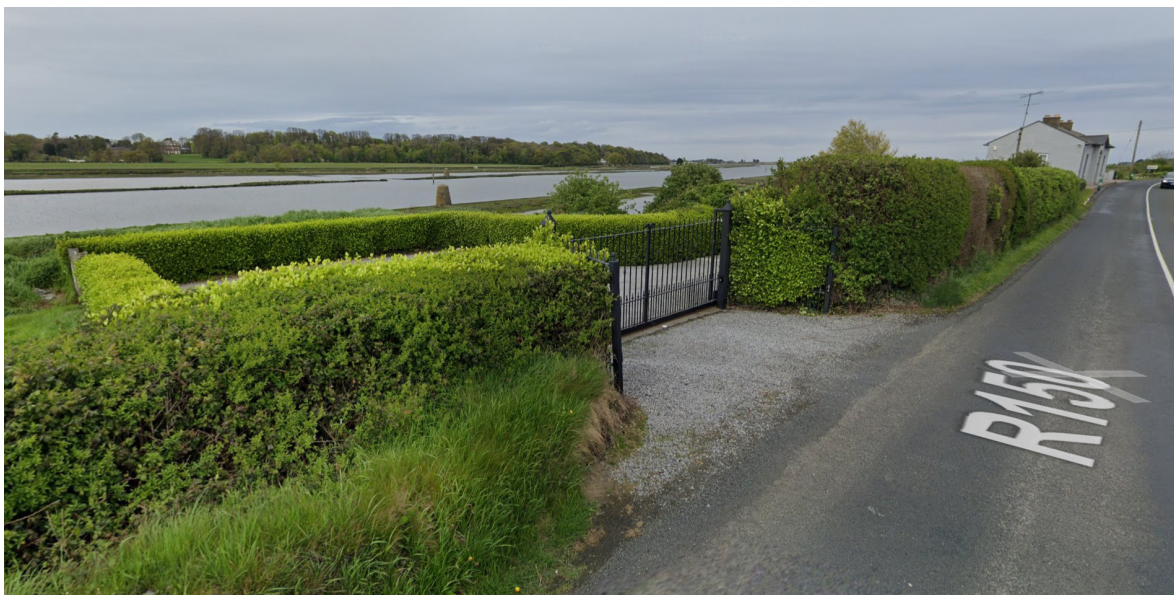
Image 20: Area O; Privet hedge 1.75m high and griselinia hedge 1.25m high. Well maintained.

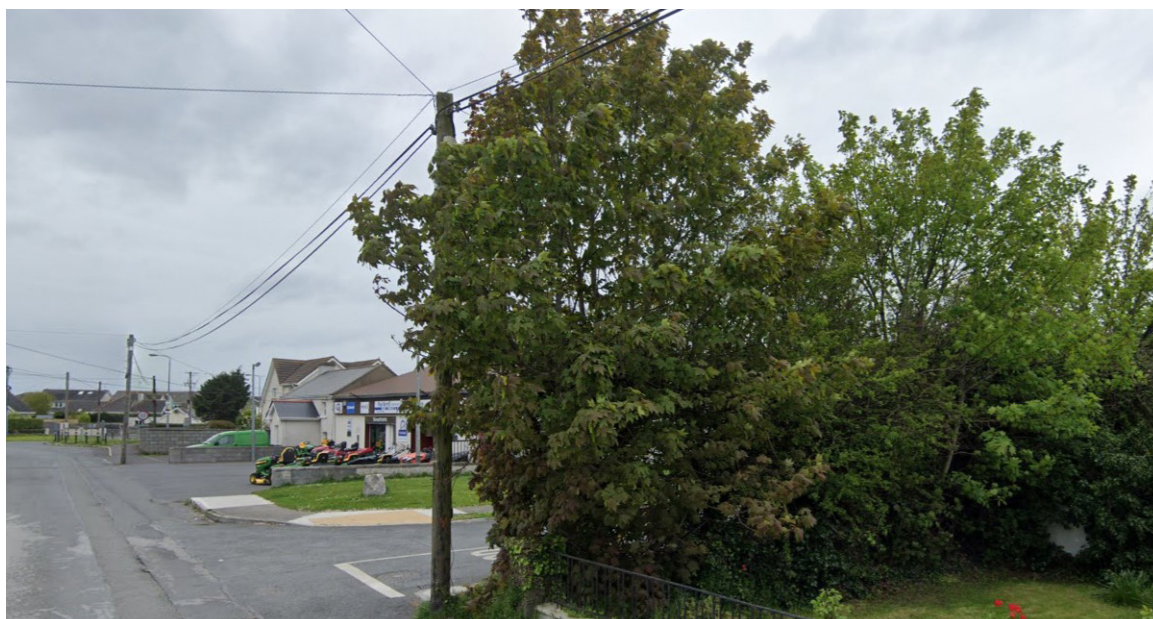
Image 21: Area P; A young sycamore inside private land at the intersection of Tower road and The Haven.
