# **Arboricultural Assessment, Arboricultural Impact and Tree Protection Strategy Report**

**Boyne Greenway -  
Drogheda to Mornington,  
Co. Meath/Co. Louth**

<b>Project No.</b>	TBOY001	<b>Date</b>	25/02/22
<b>Project Name</b>	Boyne Greenway - Drogheda to Mornington	<b>Revision</b>	C

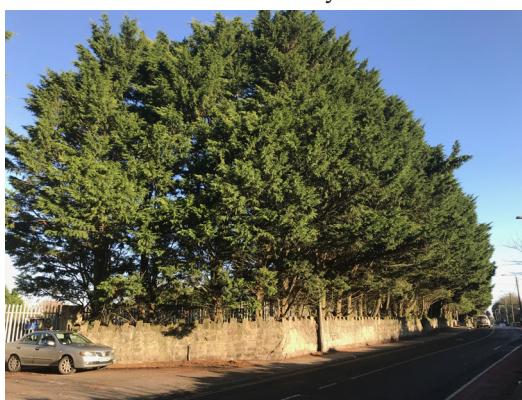
In the western section, for the first 130 meters of the survey area, a group of 61 Leyland cypress *Cupressus × leylandii* form a screen planting to former industrial grounds north (see image 2). These trees are of moderate landscape value and may have limited long-term potential due to poor root conditions from construction activity.

Image 2. Group of Leyland cypress screening former industrial grounds, 130 metre long.

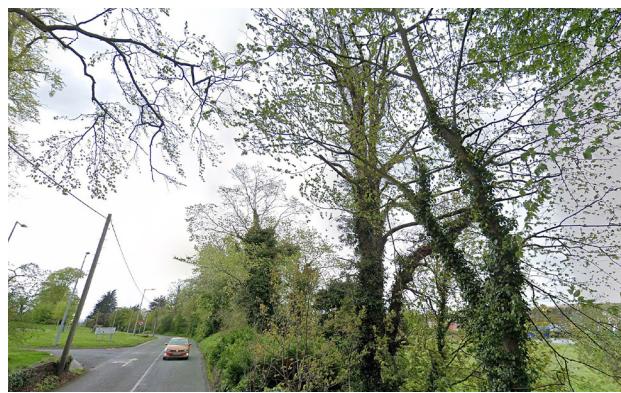
Located opposite Drogheda Grammar School in a dense roadside grouping (see image 3) are a mixture of mature horse-chestnut *Aesculus hippocastanum* and Sycamore *Acer pseudoplatanus* and younger self-seeded native/naturalised species Wych Elm *Ulmus glabra*, Sycamore *Acer pseudoplatanus* and Beech *Fagus Sylvatica*. Trees in this area constitute the greatest concentration of higher value specimens, in terms of variety, vulnerability and landscape value.

Image 3. Group of trees opposite Drogheda Grammar School.

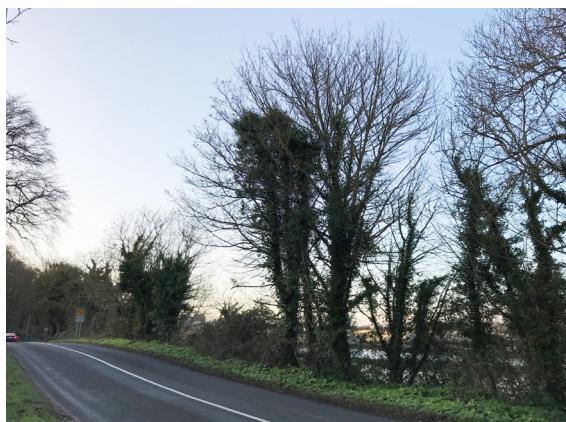
Along the central section of the surveyed area trees are located in close proximity (less than one metre) from the R150 roadside. The average quality of these trees are moderate to poor (B-C) with many being of drawn up form due to local competition (see image 4).

Image 4. Sycamore and ash along the R150 east of Mill Road.

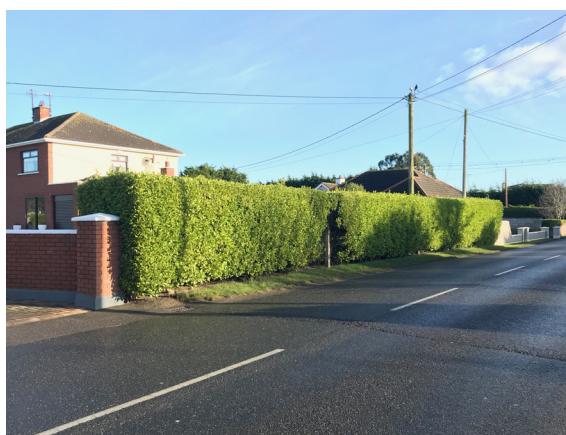
In the residential area of Mornington, garden hedges with tree plantings were surveyed along a 750 metre long section (see image 5). These chiefly consist of well maintained Green Privet *Ligustrum Ovalifolium* and Griselinia *Griselinia littoralis*. These are detailed in section 5.

Image 5. Griselinia hedge in the residential area of Mornington.

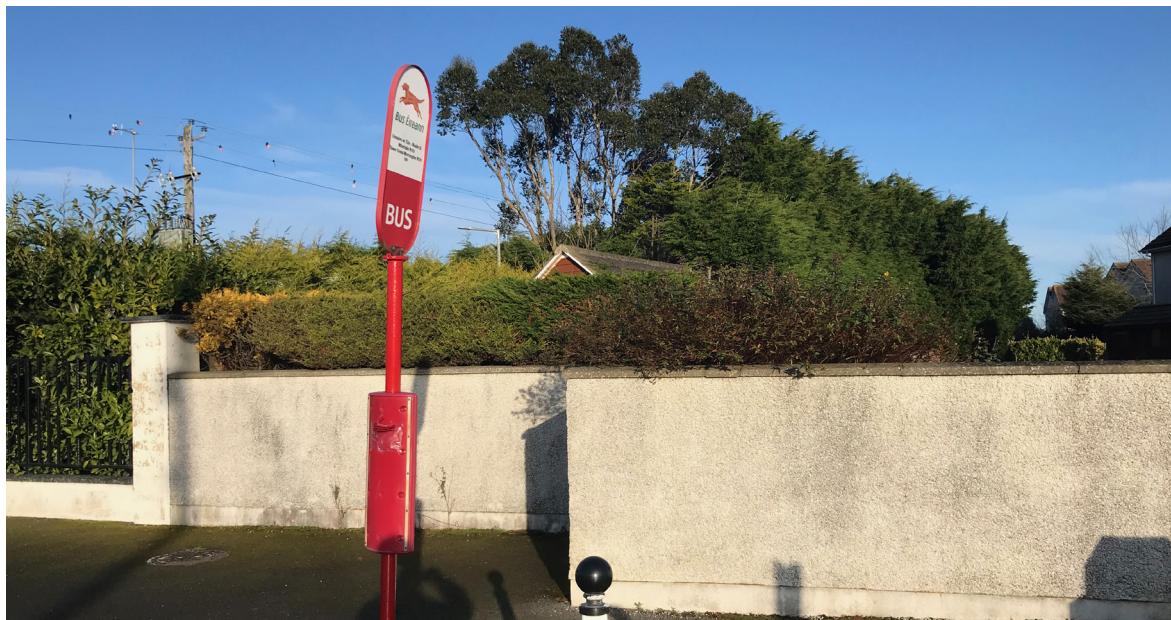
Image 7: Area A; Crinodendron hookerianum with Leyland hedge. Hedge 2 meter high and 4 metre long. Well maintained behind a 1.5 metre high pebbledash wall.

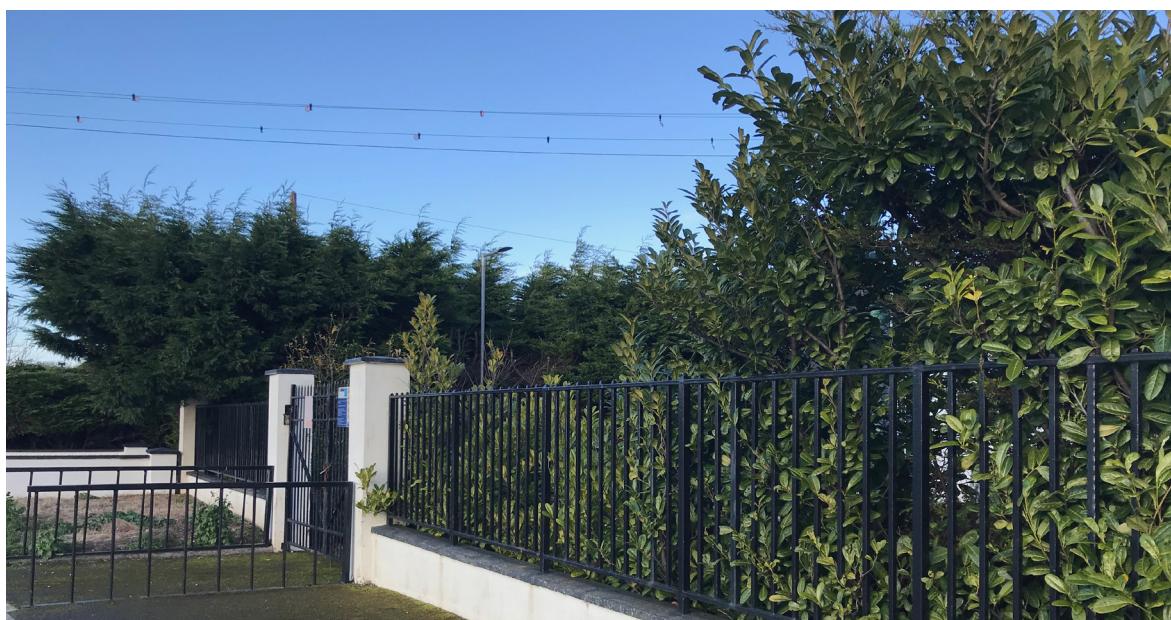
Image 8: Area B; Laurel *Prunus laurocerasus* hedge 1.5 metre high behind a metal fence screening a sewage pumping station.

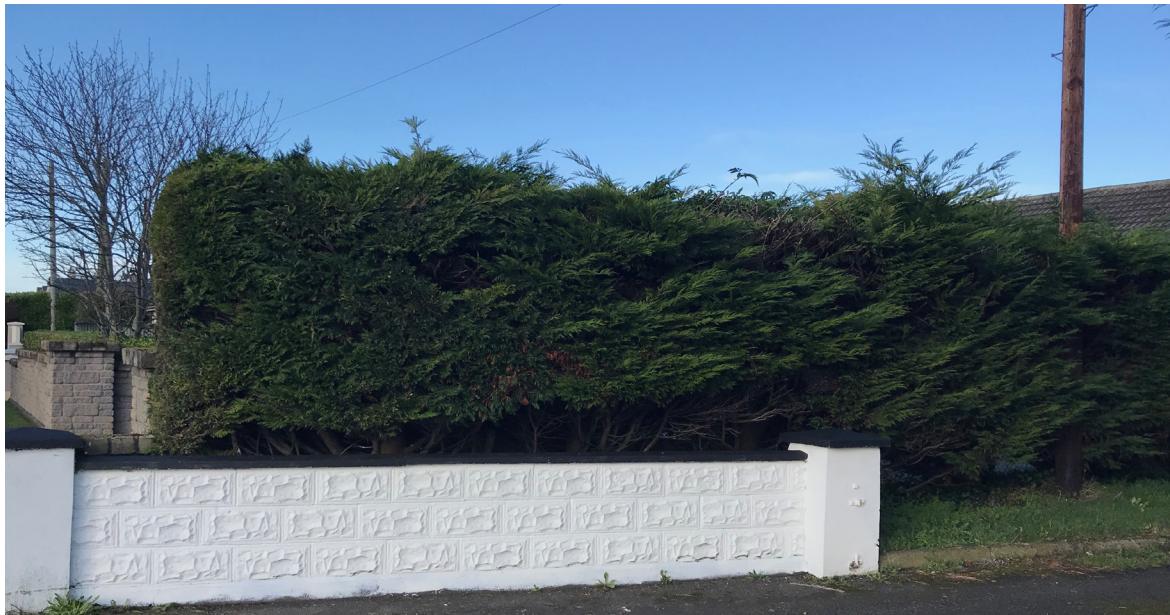
Image 9: Area C; A Leyland hedge 2.25 metre high in a line perpendicular to the roadway. Well maintained.

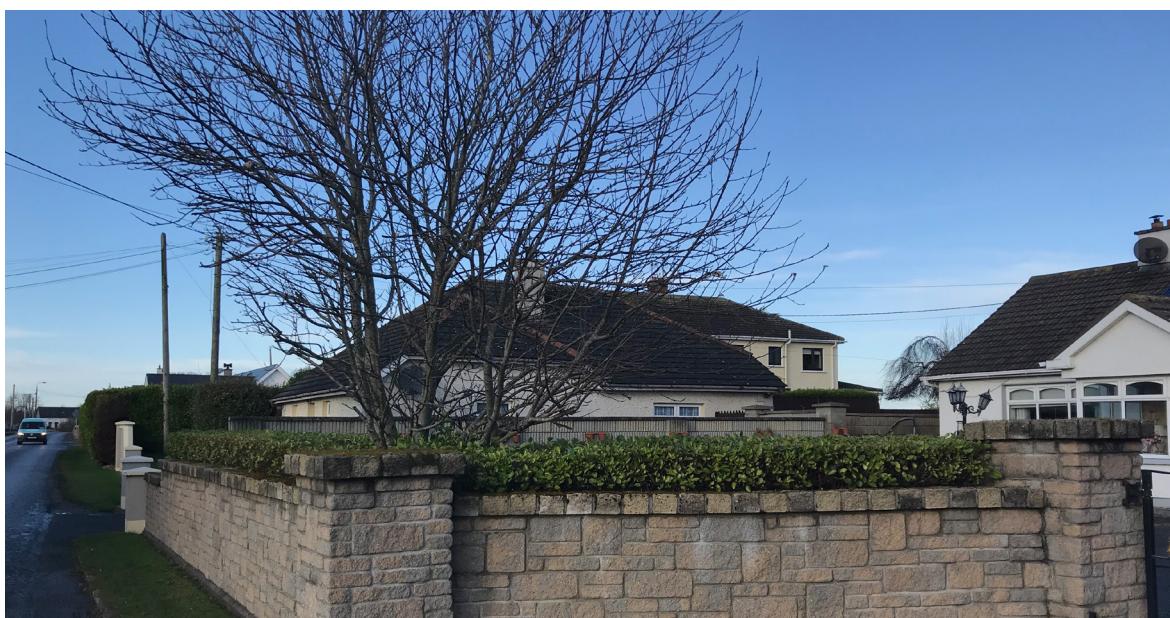
Image 10: Area D; Griselinia hedge 1.5 metre high behind a brick wall. Well maintained and vigorous. 9 metre long. Early mature Swedish whitebeam (#693) shown left.

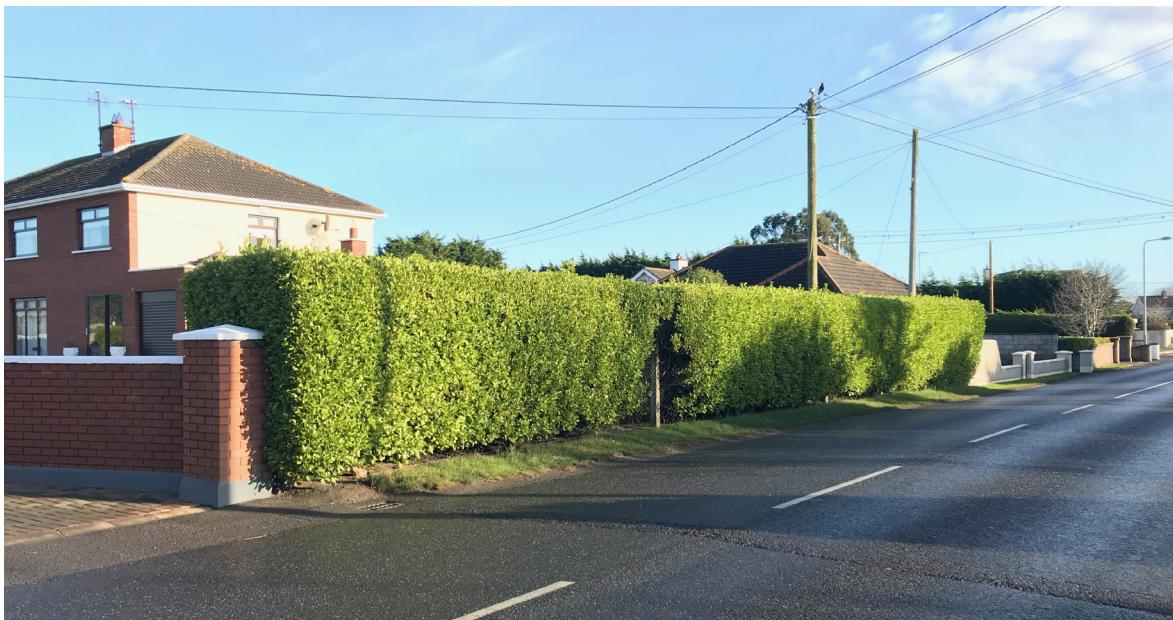
Image 11: Area E; Griselinia hedge 2 metre high behind a 1 metre high mesh wire fence. Well maintained. 23 metres long.

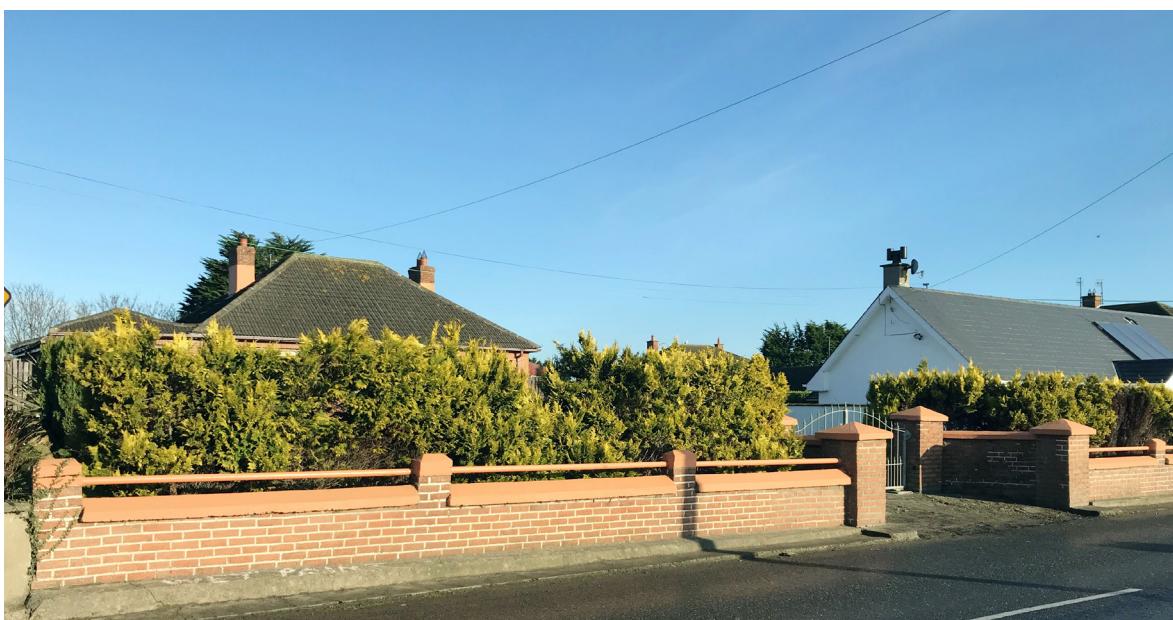
Image 12: Area F; Golden cypress (*Cupressus* cv) hedge topped to 1.75 metre high behind a low brick wall. Well maintained with no visible defects.

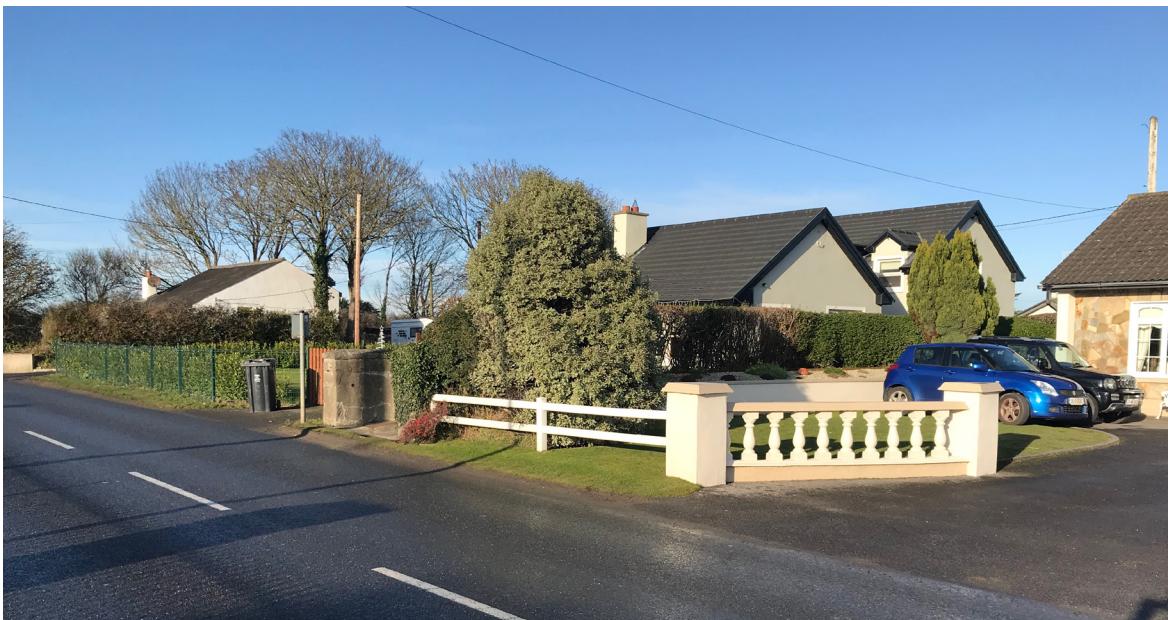
Image 13: Area G. 1.25 metre high privet hedge on eastern boundary of garden. Perpendicular to roadway. 2.5 metre euonymus cultivar, 1 metre from roadside. Well maintained.

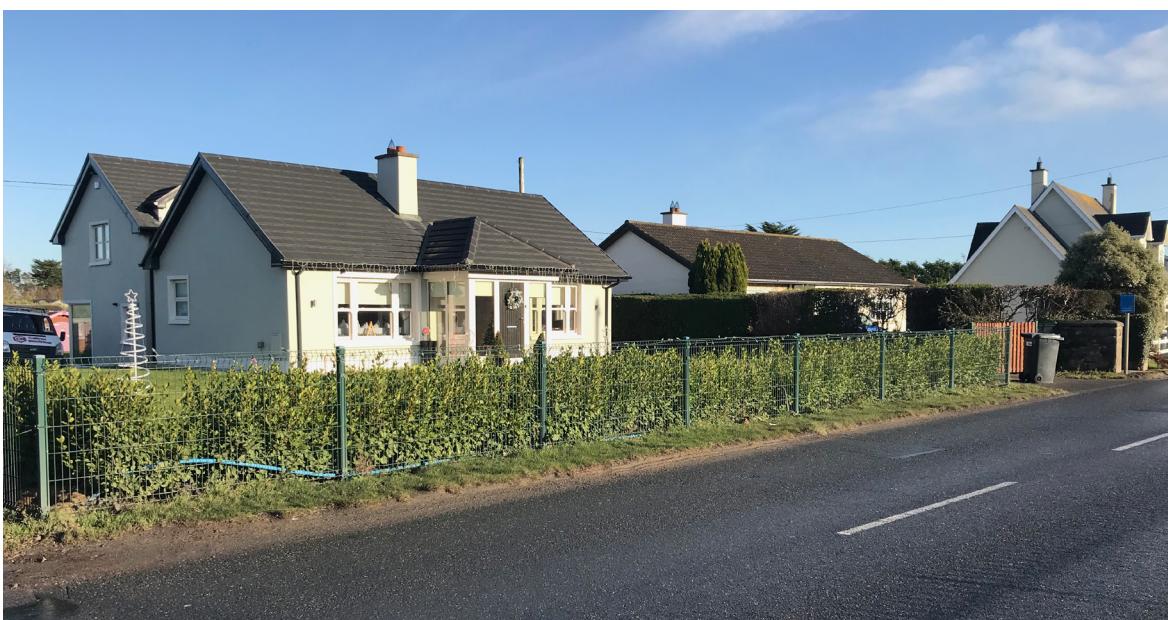
Image 13: Area H. Juvenile griselinia 0.5 high metre hedge. Recently planted for screening to residential property.

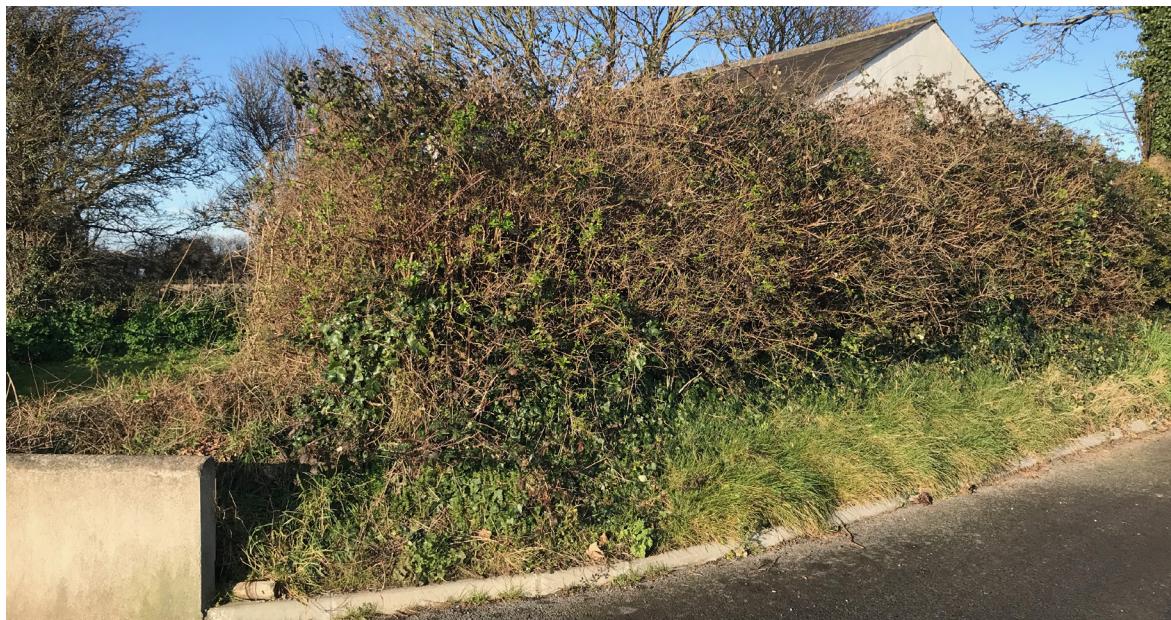
Image 14: Area I; Bramble hedgerow located on property on corner of R150 and North Lane. 2.25 metre high in a line perpendicular to R150. Well maintained.

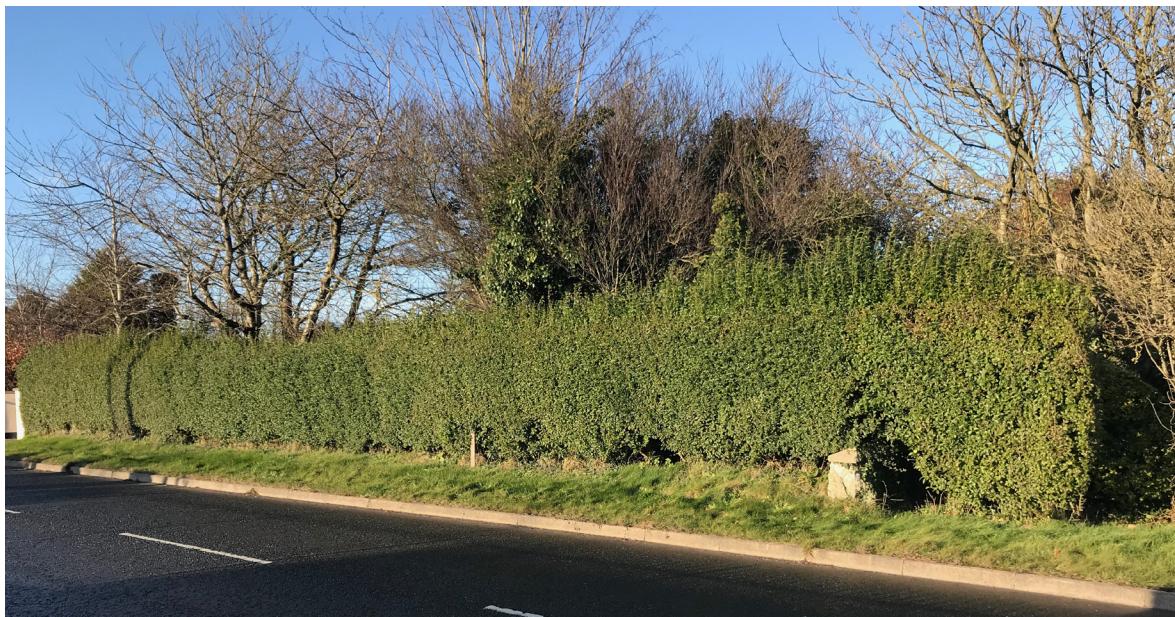
Image 15: Area J. Privet hedge 2 metre high. Well maintained. Set 1.75 metres from the roadside. Shown behind hedge are beech and cherry trees (#685, # 686 and #687).

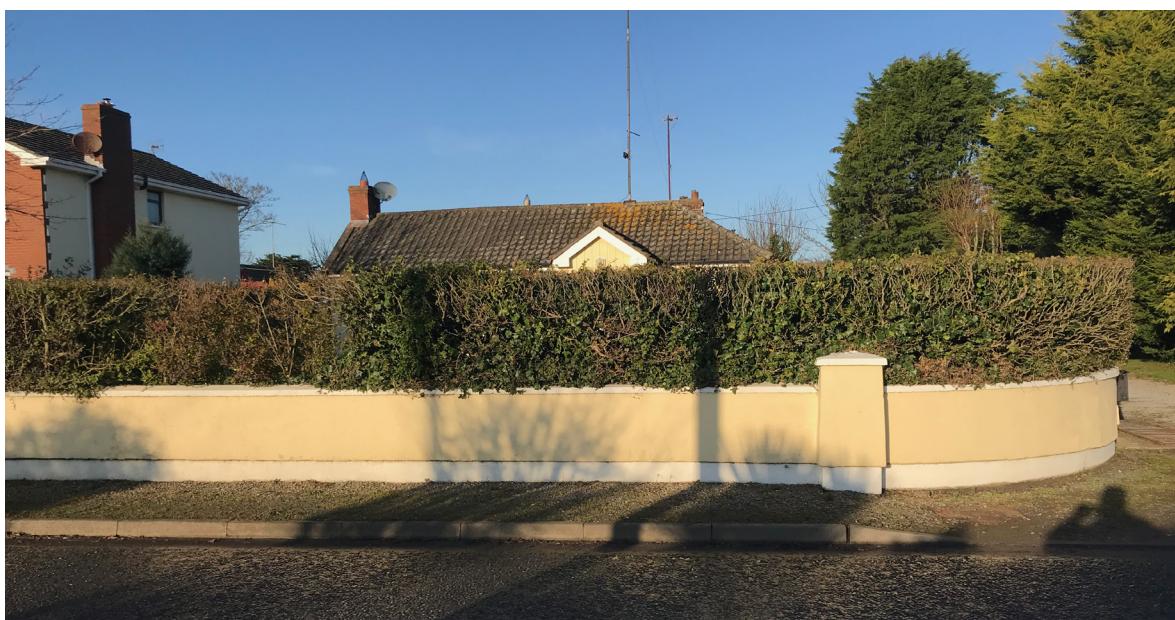
Image 16: Area K. Privet hedge 1.7m high behind a low stone wall. Gappy in places but well maintained.

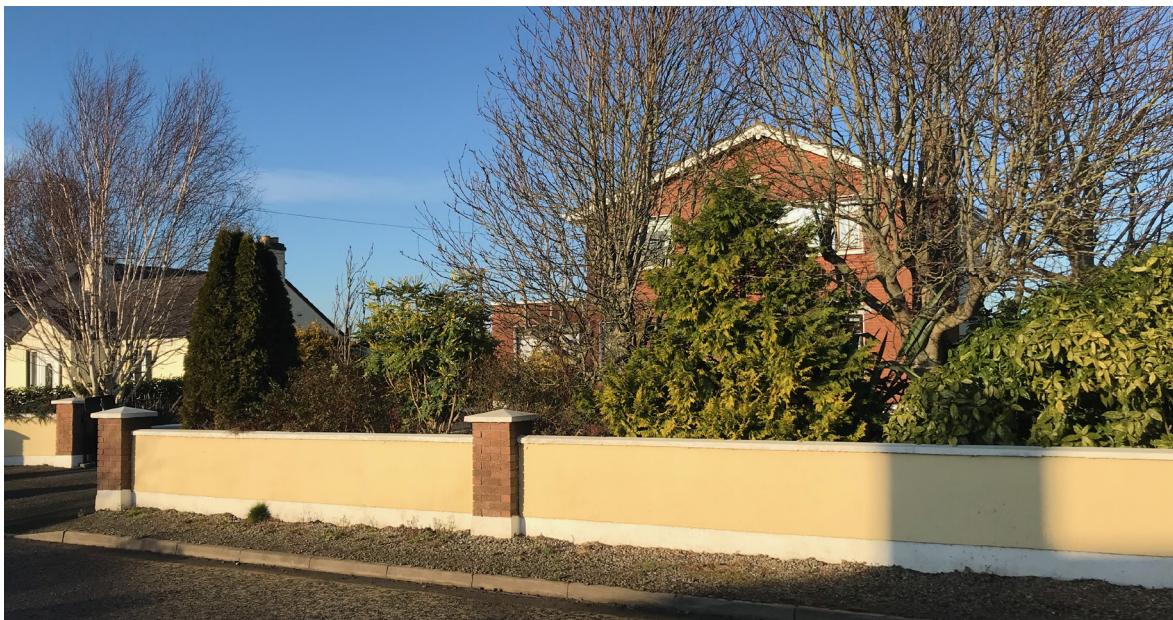
Image 17: Area L; Golden cypress (*Cupressus* cv), young birch (*Betula pendula*) and two young cherry (*Prunus* cv), behind a low stone wall.

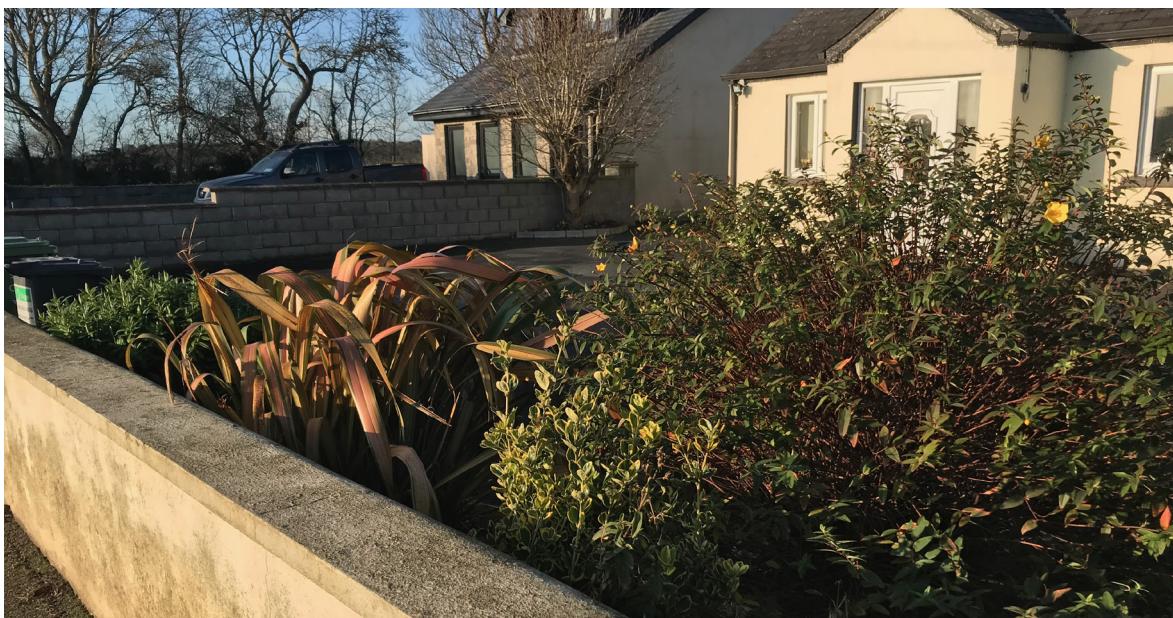
Image 18: Area M; Mix of shrubs (New Zealand Flax *Phormium* cv, *Euonymus* cv, Rose of Sharon) behind a low concrete wall.

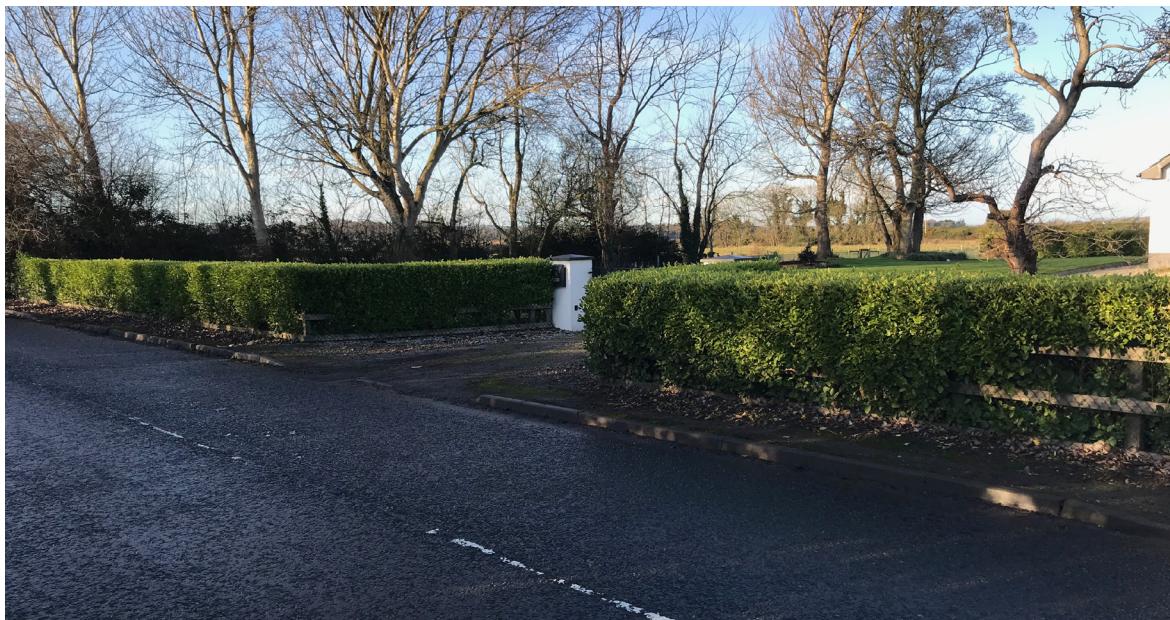
Image 19: Area N; Griselinia hedge 1 metre high. Well maintained. Located 0.5m from roadside and extending 35m long in front of the property.

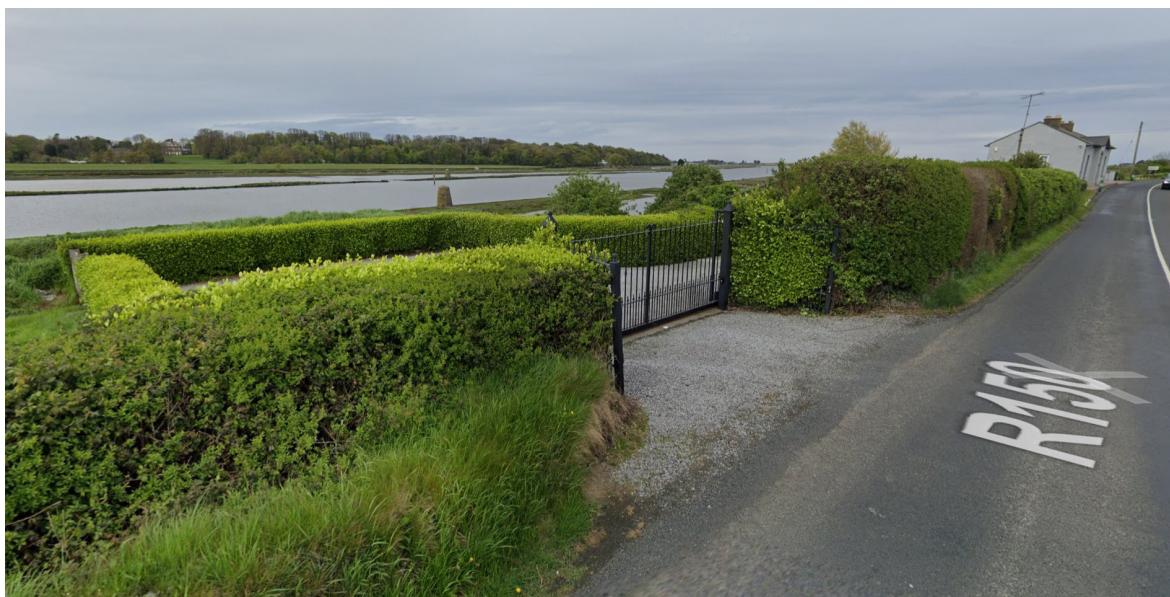
Image 20: Area O; Privet hedge. 1.75m high and griselinia hedge 1.25m high. Well maintained.

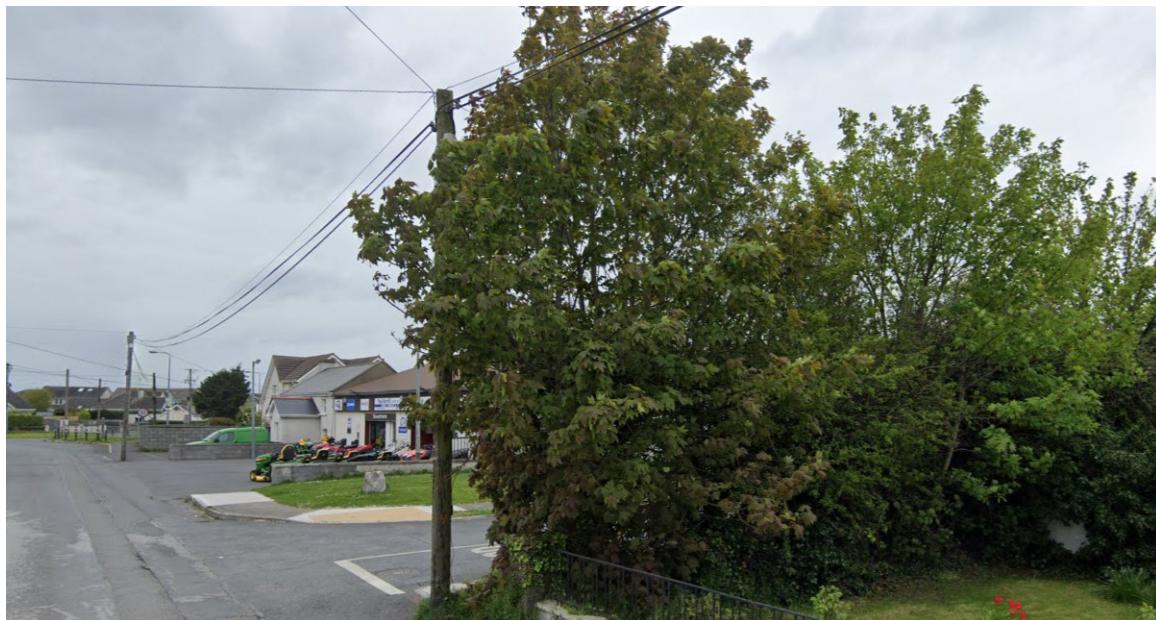
Image 21: Area P; A young sycamore inside private land at the intersection of Tower road and The Haven.
