advice series

A GUIDE TO THE REPAIR OF HISTORIC ROOFS

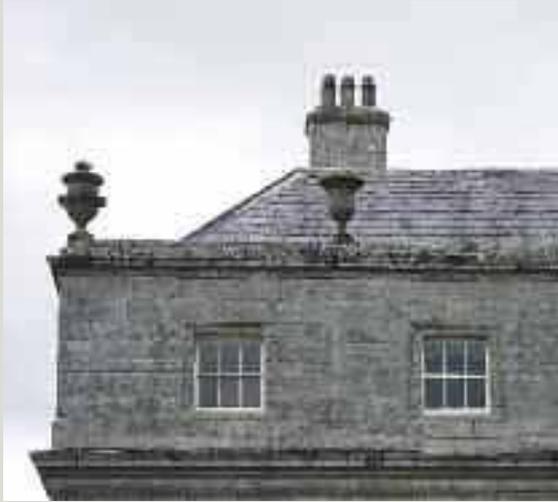
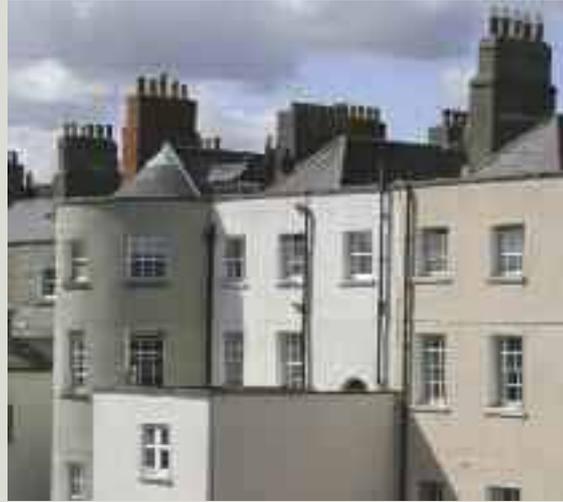
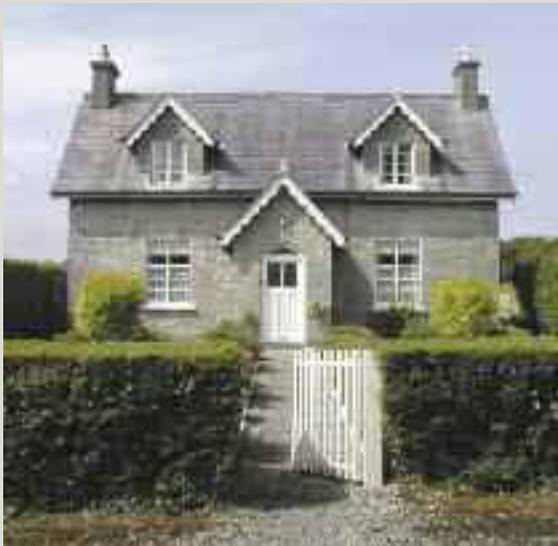
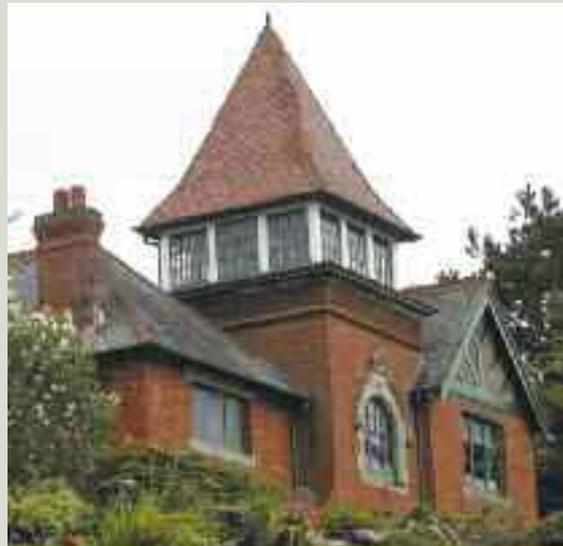
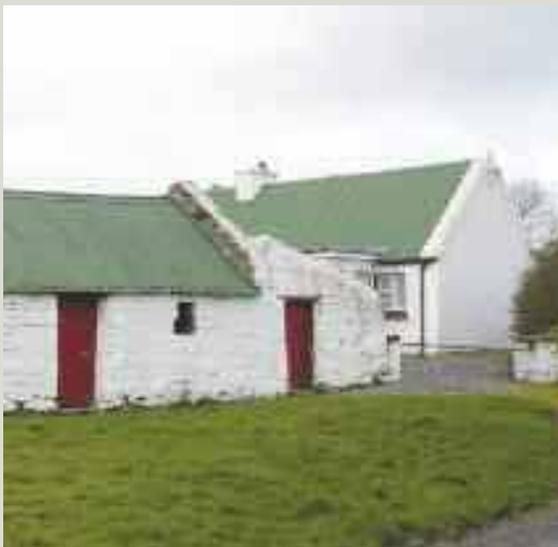
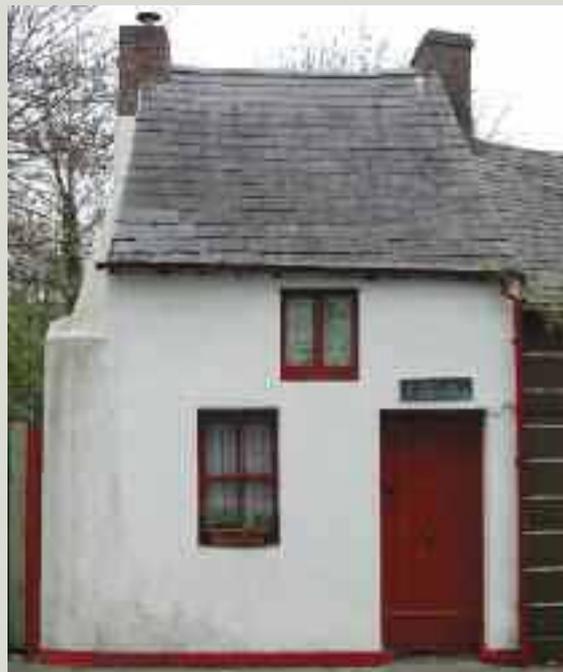
Irish roofs take many forms; the style and choice of materials used were influenced not only by the available materials, but also by architectural fashion

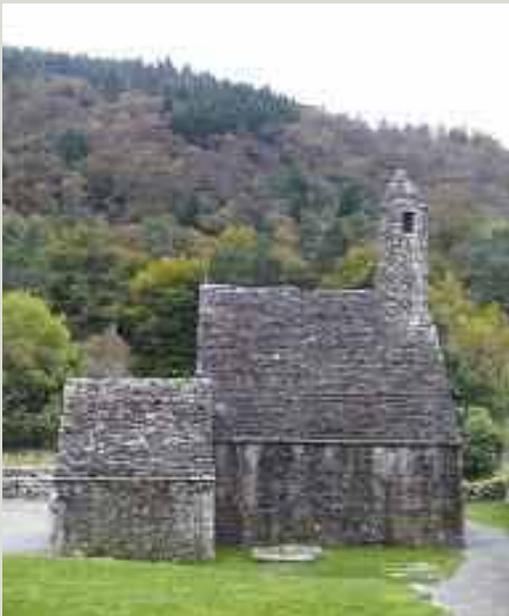
Saint Kevin's Church, Glendalough, County Wicklow. The steeply pitched roof of local stone was built up by corbelling and is supported on walls almost 4 feet (1.2m) thick

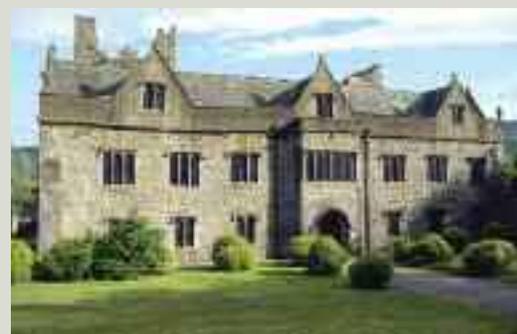
Tower houses were heavily fortified, with their roofs concealed behind battlements. In contrast, the architecture of the sixteenth and seventeenth centuries brought the roofscape increasingly into full view. At Ormond Castle, County Tipperary, the remains of the earlier tower house can be seen rising behind the Elizabethan mansion with its then highly fashionable dormer gables

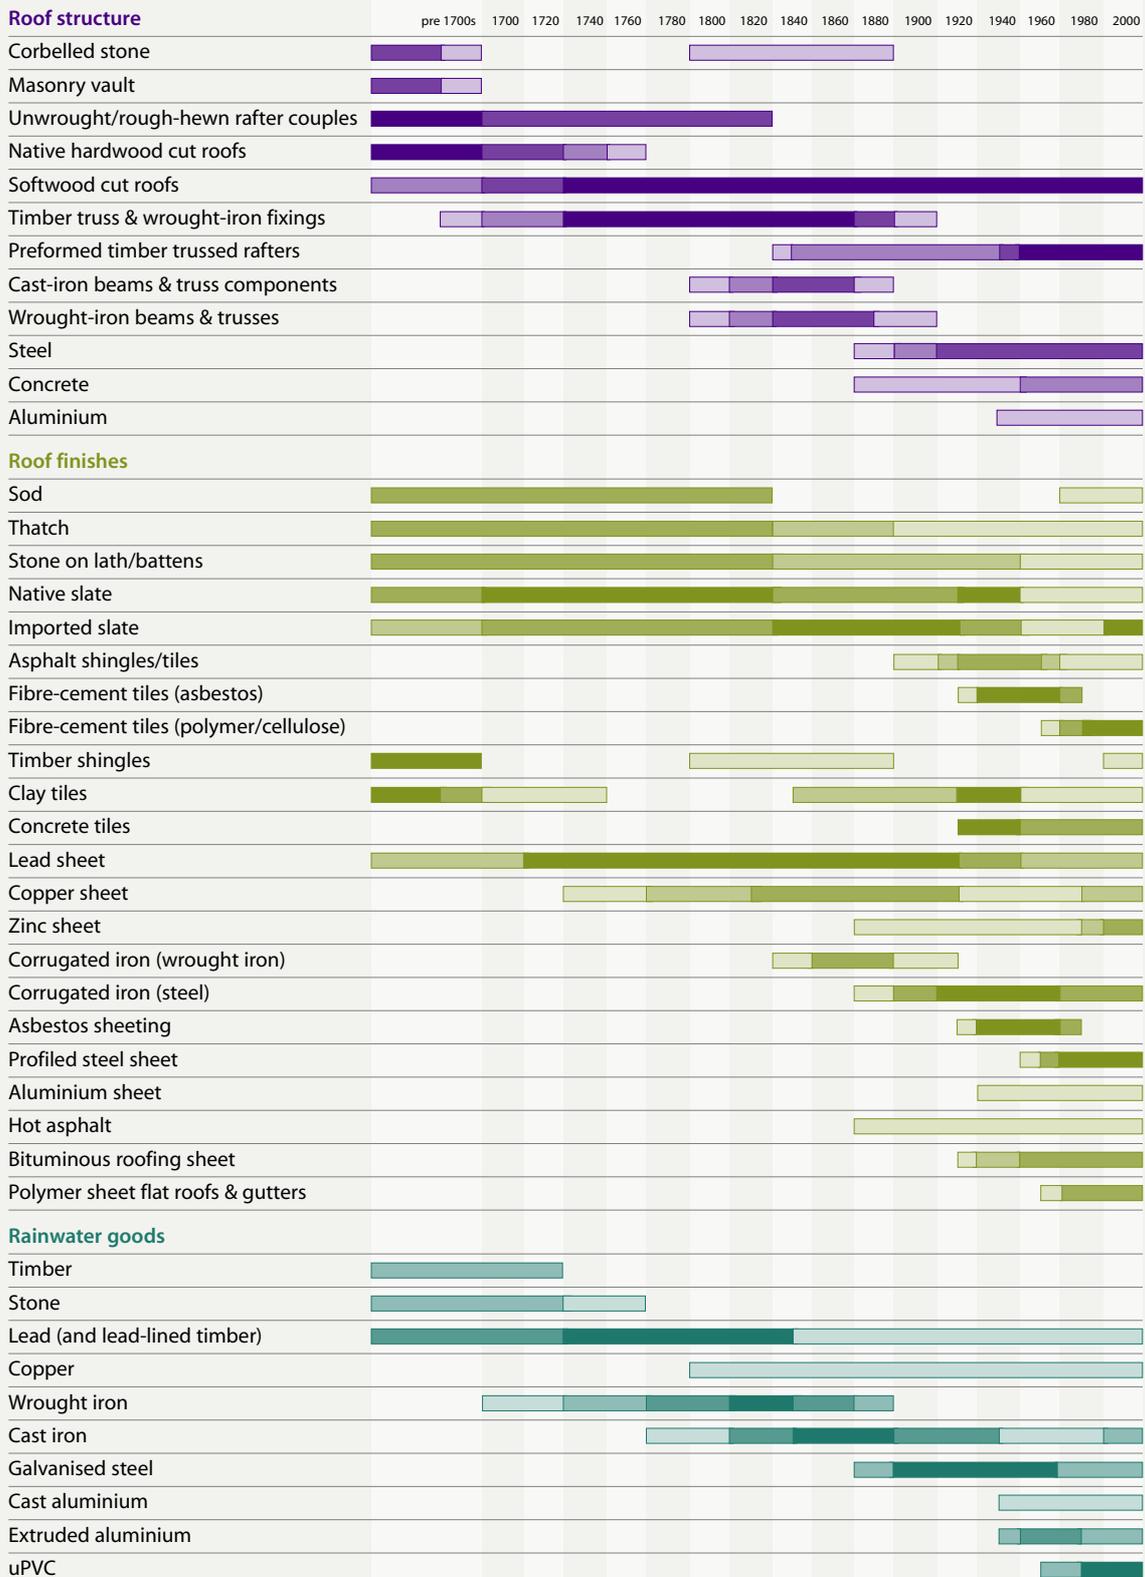
The degree of shading relates to the extent of use of the roofing material: the darkest shading indicates periods when the material was in widespread use while the lightest shading indicates periods when it has been found in use in isolated examples. In the periods where no shading is shown, there is no evidence of use of the material or it was not yet invented.

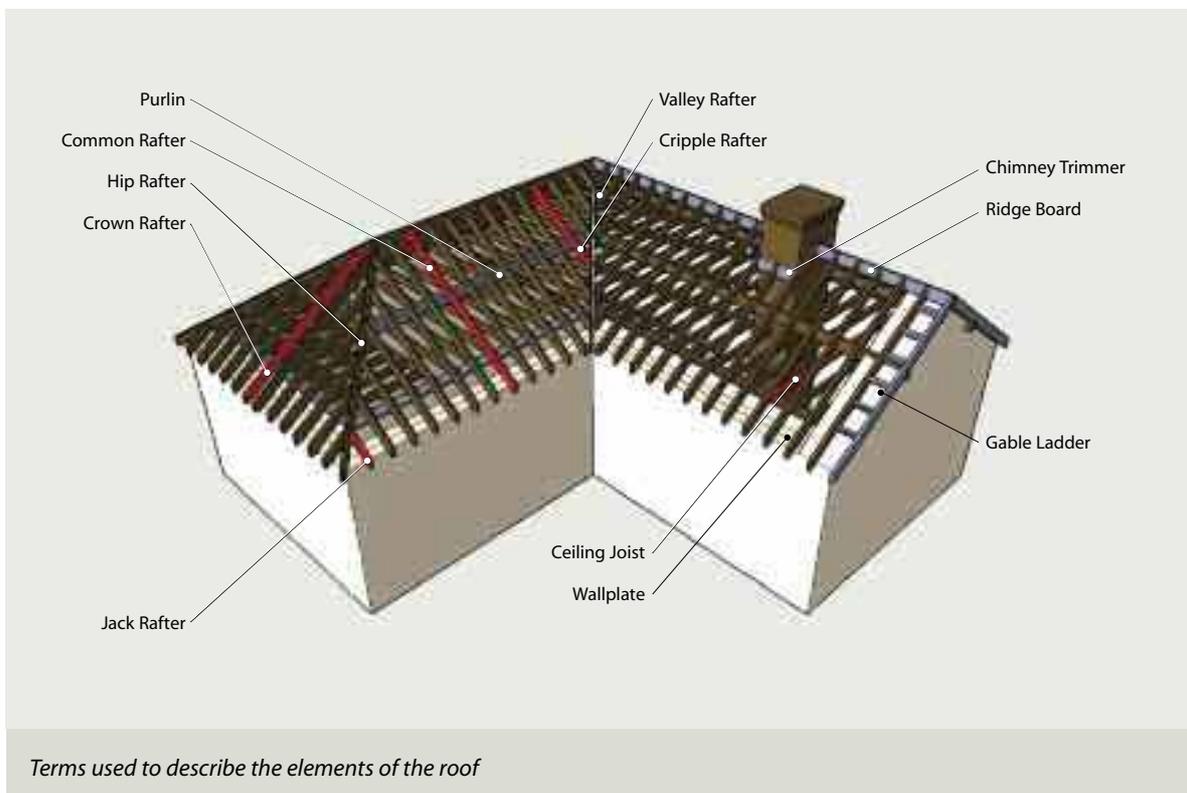
a steep pitch to prevent rainwater soaking into it. In many cases, a thatched roof may still be found beneath the metal covering. Similarly, the position of structural elements such as chimneystacks can provide clues to the date of a structure and to the internal layout of the building. Exposed chimneybreasts projecting from the gable ends of a house may indicate an English influence in the design, while a chimneystack in line with the main entrance of a vernacular dwelling denotes a central hearth protected by a jamb wall.

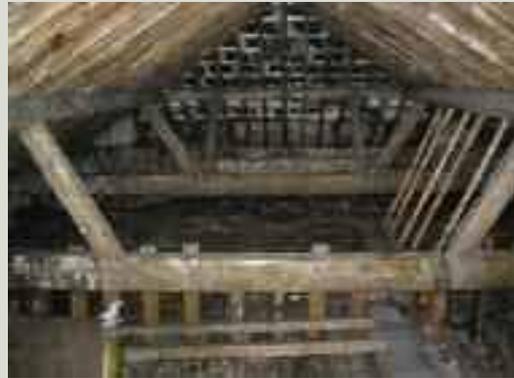
An eighteenth-century re-roofing of a tower house using imported deal

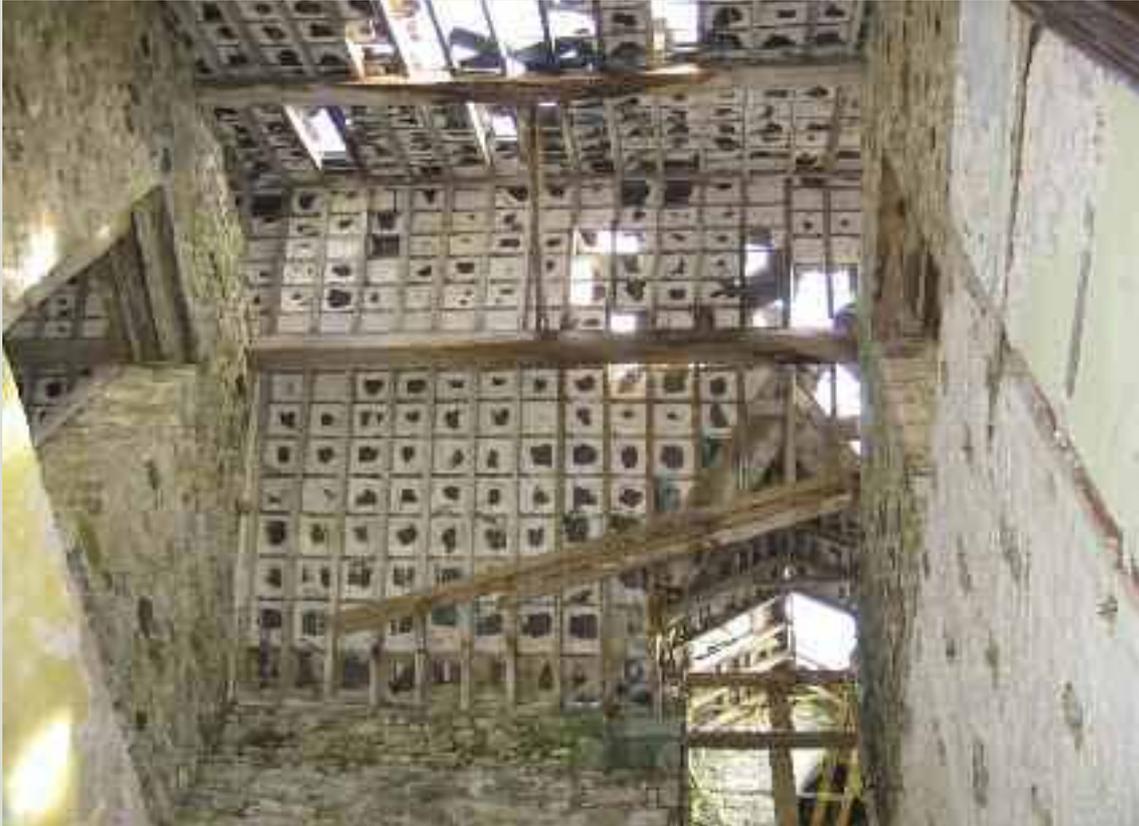
A roof detail particular to Ireland was the practice of continuing the masonry cross walls up into the roof space. Purlins were placed to span between the cross and gable walls to support the common rafters. This proved to be a very economical use of timber and also reduced the amount of skilled carpentry work required

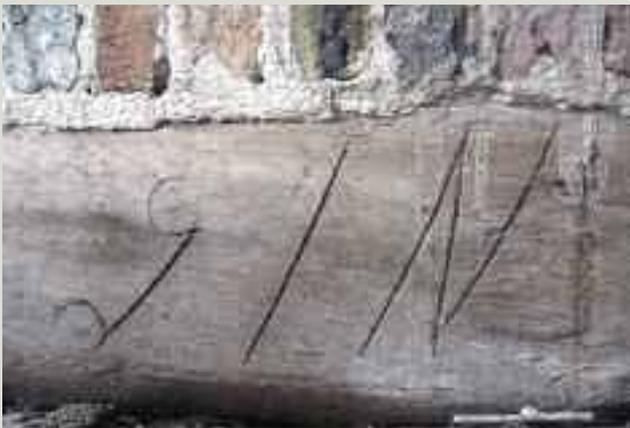
Merchant mark 'G I N' on this bay bressummer was exposed during works to repair this beam and the bay roof. Timber marks, where found, should be recorded and preserved and repair works should avoid concealment

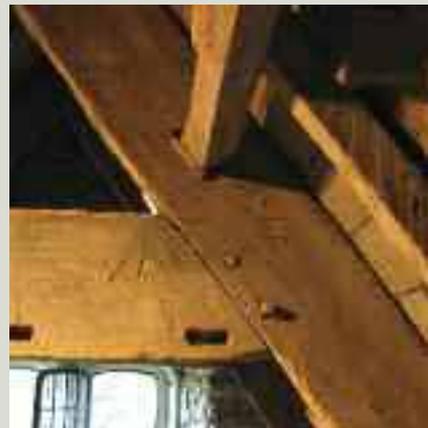
A survey of the timber structural elements of a roof often reveals merchant, religious or assembly marks on the historic timbers. These assembly marks on the oak timbers helped the carpenter to assemble the frame once on the roof. Note the pegged joints and the housing of purlins into frames. This is how roofs were constructed before nails and other metal fixings became readily available

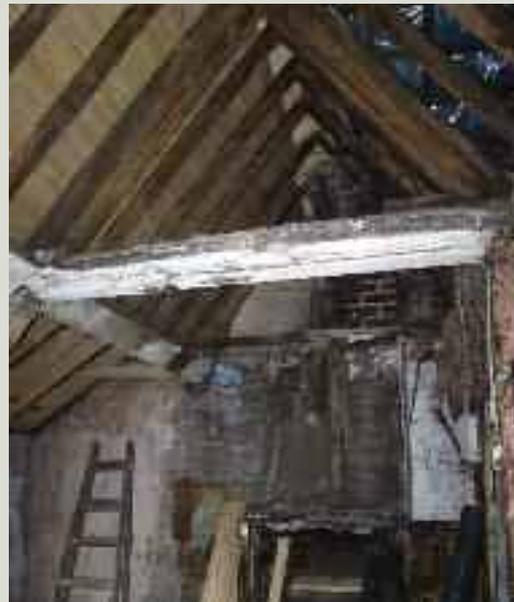
An early-seventeenth century roof showing the original principal roof structure and rafters with replacement sarking boards above (Image courtesy of Tom McGimsey, Mesh Architects)

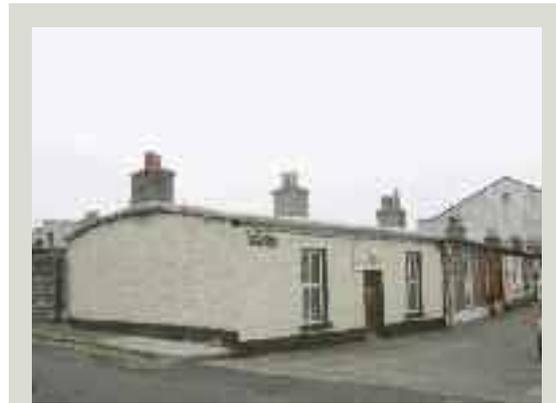
The 'Portlaw' roof was also used further afield for housing schemes, such as here in Harold's Cross, Dublin; also in Clara, County Offaly; Blarney, County Cork; and Carrick-on-Suir, County Tipperary. At one point, these trusses were exported to Germany

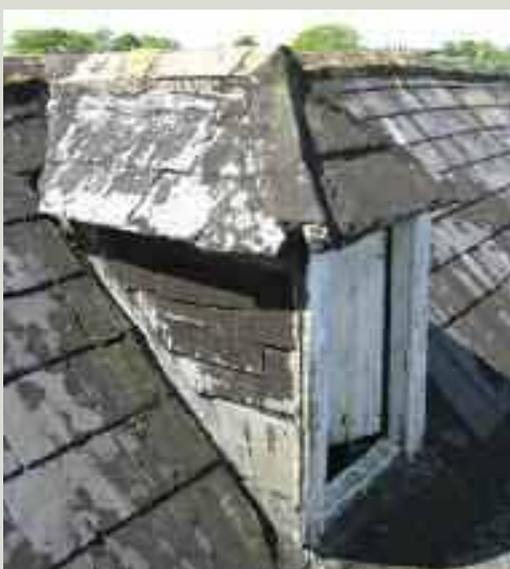
Pitch-roofed hatches, similar to dormers, were used to provide access to the roof for maintenance purposes. They were generally located in the central valleys, constructed of timber and finished with a cladding of slate or lead. By the end of the nineteenth century they had gradually been replaced by hinged cast-iron rooflights, which provided both daylight and roof access

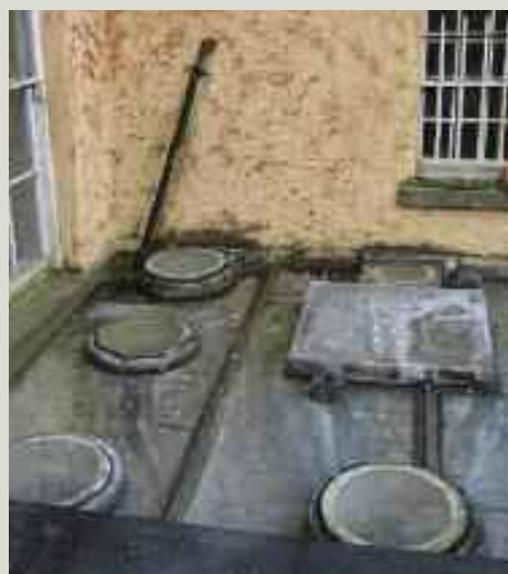
Glazed lanterns of circular and oval form were inserted into roofs as a means of bringing natural daylight into internal spaces such as landings and stairwells. Frequently these lanterns were poorly maintained because of difficulties of access and they were often replaced or covered over with a replacement roof covering. These circular glass rooflights are part of a nineteenth-century alteration

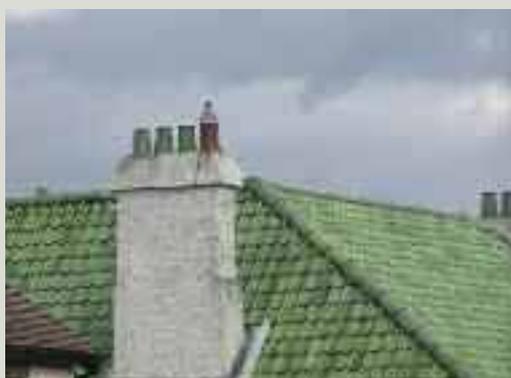
Glazed terracotta chimney pots are unusual, but examples with green, black and dark brown glazes can still be found with a simple roll-top detail. In this example, the bright green glazed pots match the glazed roof tiles. Further variations included tall dark brown terracotta pots with serrated tops and short plain black pots like crowns

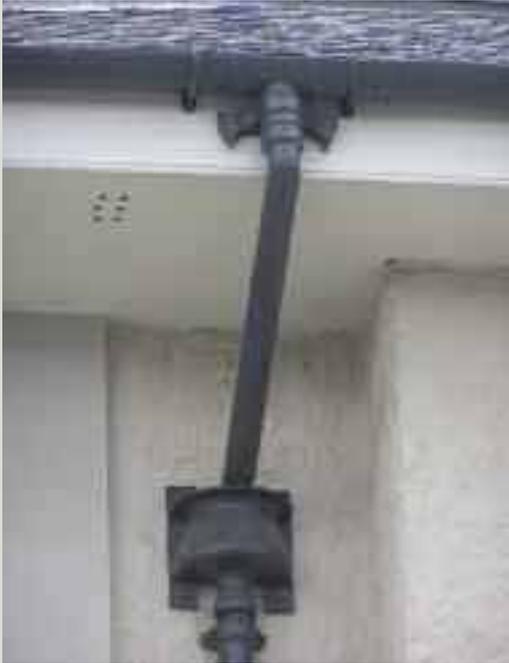
Cast-iron rainwater systems often copied the design of leadwork, but the stronger nature of cast iron enabled the use of shallow collars and two-point fixings rather than the deep collars needed to support lead rainwater goods

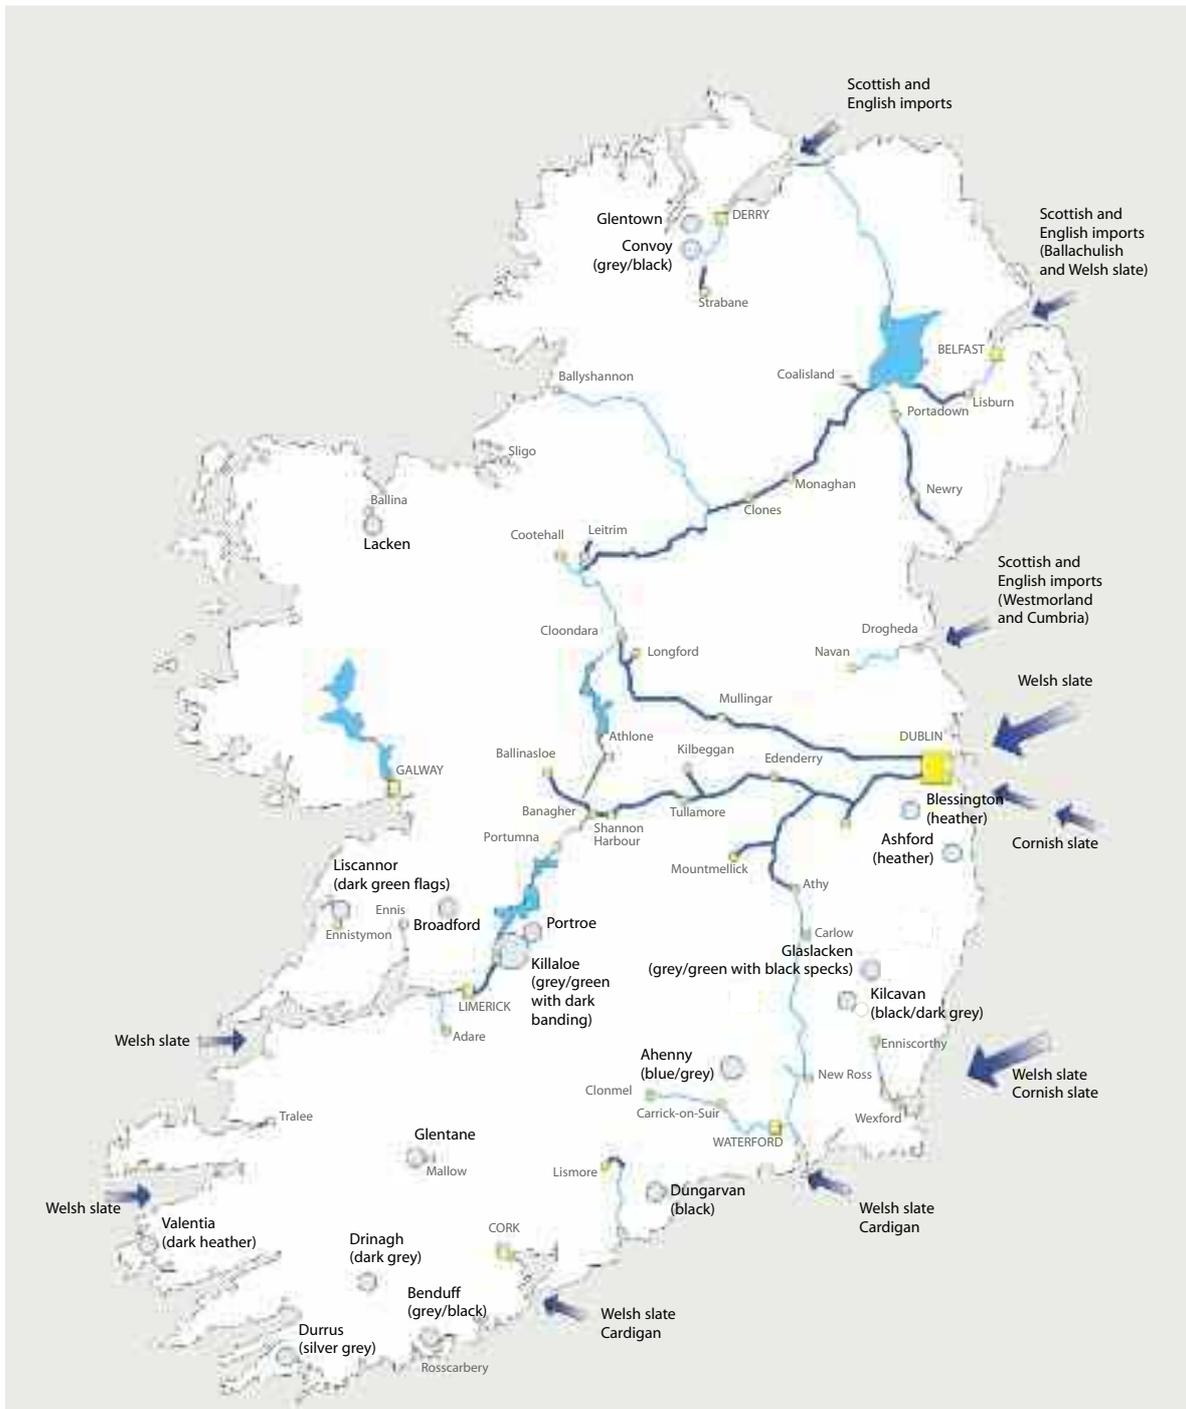
Slate quarries and locations of slate supply: this is not an exhaustive mapping, as research suggests that many sites worked on demand to supply local needs

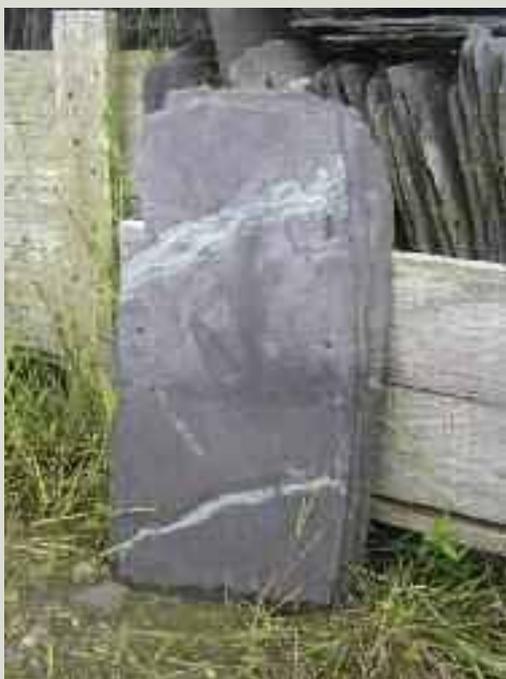
Salvaged sample of Ahenny slate. A series of quarries on the Tipperary/Kilkenny border made this one of the more prolific areas of slate production in Ireland in the nineteenth century

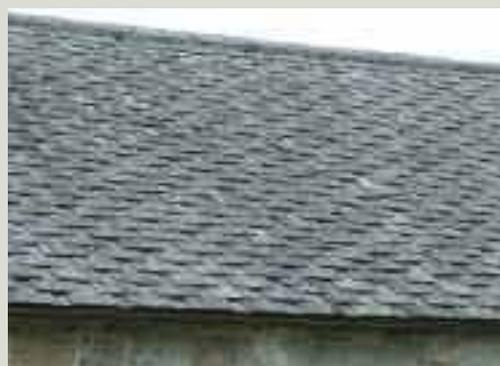
A method of slating sometimes referred to as 'open slating', 'hit-and-miss slating' or 'Scottish cant'. This slating pattern economised on the number of slates used and was primarily used for outbuildings. It is difficult to repair without face-fixing and the amount of exposure of slate surface can make the slates brittle for reuse

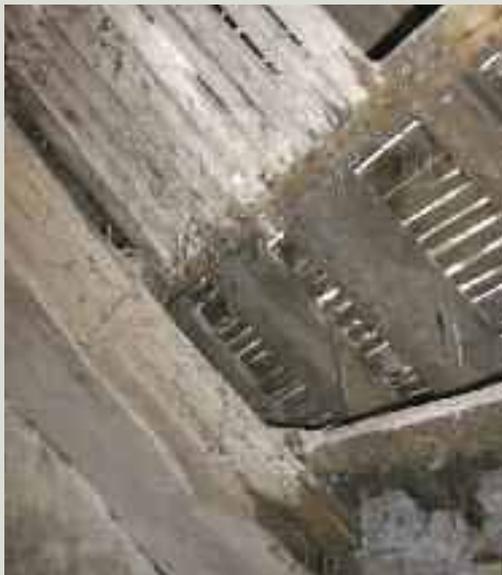
The recent discovery, within a later roof space of part of the former medieval friary in Ennis, of closely spaced riven laths fixed onto covered-over rafters substantiated the presence of an earlier structure within the historic fabric

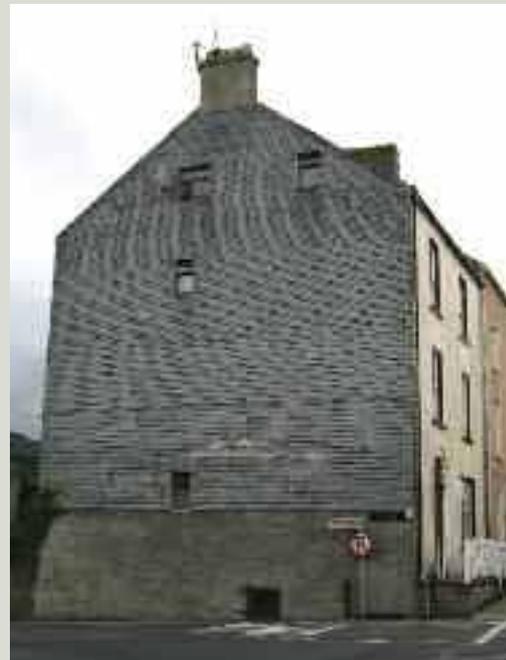
The best surviving examples of native Irish slate are most often found in vertical slate hanging, as it requires less frequent replacement than roofing slate. It is thought that this example of a slated gable is covered in Ahenny slate from the nearby Ormond quarries in the Carrick-on-Suir area

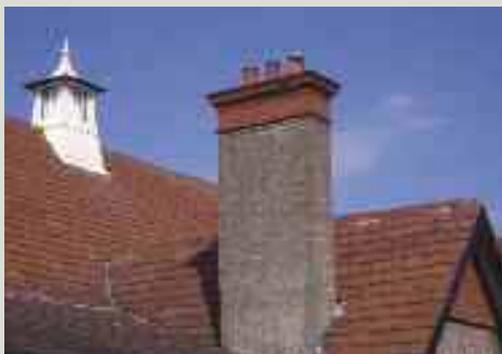
An Arts and Crafts style clay-tiled roof with tile hanging to the upper part of the gable

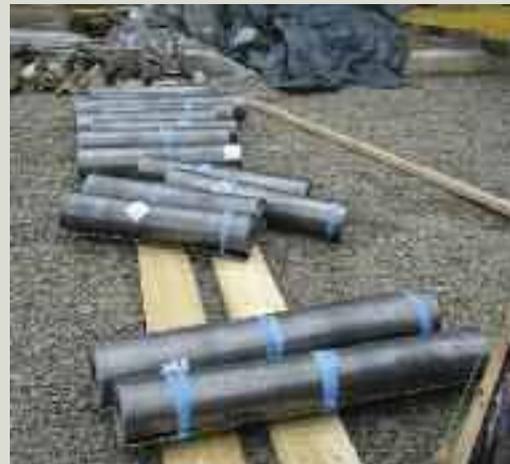
New lead sheet is supplied in rolls. Depending on the code specified, it can be exceedingly heavy and needs to be lifted with care. Despite this it is vulnerable to theft

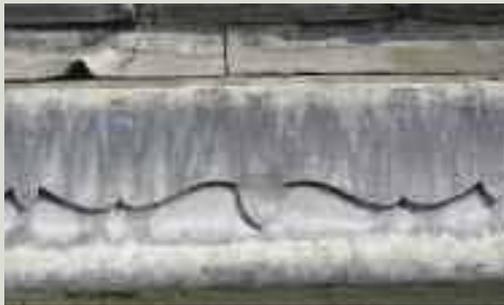
In high-quality work, the visible edges of lead flashings were cut to decorative shapes

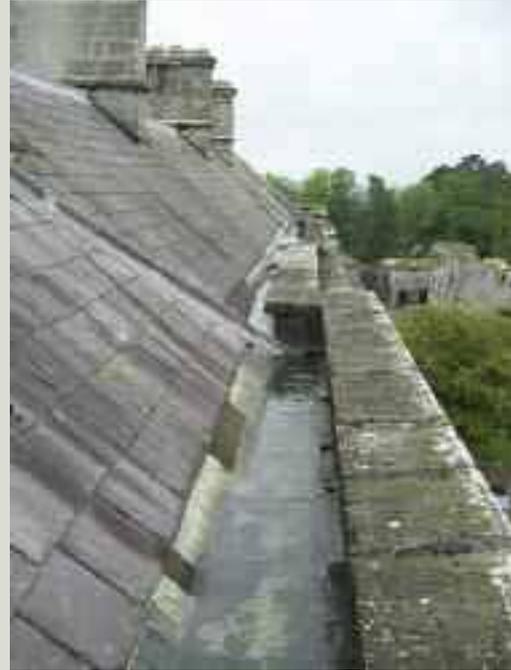
Copper can be laid to very shallow falls as in this copper-lined parapet gutter. It can be used to resolve situations where the falls necessary for stepped lead gutters cannot be achieved

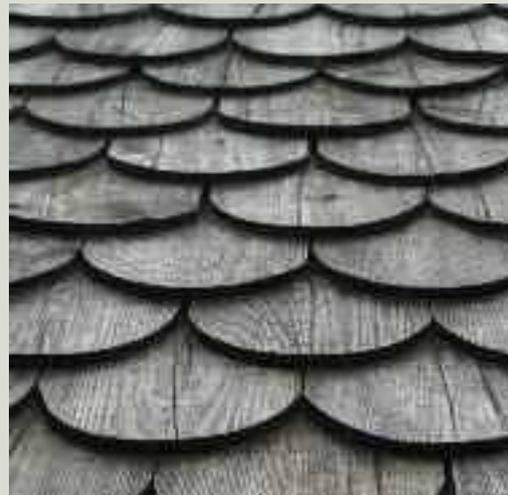
Now usually machine-sawn cedar, chestnut or oak, shingles were traditionally cleft or split. They can be found on the roofs of buildings such as a cottage orné or on decorative architectural features such as roof lanterns or lych gates

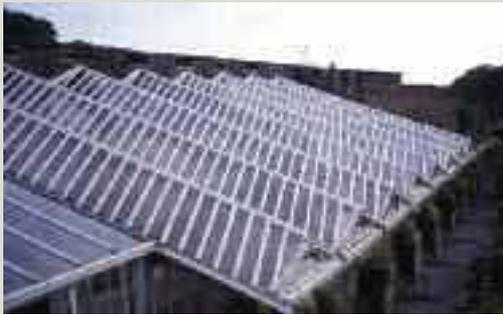
Glass roofs, using timber or iron structural elements, were used on conservatories and greenhouses and can be extensive

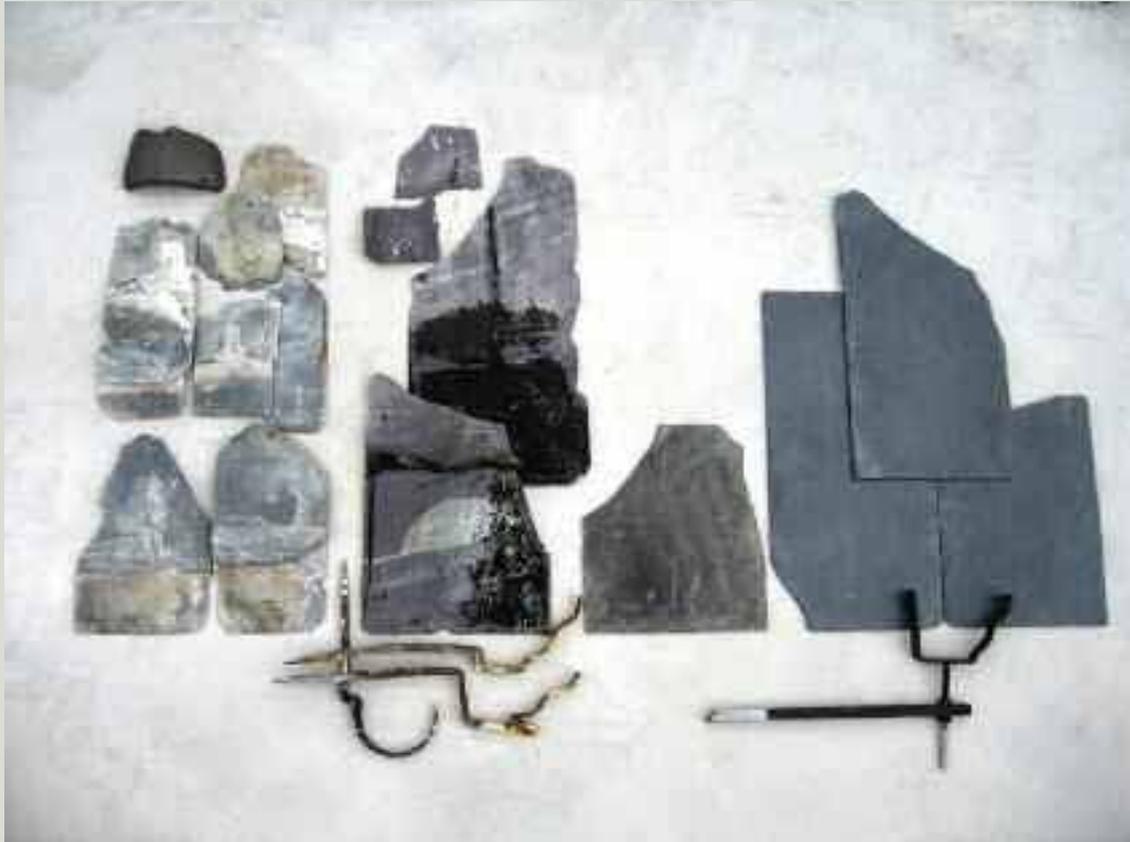
This set of slates indicates a sequence of re-roofing projects, over a period of centuries, on an early eighteenth-century country house. On the left, the small greenish, hand-dressed slates, held in place by pegs fixed into lime mortar, are thought to represent the original roof covering. Clay tiles may have been used to cover the ridge; the fragment shown here (top left) was found in the attic space of the house. An extension to the house in the 1800s appears to have been the impetus for re-cladding the entire roof with a blue-grey slate in a gauged slate pattern, possibly Ahenny slate (second from left). This roof survived until the mid-1960s, when neglect over time had caused serious damage and undermined the roof covering. The roof

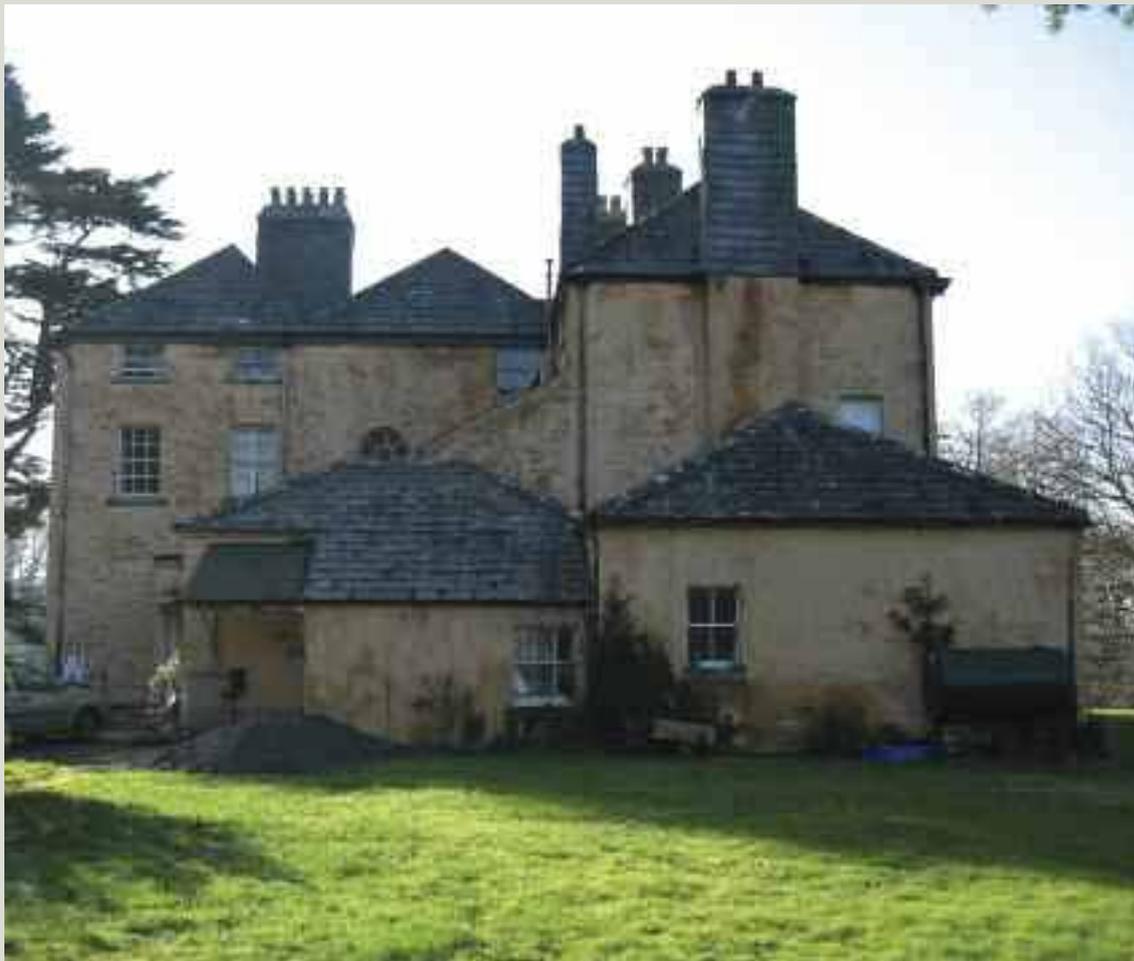
This house has a particularly interesting roofscape, complex in form with several valley gutters and a series of slate-clad chimneystacks with plain clay pots. This type of roof is known as a gauged slate roof because of the use of courses of diminishing slate sizes from eaves to ridge, probably of imported Welsh slate. The ridges are covered in stone, bedded in lime mortar with tight joints. The character and appearance of the roof were

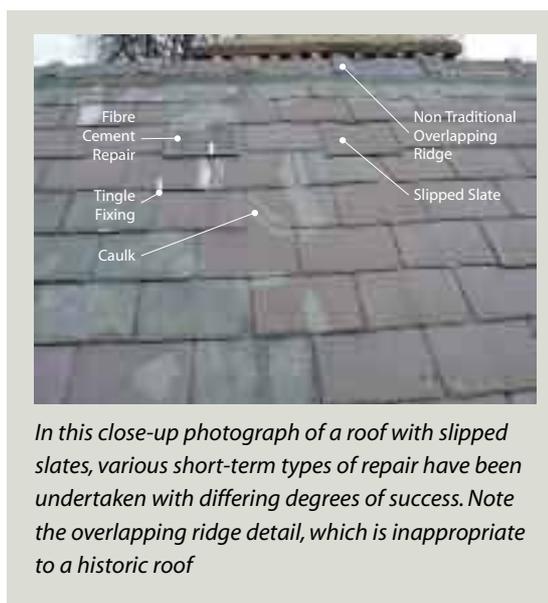
In this close-up photograph of a roof with slipped slates, various short-term types of repair have been undertaken with differing degrees of success. Note the overlapping ridge detail, which is inappropriate to a historic roof

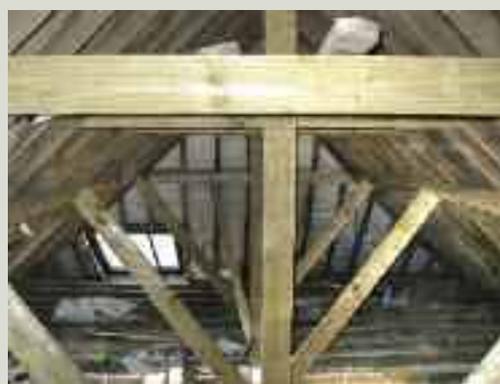
These rafters were originally undersized for their span and had deflected, causing slates to lift or slip, and thus allowing water to enter the roof space. To correct the problem, this additional support structure was added during roof repair works

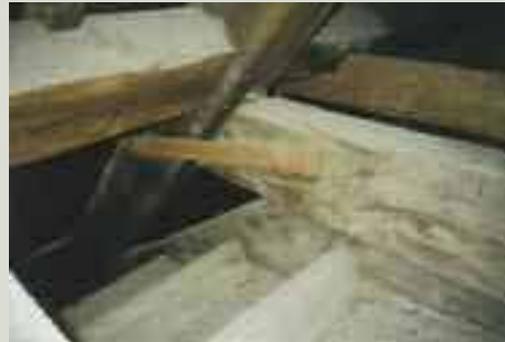
The extent of movement in this roof truss is serious, indicating not only the poor quality of the original detailing but also potentially serious movement in the main supporting walls below

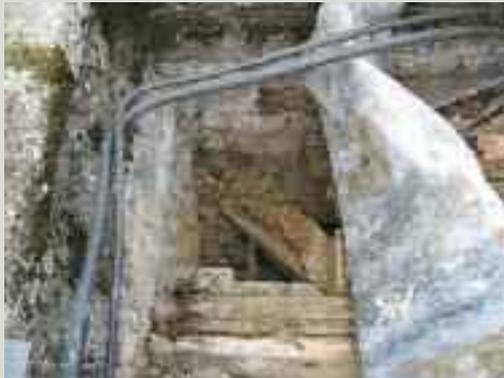
Rot beneath this section of parapet gutter resulted in localised ponding of rainwater, exacerbating the problem and leading to wet rot damage to the truss end. Note that bonding timbers embedded further down the wall may also be affected by such leaks

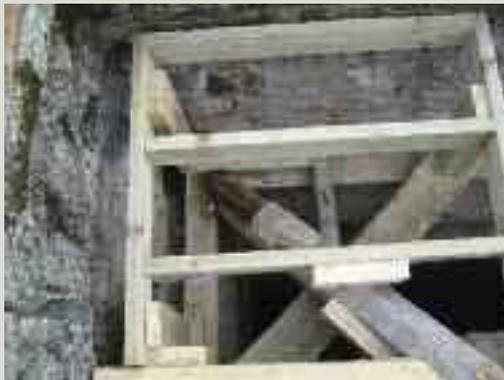
Additional support was added on the diagonal below the truss end, thus avoiding the need for new timber splice and steel connections or the local removal of the rotten timber truss end. The timber that had supported the gutter above had to be fully replaced

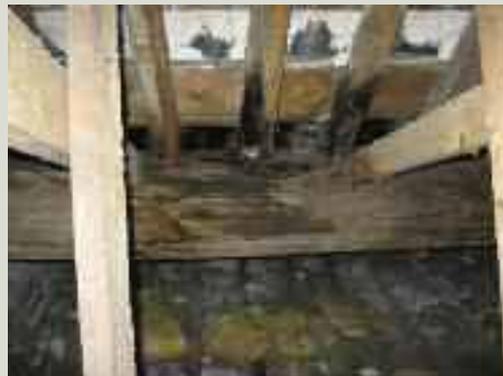
Evidence of wet rot damage to a roof beam and rafters under a tapered valley gutter. Only about ten per cent of the beam section was degraded, so no strengthening works were required to the beam. The rotted rafter ends, however, needed replacement

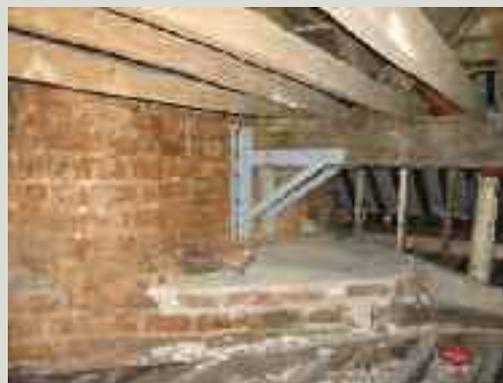
A new steel support bracket has been supplied to support this roof beam severely affected by wet rot at a chimney breast. The chimney flashings above, which had failed, were also repaired as part of these works

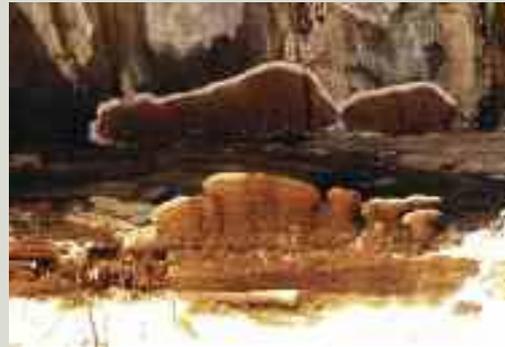
The fruiting bodies of the serpula lacrymans fungus can be identified by their rust or orange colour, usually with a white edging

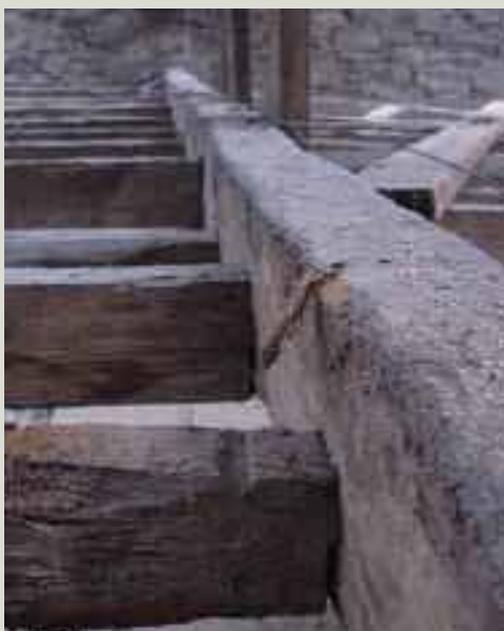
Furniture beetle has damaged only some of the faces of these timbers – these are the sapwood faces of ceiling joists. The slight shrinkage of the joists where they are mortised into the ceiling beam was not seen as problematic in this case but, if the displacement were any greater, it would need thorough investigation

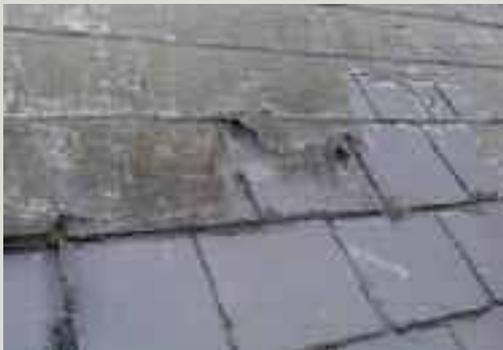
The process of covering a leaking slate roof with a bitumen covering was known as 'turnerising.' It is ineffectual and damaging and should never be carried out on a historic roof. Furthermore, it prevents the slates ever being salvaged for reuse

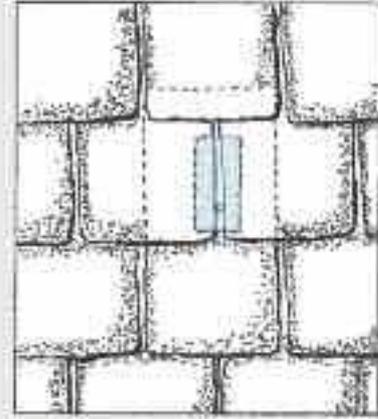
The 'bib' repair, which is used to re-affix a slipped slate

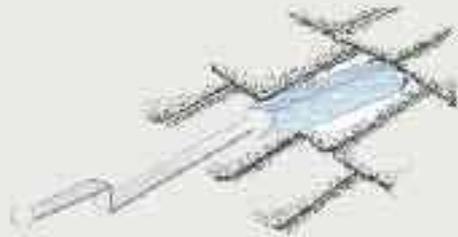
Here, a partially folded metal piece is slid under the upper slate as part of the bib repair. The metal is partially folded to allow the metal to sit above the nail head. The metal used should preferably be a painted aluminium or copper but should be matt in texture

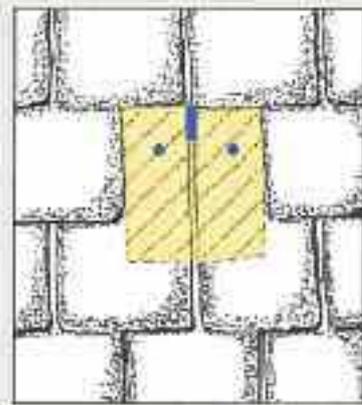
The slipped slate (in yellow) and the areas most likely as a result to spring a leak (in blue): the nail holes and the top of the joint

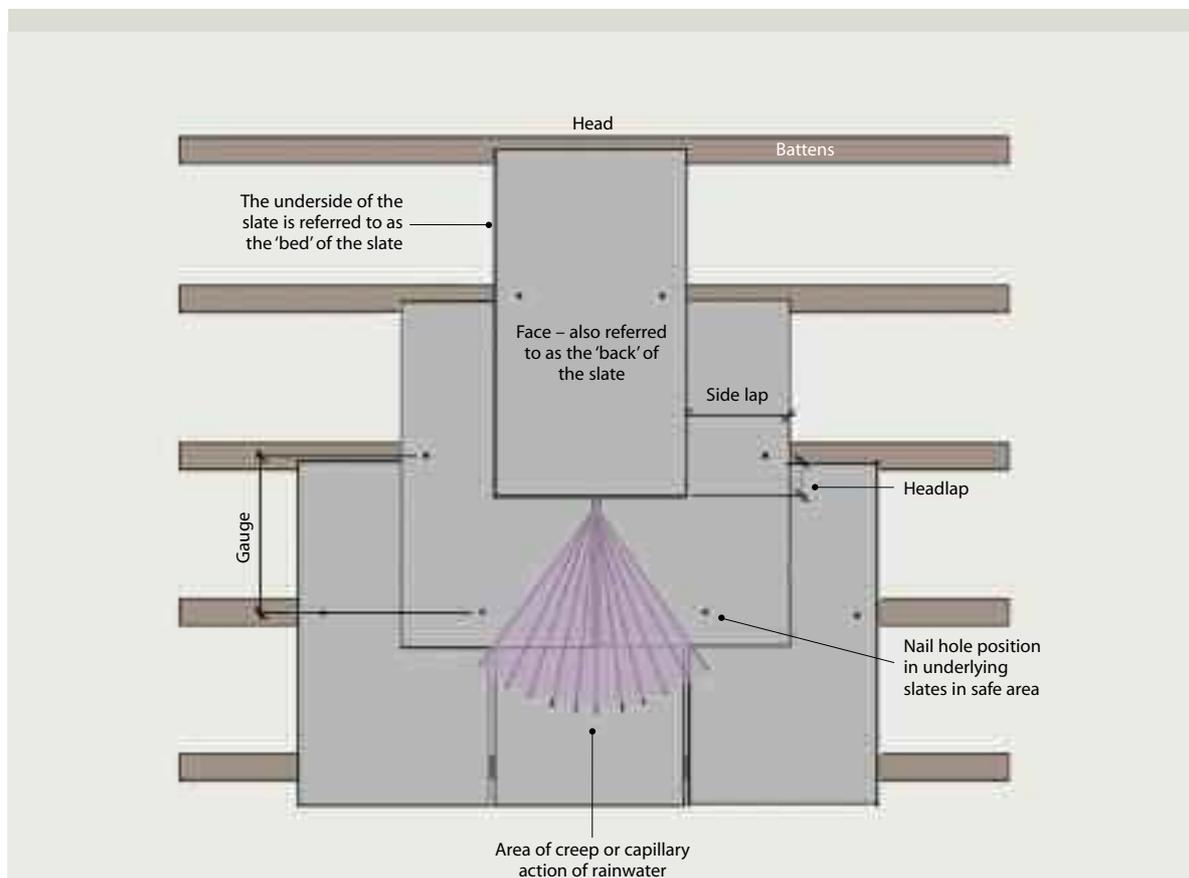
This drawing shows the terms relating to a slate and its fixings and illustrates the main area of water run-off on a double-fixed slate. If this area is cracked or holed or not adequately lapped, this will most likely be the area in which a leak will occur. If a leak occurs in the area called the headlap by way of a crack, it can be very difficult to spot, as the overlying slate conceals it from above and the

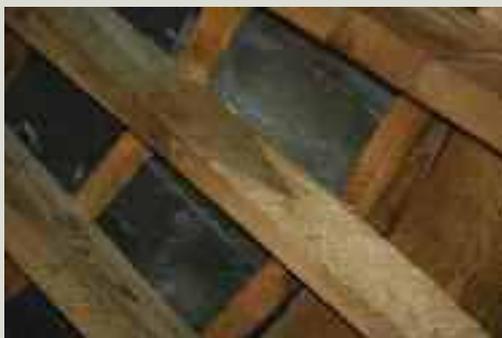
The use of a traditional scarf joint repair to damaged rafter ends is particularly worthwhile where the roof structure is exposed to view (Image courtesy of the Irish Georgian Society)

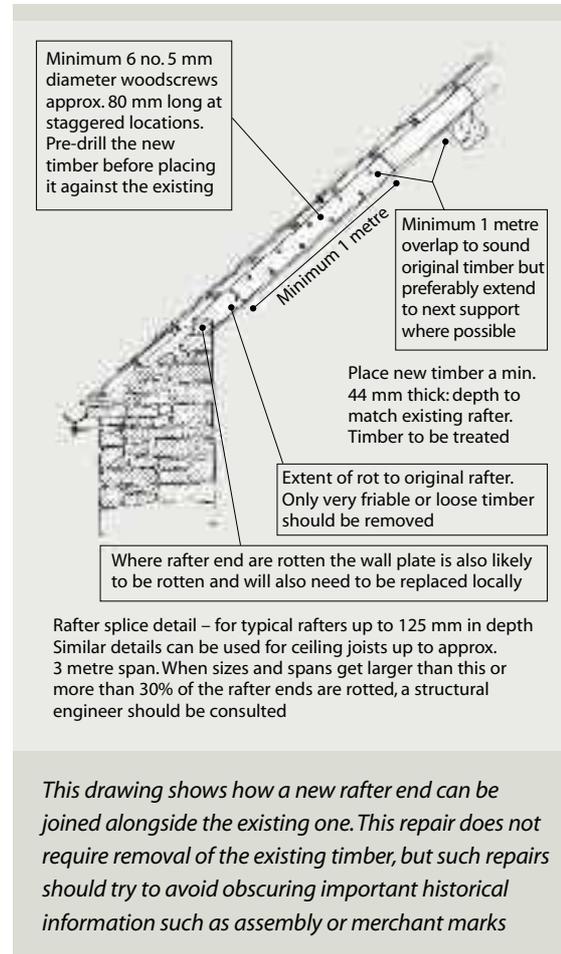
CHOOSING THE RIGHT TIMBER FOR REPAIRS

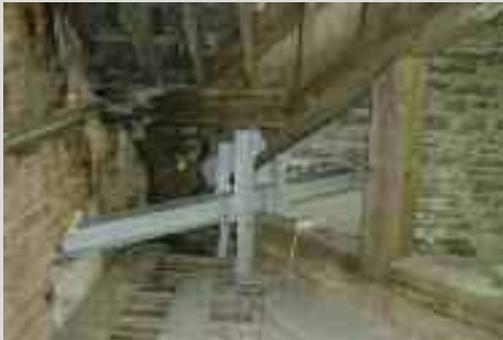
Added support has been given to the main hip roof truss at an internal valley. This repair detail used prefabricated steel elements and tooth plate connectors, but avoided the need to open up the recently repaired valley finishes and does not obscure the original truss details

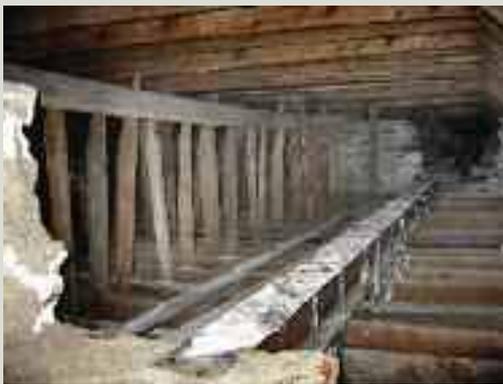
Two consecutive corrective structures to provide additional support to undersized ceiling joists. The first intervention (upper left) occurred early in the roof's history and consisted of the addition of a timber beam and timber hangers to give extra support to the ceiling joists. The new beam itself then deflected. Further corrective measures were taken using a new steel beam (lower right). Note that all original timbers were retained intact and the history of the roof and successive repairs can easily be read

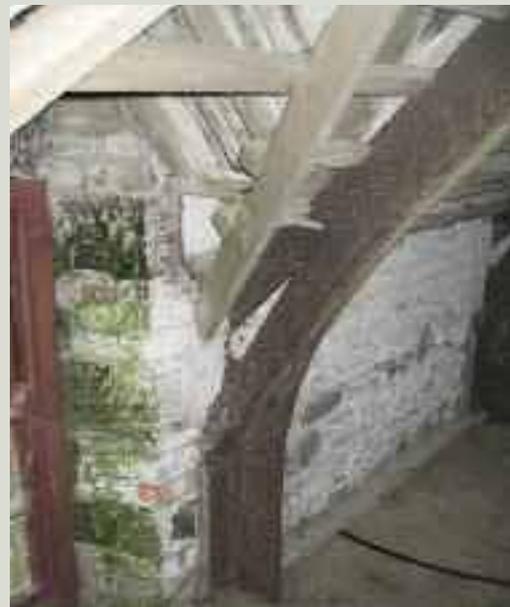
Ferrous metal roof structures should be regularly checked for corrosion, particularly at supports and where built into potentially damp masonry. Where there is significant corrosion of the ironwork, the masonry is likely to crack, as the products of iron corrosion (rust) are approximately eight times the volume of the iron itself
