advice series

A GUIDE TO THE REPAIR OF HISTORIC ROOFS

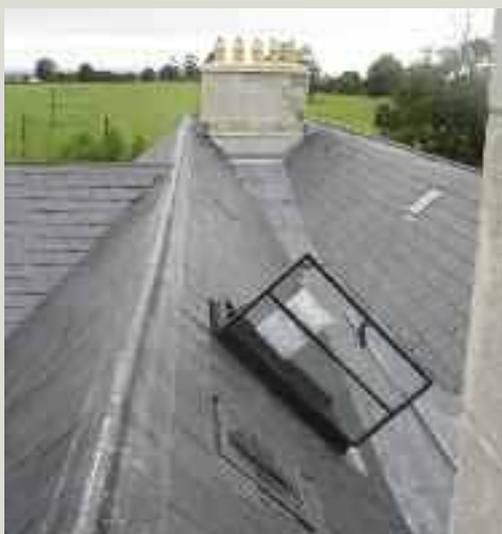
There are several contemporary products available, of which the side-opening rather than top-hung skylight type is possibly the most convenient for providing access for maintenance inspections of the roof

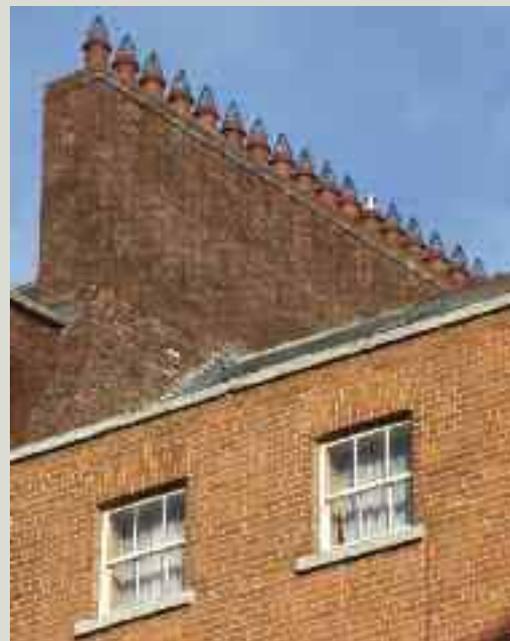
Chimneystacks are prominent features and add considerable character to a historic building. They are integral to the design as well as to the original use of the structure and, even when redundant as vents for fires, play an important role in providing ventilation to the interior of a building

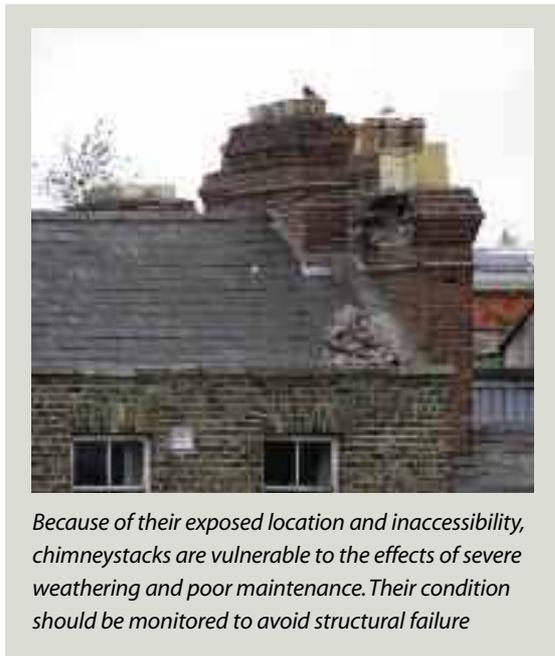
Because of their exposed location and inaccessibility, chimneystacks are vulnerable to the effects of severe weathering and poor maintenance. Their condition should be monitored to avoid structural failure

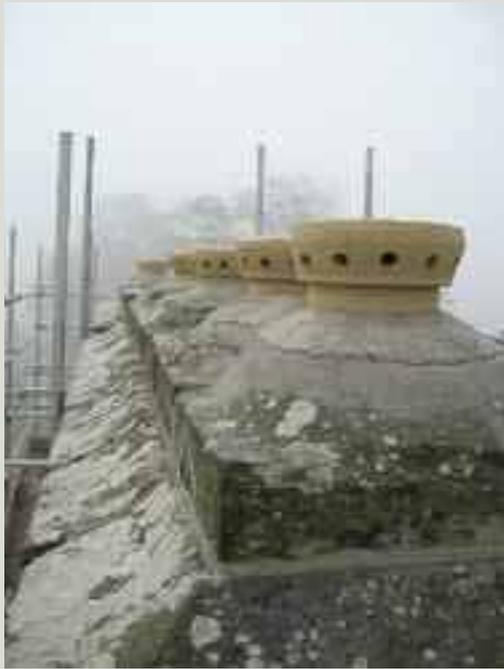
From about 1900 onwards, the insertion of chimney trays into brick stacks became standard building practice. A chimney tray is a lead tray inserted at roof level into a chimneystack, forming a barrier to moisture ingress. In combination with a DPC below the coping and with flashings at the base of the stack, water is prevented from passing through the brickwork and entering the attic space.

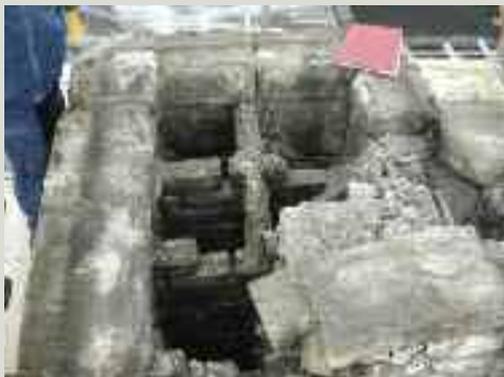
Many older flues have little more than half-brick fin walls called 'feathers' within the stack separating the flues from each other. These can be poorly tied in or even entirely missing as the result of chemical attack from soot, heat damage or over-vigorous cleaning with soot brushes

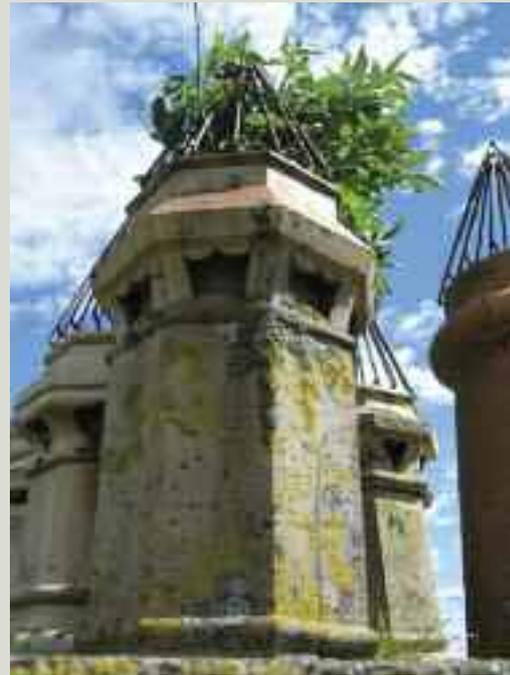
The use of wire crown guards prevents birds from nesting in chimney pots, but does not stop plants rooting in blocked flues

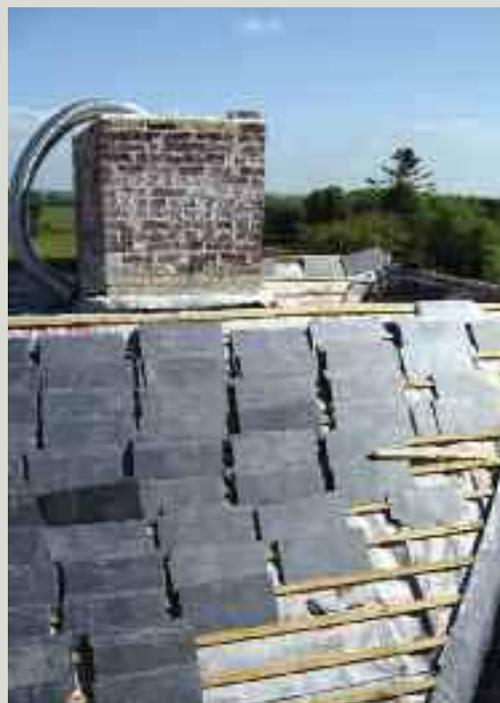
Flexible stainless steel flue being inserted into a historic masonry flue

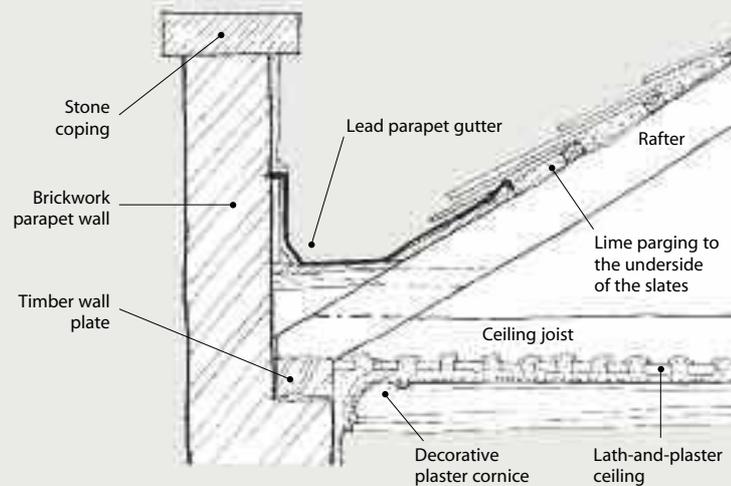
The use of lead flashings to parapets in excessive lengths that deteriorated, cracked and split under pressure from thermal expansion has resulted in water soaking into parapet walls and main walls below, often causing deterioration of the bearing ends of roof trusses, beams and joists.

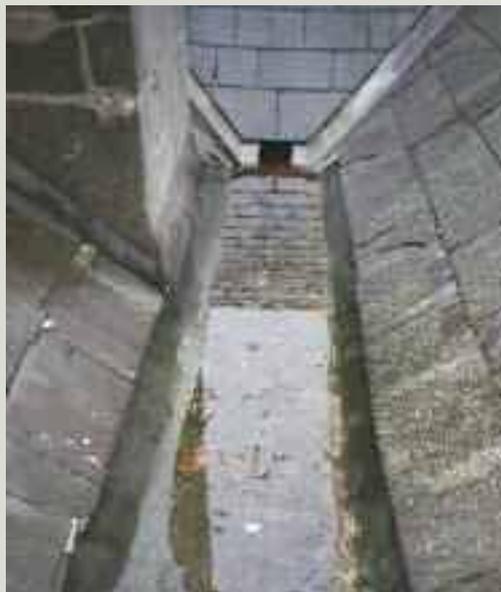
View of a defective valley gutter with a shallow fall that is now holding water. Birds' nests in the outfall of the secret gutter (seen at the top of the image) blocked this roof outlet

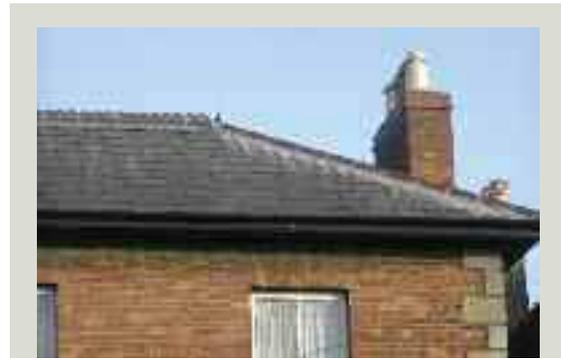
Incorrect bedding and detailing, with fat joints to the ridge and hip tiles, are visually very disruptive and inappropriate to a historic building

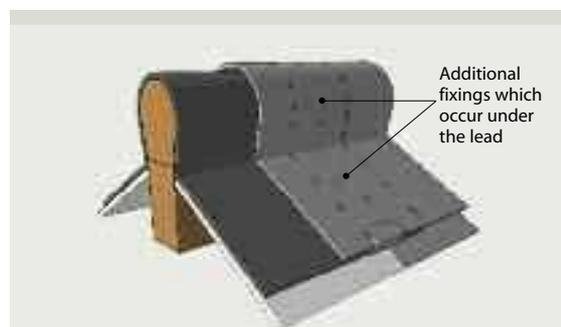
The Lead Sheet Association advises a modification to the profile of the 'broom handle' timber roll and promotes instead the use of a more elongated section in treated softwood to reduce the likelihood of the pinched lead cracking along the roll

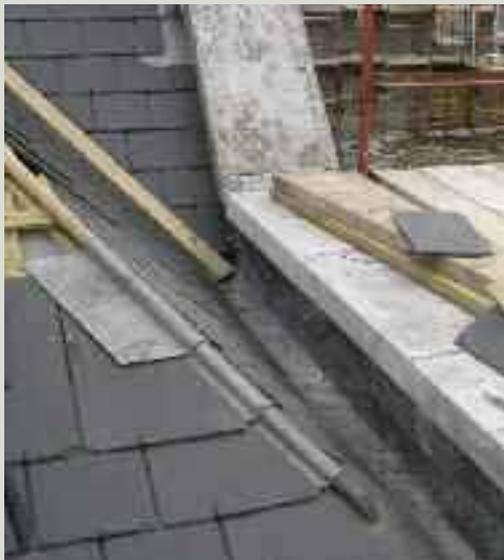
Interleaved soakers: a variation of the external lead roll is the cloaked version seen on hips of roofs, which conceals much of the leadwork below the slate courses. In this detail, the lead flaps are interleaved with the slate on the ridge or hip. If this detail requires repair or replacement, local re-slating of the roof will be necessary to access and replace the damaged leadwork

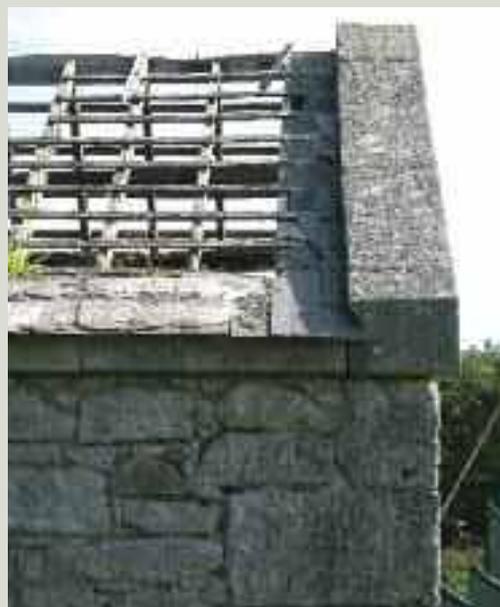
A gable detail where the verge is held or 'locked' in place with a stone coping. A particular difficulty arises with this detail if there is damage to slates set below the coping, as the coping will need to be removed to allow for repair of the roof covering

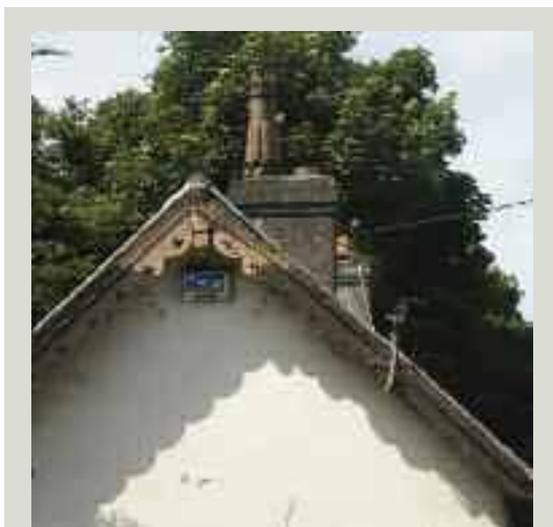
The poor condition of overhanging verges can lead to deterioration of the ends of the purlins as well as the loss of sections of decorative timber bargeboards

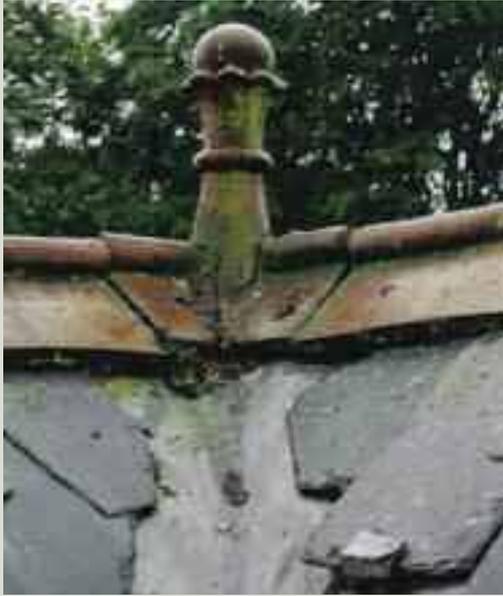
This terracotta ball finial was cracked; as part of a roof repair project it was removed, carefully cleaned and repaired before re-installment

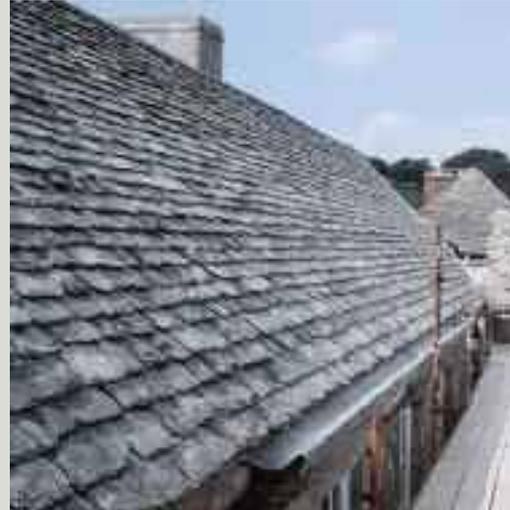
A new flush eaves gutter formed in lead along the top of the wall

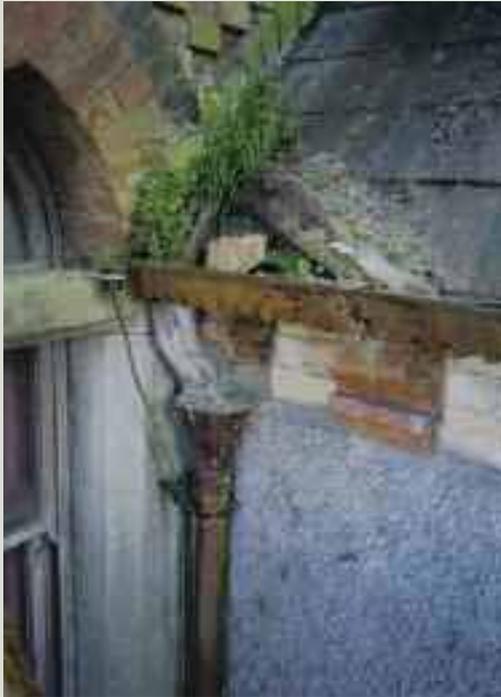
Cracked or broken rainwater goods can be replaced on a like-for-like basis with half round, box or ogee cast-iron gutter profiles which are readily available. Where castings are more decorative, such as in this case, new gutters can be cast to replace the broken sections. Downpipes should be carefully examined, cleaned down and fully refurbished on a regular basis

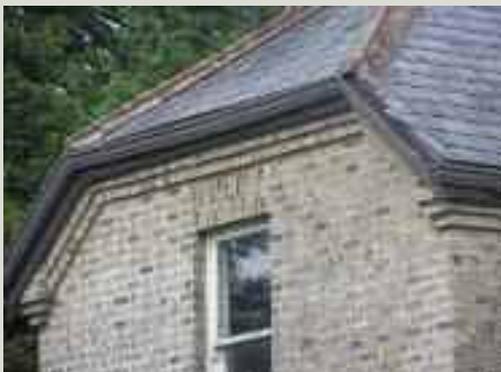
An unusual example of a decorative cast-iron gutter detail following the profile of a half-hipped roof

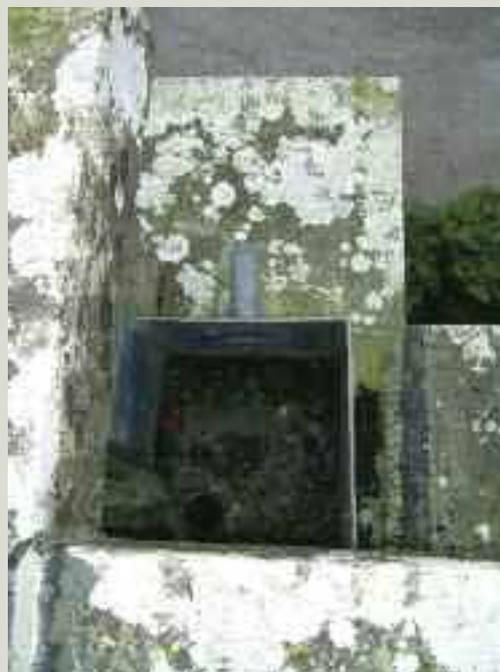
The installation of an early warning system in the form of an overflow pipe will alert the owner that the catchment pit is full and that a blockage in the gutter or hopper head needs to be cleared before excessive damage occurs

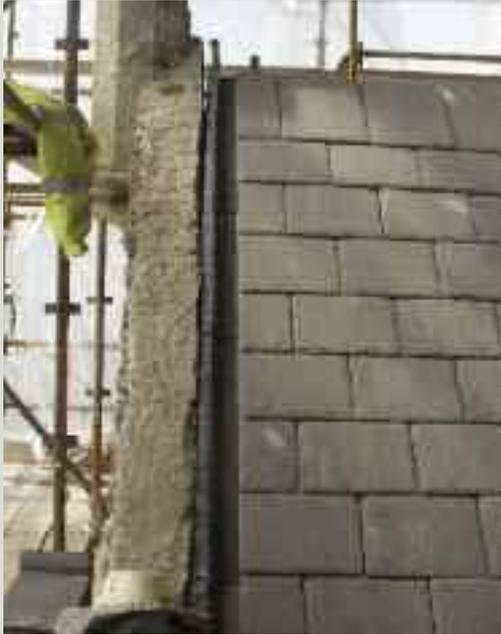
This so-called 'secret gutter' detail is not a traditional one. However, it may be recommended in instances where there is a history of water penetration below lead cover flashings at the junction with abutments, particularly on roofs of a low pitch (Note: in this image the gable capping stones have yet to be replaced)

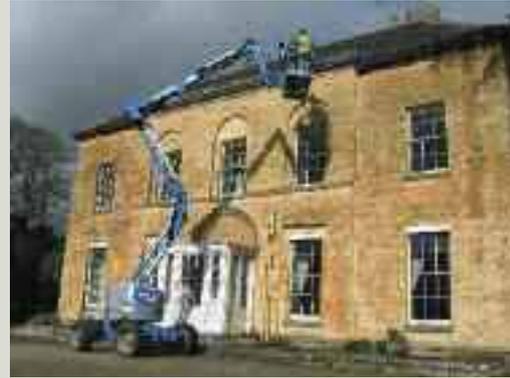
In some cases, the use of a cherry-picker may be an economical alternative to scaffolding for undertaking maintenance inspections and minor repair works to high roofs

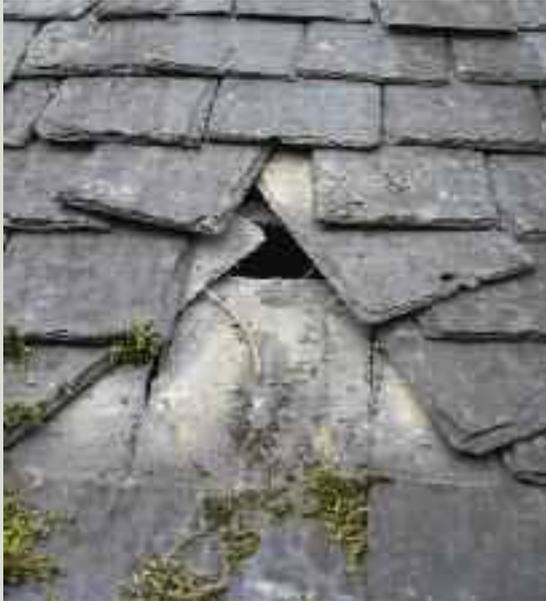
Earlier slate roofs using top-hung, single-nailed slates can easily be repaired by swinging individual slates aside allowing access to replace or re-peg the slates beneath

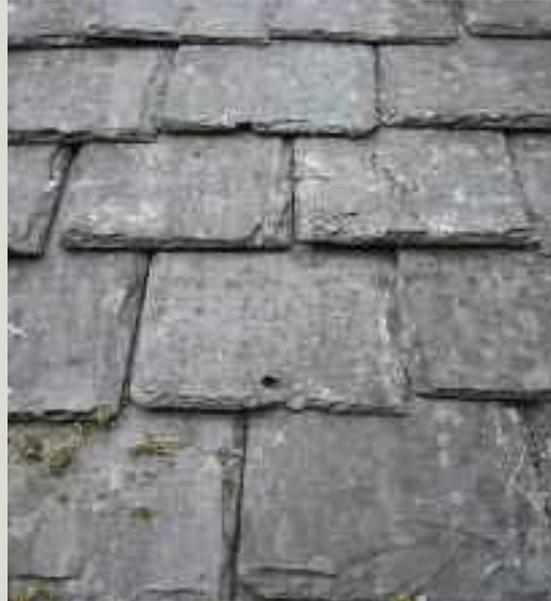
Slates are swung back into place after works

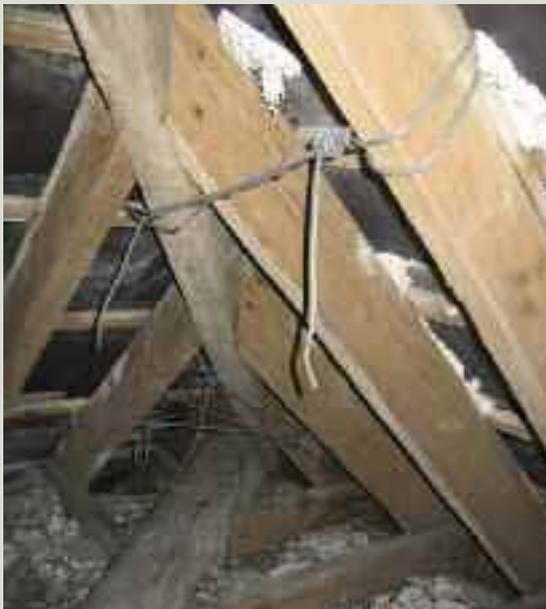
An alternative repair method is to tie the slates within the roof. This is useful where the slates are large or have square shoulders or, for some other reason, cannot be swung aside. A plastic-coated wire such as electrical lighting wire is threaded through the gap from inside the roof and attached to the slate outside. The slate is then carefully pulled back into position and the wire tied back to the timber roof structure

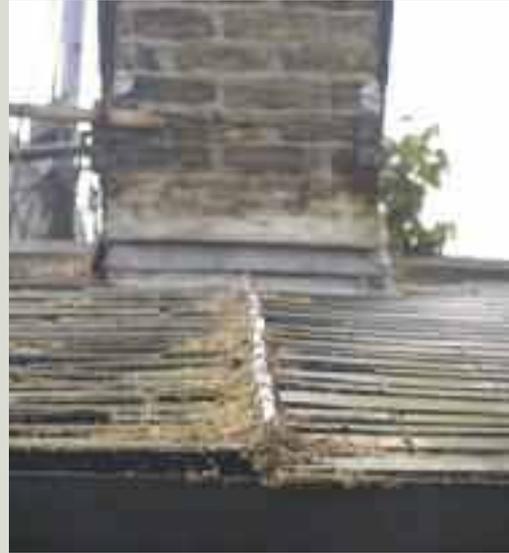
A lead divider batten roll can be used to disguise a difference in level caused by the use of deeper battens. The use of larger battens when re-roofing or the use of counter-battening with roof membranes can mean an increase in the roof plane height. This causes a difference in height between roofs in a terrace of buildings and a lead soaker may be used to accommodate the difference in levels

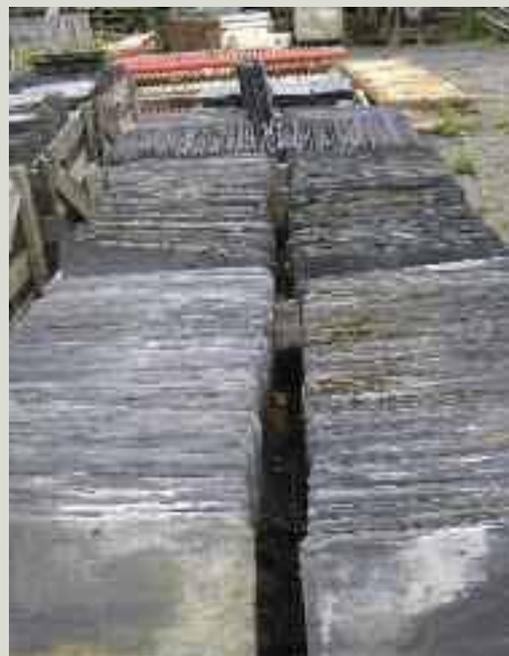
Slates properly stripped and sorted

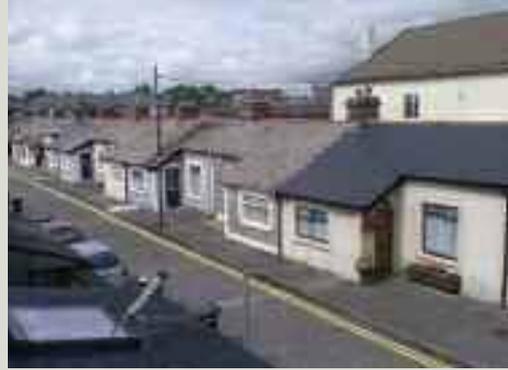
The mix of roofing materials on this terrace of houses visually fragments its appearance. The use of 'artificial slate', or fibre-cement tile is visible in the foreground, and also further down the street, striking discordant notes among the original slate-covered roofs

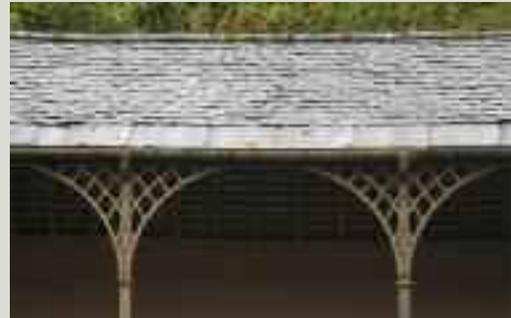
Large eaves slates helped to ensure that a good weatherproof detail was achieved where the accumulation of rainwater was greatest. It is a particular feature of historic slate roofs and should be retained when undertaking repair works

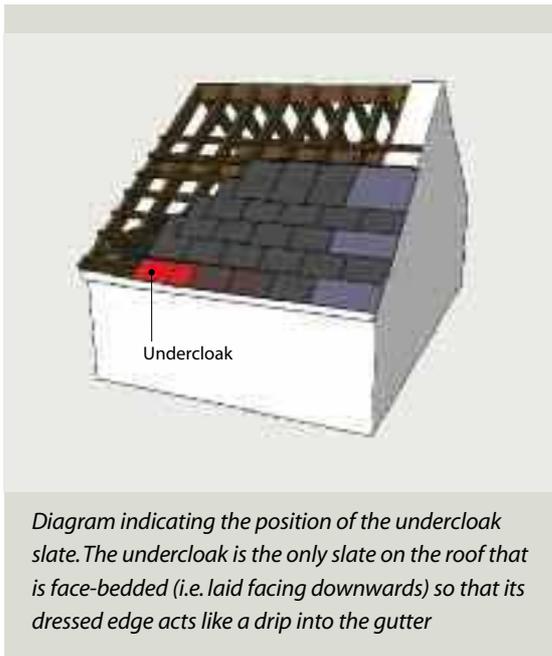
Diagram indicating the position of the undercloak slate. The undercloak is the only slate on the roof that is face-bedded (i.e. laid facing downwards) so that its dressed edge acts like a drip into the gutter

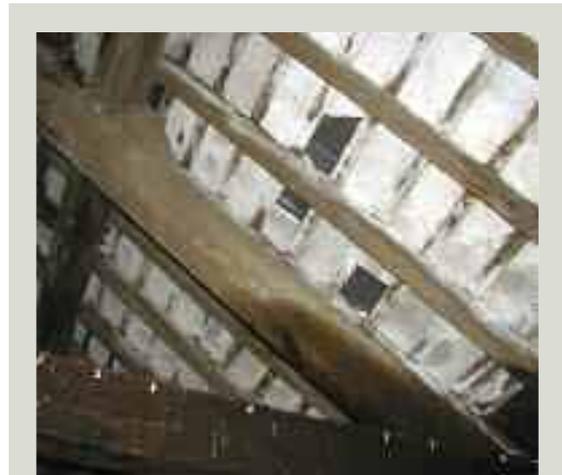
Substantially intact parging to the underside of slates is visible from within the attic space and provides a secondary line of defence against rain and wind entering the interior of the building

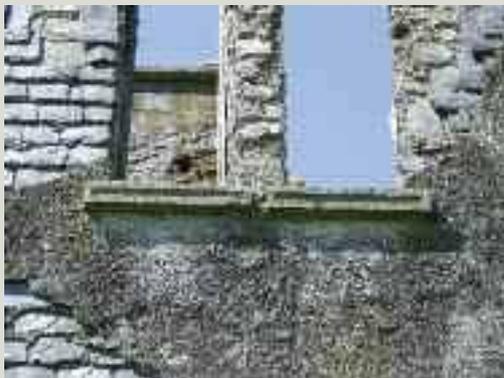
On this ruinous house in County Cork, the vertically hung slates, bedded in lime mortar, were later rendered over. Their existence only came to light as the external render decayed and fell off

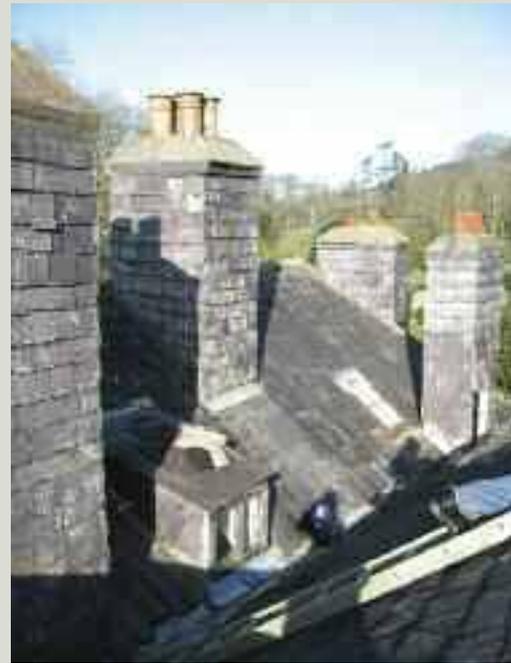
The change in colour of the slate on the chimneystack in the background indicates where a number of courses were removed and replaced. In areas of extreme weather exposure, vertically hung slating gives increased protection to the stacks

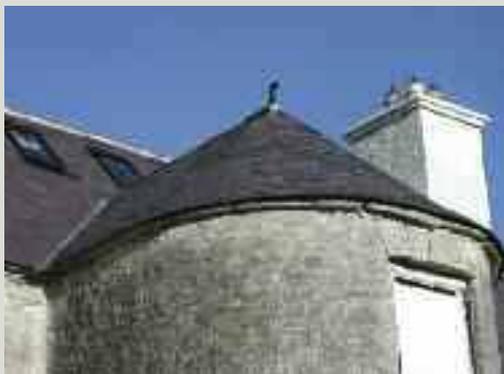
The repair of curved slate roofs is highly specialised work and requires a roofing contractor who has experience and skill in gauged work

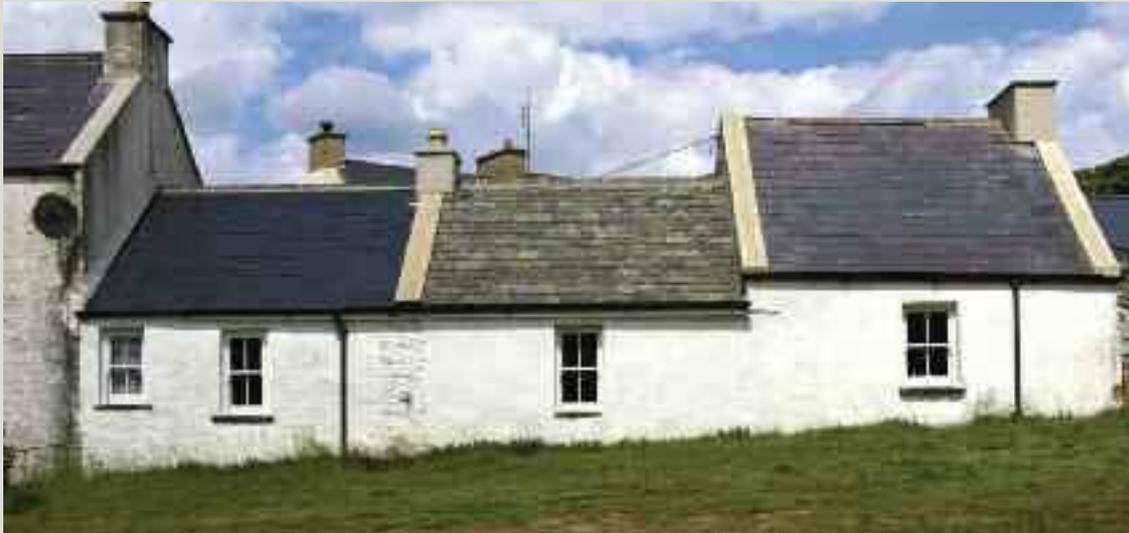
Most buildings using stone roofing slate are distinguishable by their simple gable-ended roofs. Hipped profiles, dormer windows, and valleys are difficult to achieve because of the large and somewhat unwieldy nature of the stone slate

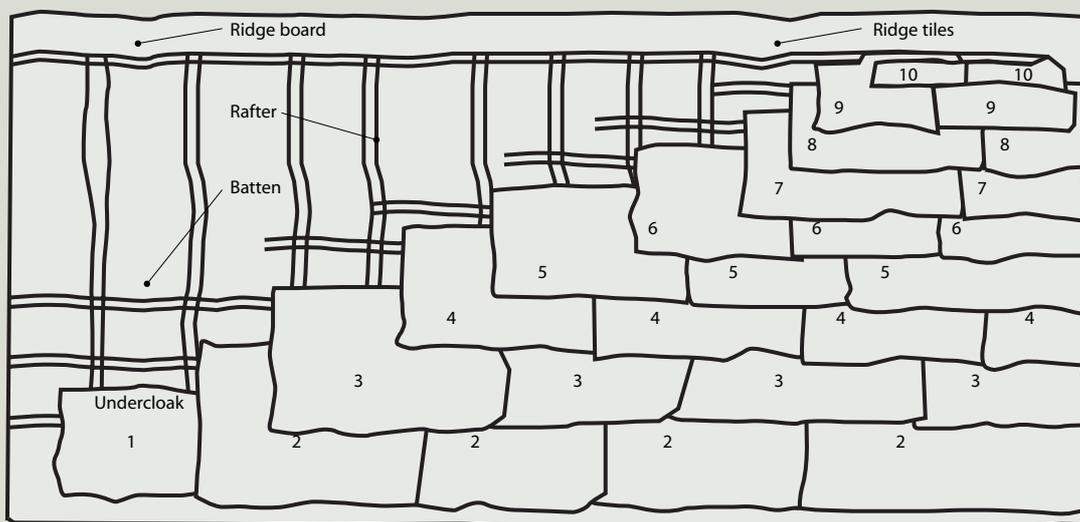
Graduated stone slates
Note: the distance between the battens decreases towards the top of the roof

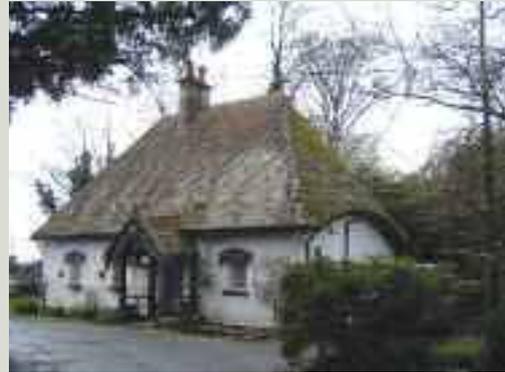
A gate lodge with a decorative clay-tiled roof, having striking curved elliptical eaves and a patterned use of plain and scalloped tiles. Overhanging branches and the proximity of large trees have tended to promote extensive moss growth on part of the roof

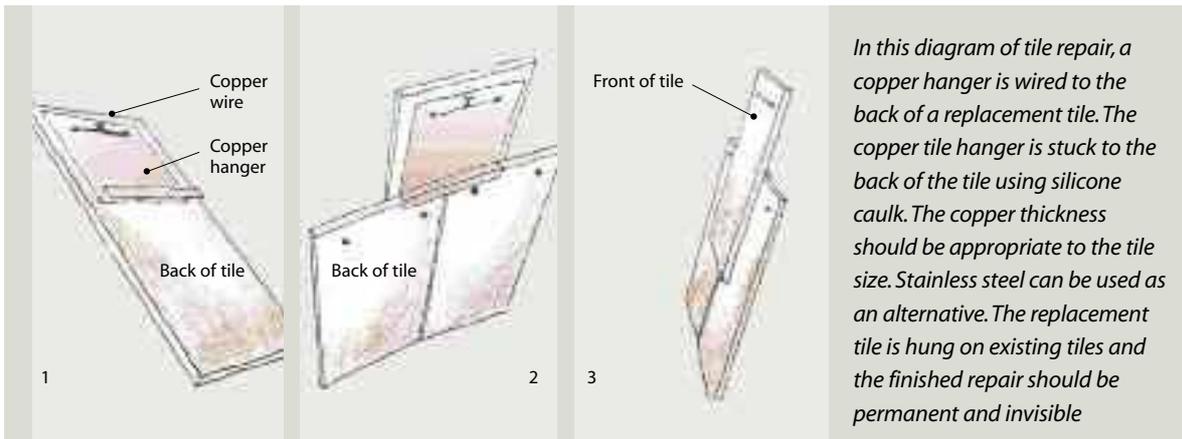
REPAIR OF TILED ROOFS

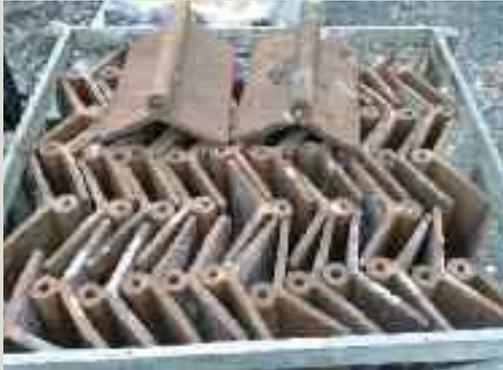
There is a wide range of clay ridge tiles available, including ornamentals, which enhance the character of a roof. These should be repaired or replicated as necessary, but not introduced unless there is evidence of their use on the building

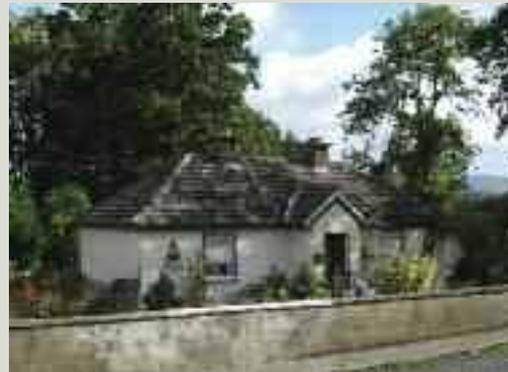
A Marley concrete roof tile on this modest 1940s cottage

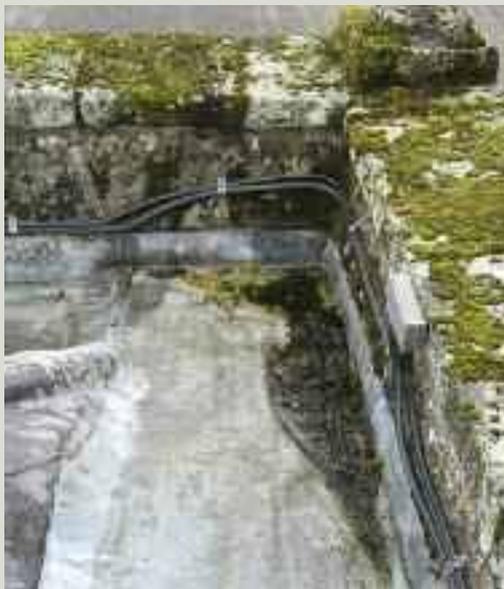
Ponding of water away from gutter outlets indicates a problem with the substrate timbers. In this case, a likely cause was poorly functioning flashings at the junction with the parapet wall

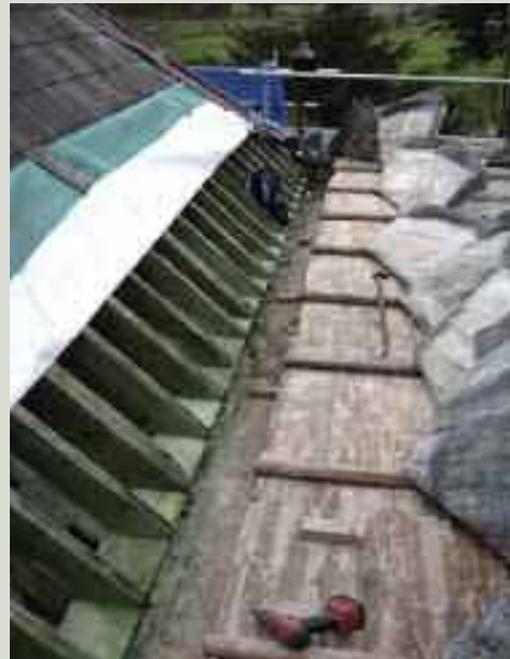
Slight lead corrosion can be seen on the exposed underside of the lifted lead sheeting on the right. The main problem here was a poorly detailed gutter. There was no need to change the regime of the flat roof, although good practice would include an underlay between the deal boards and the sheet lead

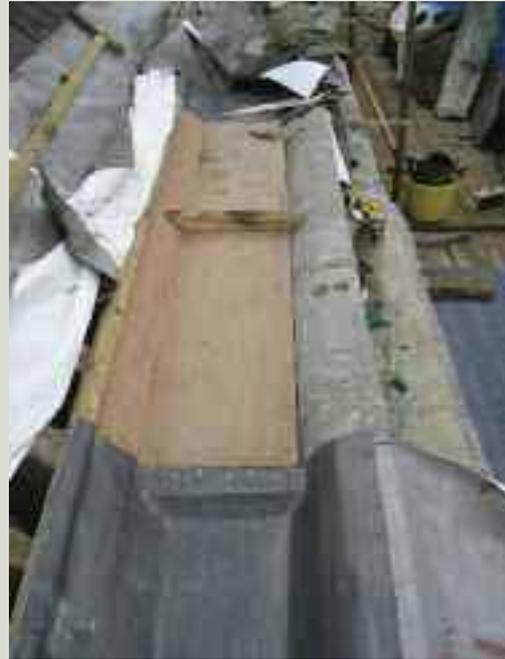
The design of this parapet gutter has been revised to achieve correct lead sheet lengths, falls and step heights in order to ensure that the newly-laid gutter will achieve a good lifespan. Note that the lead sheets have been fixed at the top end only (to allow for expansion and contraction), using copper nails in a staggered pattern

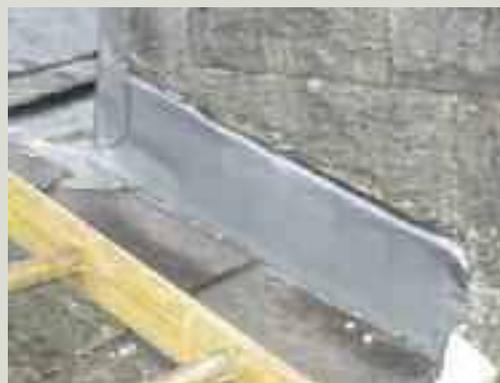
New lead flashing over lead soakers, turned into a mortar joint in the stonework at the base of a chimneystack and fixed using lead welts. The mortar joint is yet to be repointed

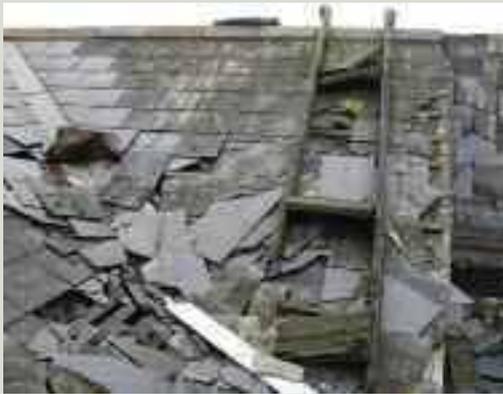
The theft of lead and copper from a historic roof can cause significant damage and leaves the interior of the building vulnerable to further damage from flooding

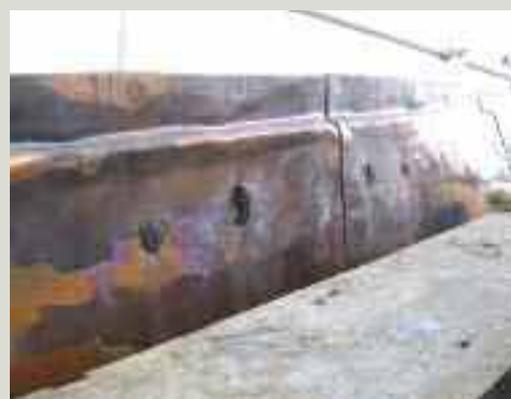
This copper parapet gutter lining has been lifted for inspection following water penetration problems. The bright salmon-coloured areas indicate that corrosion is occurring. Holes in the copper had been previously filled with a bitumen product in an earlier repair attempt which has exacerbated the problem, as bitumen corrodes copper

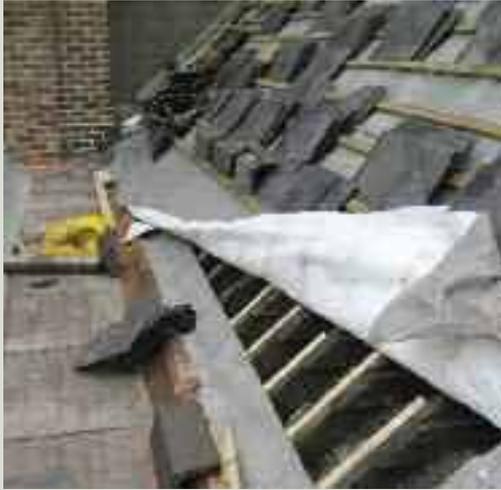
Re-lining a valley gutter in copper. Splice repairs were required to the ends of rafters where the previous valley had leaked over a significant length of time, causing decay of the timber structural elements below

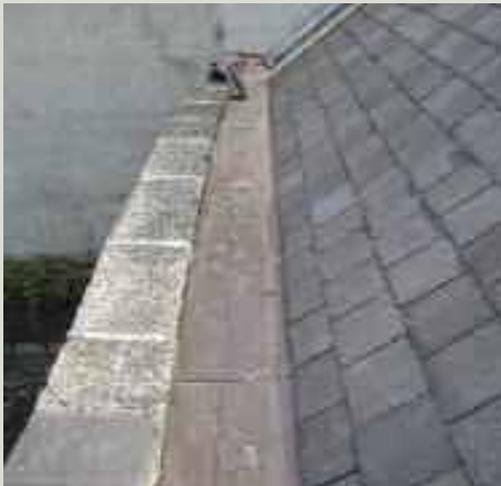
Parapet gutter re-lined in copper. The very shallow falls to this gutter precluded the use of lead

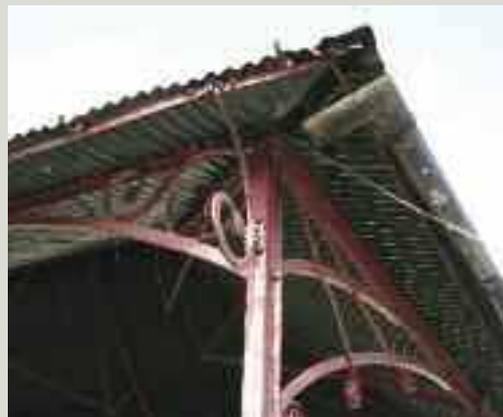
This corrugated iron is suffering from pitting, visible as small pinpricks of light where the metal has corroded through. There is also crevice corrosion occurring at the junction of the sheet with the hip roll. In addition, work is urgently needed to repair the rainwater goods

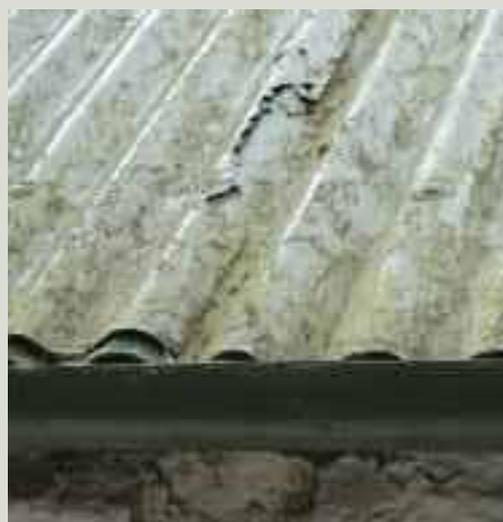
Crevice corrosion is frequently a problem with corrugated iron, particularly at the laps between corrugated sheets

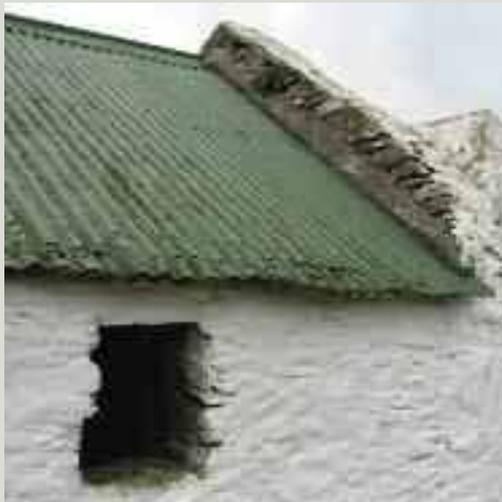
The eaves edge of corrugated-iron sheeting is particularly vulnerable to corrosion. Here, additional layers have been inserted under the eaves

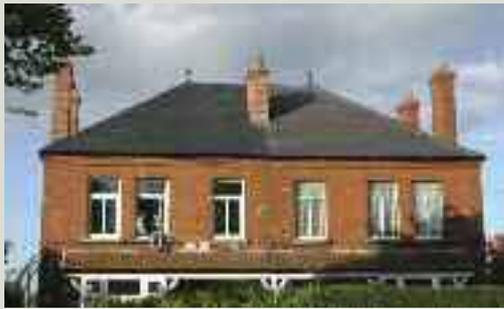
A recently replaced Welsh slate roof (to the left) adjoining a historic one (right), where the difference of character, colour and texture can easily be seen

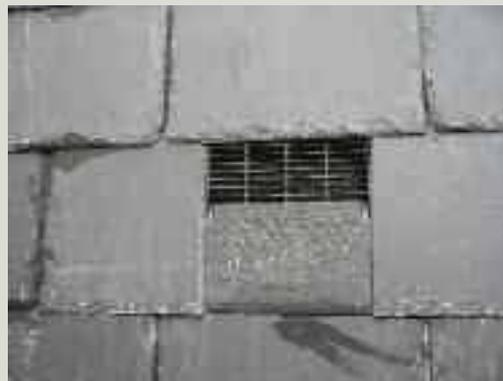
Example of an in-line slate vent. The vent will not protrude above the roof plane. However, such vents may be unacceptably conspicuous if used on the outward-facing slopes of a roof

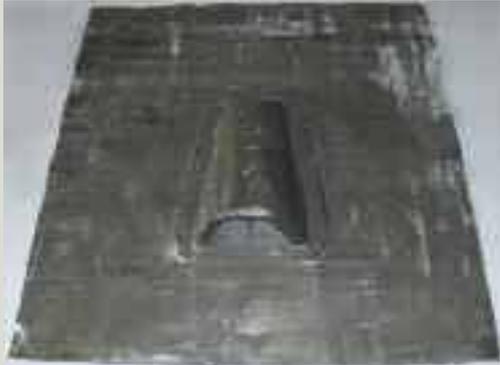
An especially formed lead vent with fly mesh, for use on a church roof. As they are quite distinctive and visible, the use of these vents on a roof where none existed previously should be discussed with the architectural conservation officer in the local authority

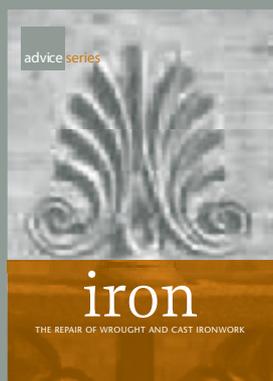
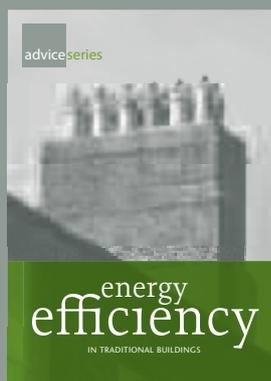
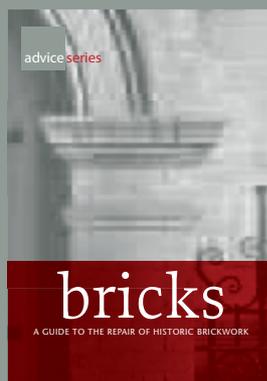
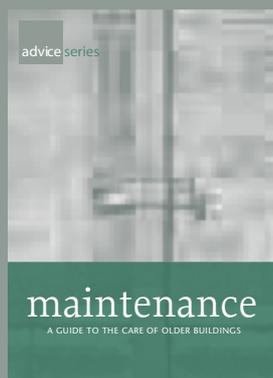
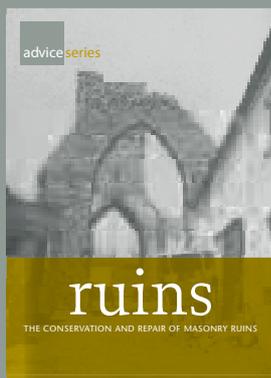
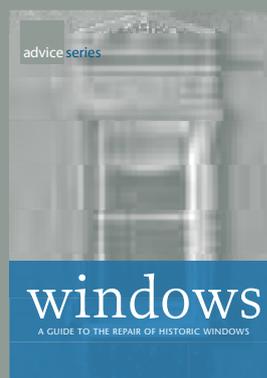
This guide will advise you in caring for your historic roof, helping you to:
