## Conservation and presentation practices

## 5.1 Introduction

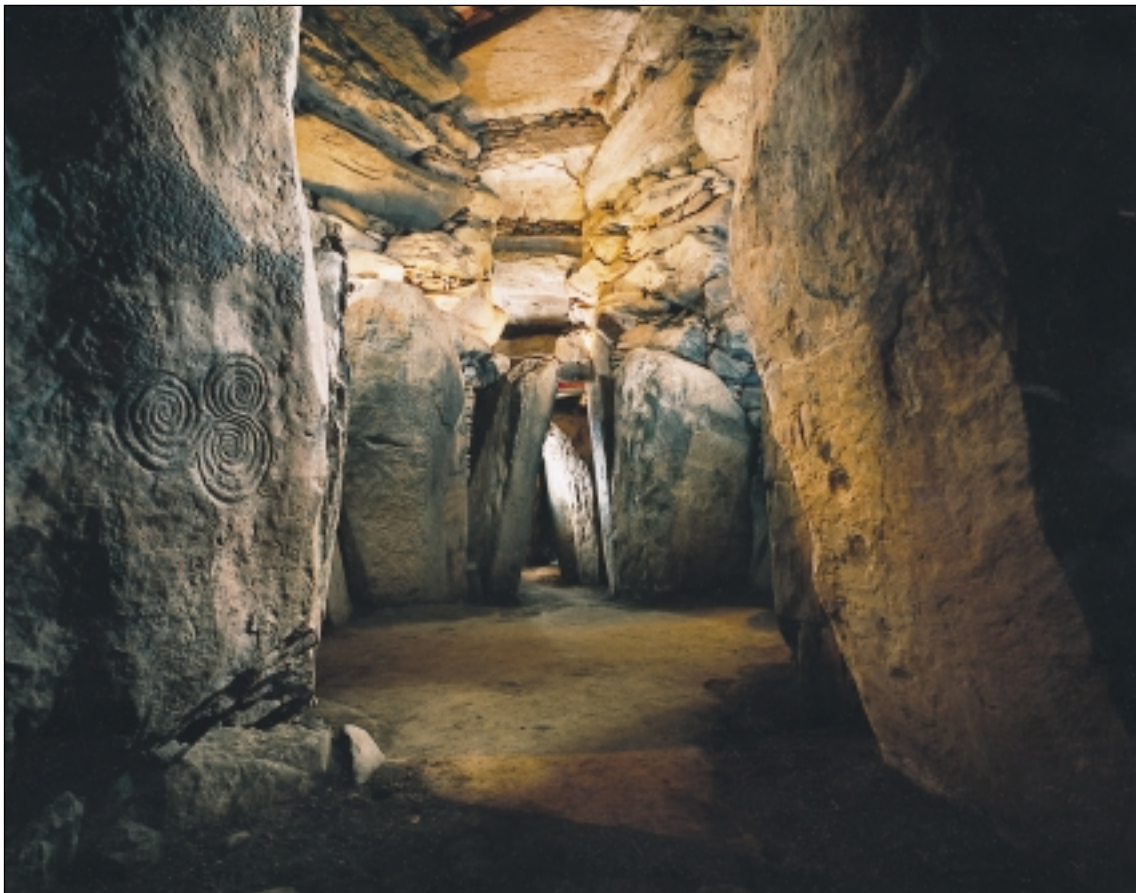
▲ *The chamber and passage at Newgrange when viewed from the recess.*

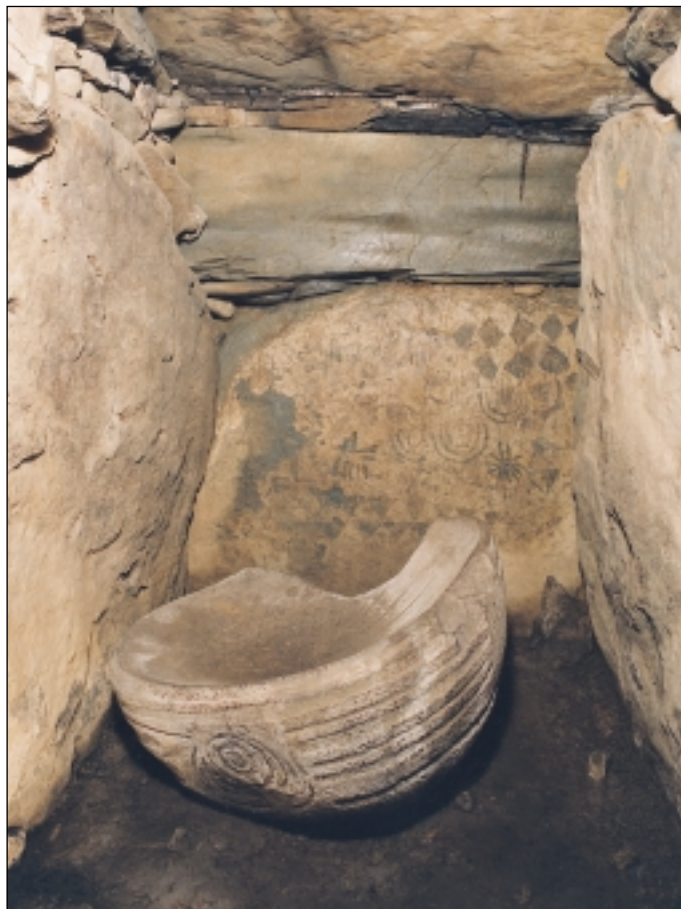
▲ *The basin stone at Knowth is the finest ever found in passage tomb in Ireland*

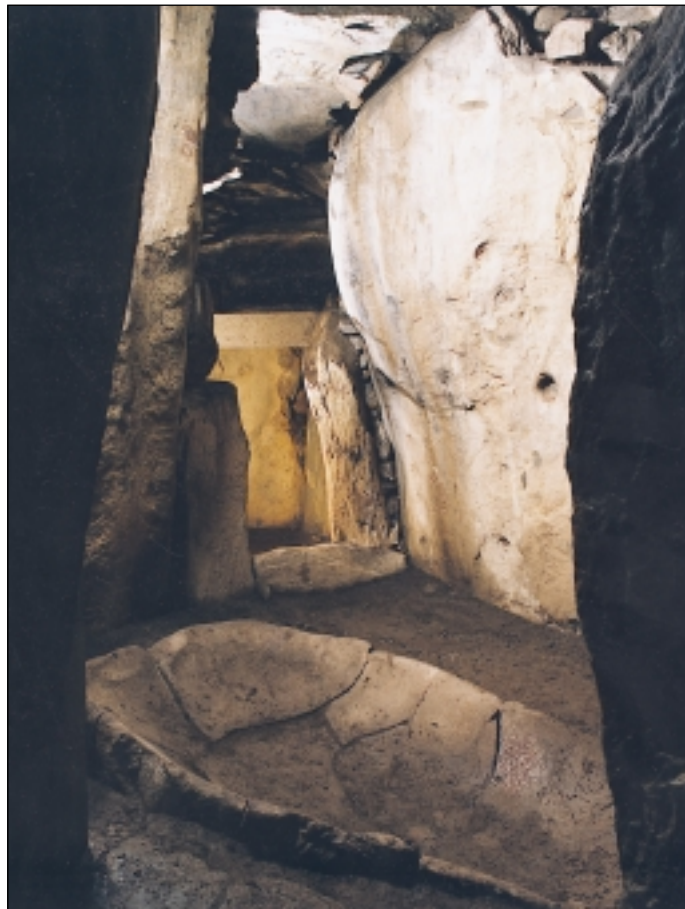
➤ The deposition of human remains was usually confined to chamber areas. They were laid in stone basins like this impressive example from the passage tomb at Dowth
