Title: **STAGE 1 ROAD SAFETY AUDIT**

Boyne Greenway, Drogheda to Mornington

Client: **DBFL Consulting Engineers.**

Report reference: **1232R01**

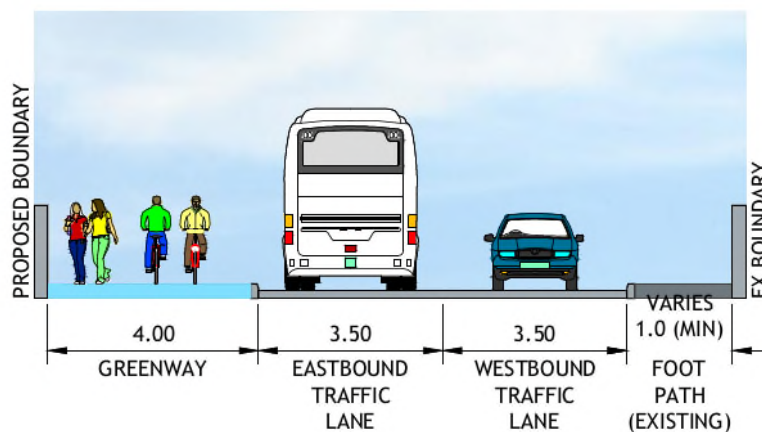
TYPICAL CROSS SECTION TYPE A-1 (CH 0 TO 600)

Throughout the scheme, speed limits.

There is an 80km/hr speed limit on sections of the R150 and generally a 60km/hr speed limit along other sections with a 50km/hr speed limit adjacent to Drogheda Grammar School and at the start of the greenway at the outskirts of Drogheda town.

There is a risk that where the proposed greenway is adjacent to the public road that high vehicle speeds will lead to pedestrians and cyclists being sucked into the carriageway by passing vehicles, especially heavy commercial vehicles or buses.

There is also a very low likelihood of a vulnerable road user surviving a collision with an errant vehicle travelling at 80km/hr or even 60km/hr.

The high vehicle speeds would discourage younger users of the greenway particularly school going children.

It is noted that the design contains raised tables at regular intervals such as side road junctions and crossing points. It is unclear if an overall traffic calming strategy has been assessed based on the spacing and effectiveness of these features.

It is recommended that this issue be forwarded to the Roads Authority to form part of the next county wide speed limit review. Vehicle speeds should be assessed and additional traffic calming should be provided where excessive speed occurs.

As an interim measure a buffer strip along the kerb edge should be provided to discourage use by pedestrians or cyclists.

A review by the Design Team on the design speeds post the introduction of the proposed traffic calming should be undertaken to see if any additional measures are required.

| Paragraph No. in Safety Audit Report | Problem accepted (yes/no) | Recommended measure accepted (yes/no) | Alternative measures (describe) | Alternative measures accepted by Auditors (Yes/No) |
|---|---|---|--|--|
| 3.1 | Yes | Yes | As part of this Boyne Greenway scheme, it is proposed to reduce the speed limit of the R150 and R151 to 50km/hr, this will be forwarded to the Roads Authorities to form part of the next county wide speed limit review. In addition, a number of traffic calming features such as table-top ramps have been provided to reduce vehicle speeds. Upon construction of the scheme, and for intervening period until the implementation of the speed limit reduction as outlined, a Temporary Speed Limit Order will be applied to the R150/R151 along the route of the Greenway, which shall reduce the speed limit to 50km/hr. | Yes |

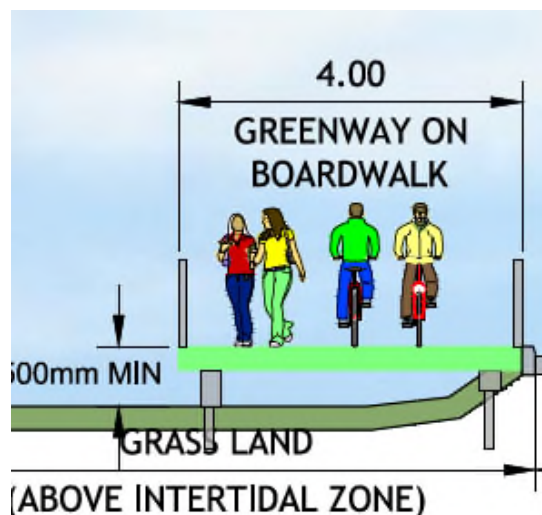
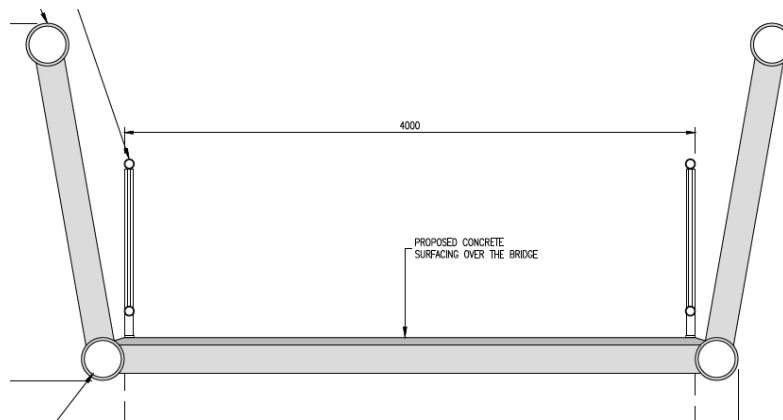
Throughout the scheme, width of the proposed greenway.

It is proposed that the greenway will be 4.0m wide throughout the scheme. In areas where the greenway goes off-line the 4.0m width includes the pedestrian railings and could also include furniture such as lighting columns and life buoys that would be developed during the detailed design stage. There is a risk that the effective width of the greenway along these off-line sections will be much reduced from the on-line sections and that there would be insufficient width for both two-way cyclists and pedestrians. In addition, cyclists may be travelling at relatively high speeds given the flat nature of the proposed greenway and they may not reduce their speed when they enter the tighter off-line sections. This could lead to collisions between cyclists and pedestrians.

It is recommended that the effective width of the greenway be kept constant throughout the scheme.

In addition, where there are any particular interesting viewing areas the cross section should be widened locally to allow people stop and rest (provision of benches) but at the same time let others continue their journey.

| Paragraph No. in Safety Audit Report | Problem accepted (yes/no) | Recommended measure accepted (yes/no) | Alternative measures (describe) | Alternative measures accepted by Auditors (Yes/No) |
|---|---|---|--|--|
| 3.2 | Yes | No | The width of the proposed greenway has been calculated using the TII Publication "Rural Cycleway Design, April 2017, ref no. DN-GEO-03047. The 4m width is considered to meet/exceed the minimum desirable width of 3m for low volume routes (i.e. < 1,500 daily users). Lighting columns will not be provided within the greenway. | Yes |

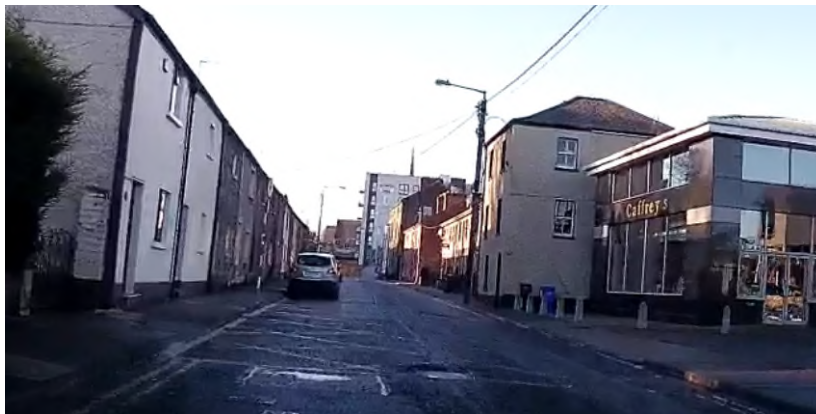
Drawing 170029-2201 Rev P2, Start of Greenway in Drogheda.

It is unclear if there are proposals for another section of greenway through Drogheda town to connect with this greenway at some time in the future. The existing R150 has no dedicated cycle facilities from the town centre to the proposed scheme. The R150 is a busy regional road and appears to have a relatively high proportion of heavy goods vehicles given the presence of the port and associated industries. There is a risk that users of the greenway coming from the town centre will be exposed to this traffic without dedicated facilities. As the number of greenway users increase then the likelihood of a collision will increase.

It is recommended that the scheme be extended to include the upgrade of pedestrian and cyclist facilities to the town centre.

It is also recommended that provision be made for parking for those who wish to use the greenway who initially travel there by car.

The nature and scale of these works may depend on possible future phases of greenway construction.

| Paragraph No. in Safety Audit Report | Problem accepted (yes/no) | Recommended measure accepted (yes/no) | Alternative measures (describe) | Alternative measures accepted by Auditors (Yes/No) |
|---|---|---|--|--|
| 3.3 | Yes | No | The upgrade of pedestrian and cycle facilities into Drogheda town is part of a separate phase/section of Boyne Greenway scheme. | Yes |

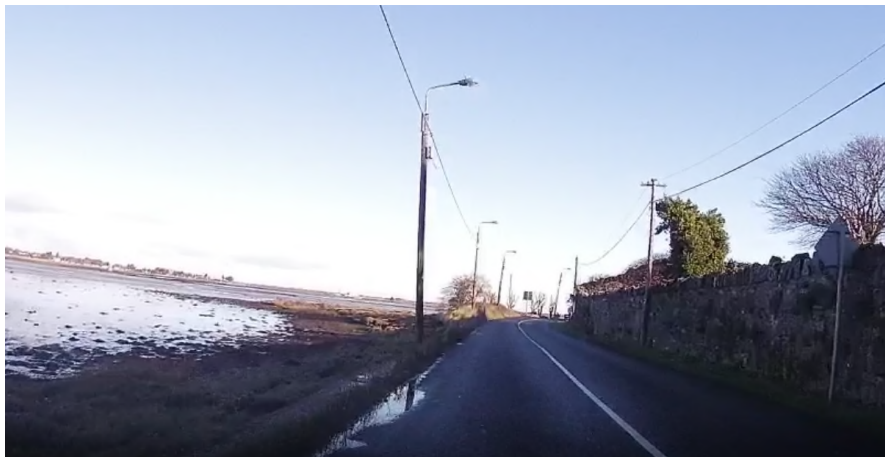
General, throughout the scheme adjacent to the Boyne estuary.

At some locations along the scheme the existing road is close to the banks of the River Boyne. At some locations there is a vertical drop at the edge to the bed of the river/mud plains. There are also some tributary crossings with retaining walls/headwalls along the route. There is a risk that an errant vehicle could enter the river bed and there could be a secondary effect if the tide was high of drowning or of the vehicle not been seen by passing drivers given the height difference.

Where the greenway is located beside the existing road there is a risk that the removal of a bund may lead to an increased risk of an errant vehicle reaching the river/floodplain.

It was observed during the site visit that there is a high kerb along some sections of the existing public road. It is unclear if such a kerb is adequate to provide containment for errant vehicles.

It is recommended that risk assessments are carried out on the need to provide protection for errant vehicles from entering the river bed at various locations along the scheme. This should include the approach and departure lengths to parapet/retaining walls. Based on the outcome of the risk assessments suitable containment should be provided.

The use of high kerbs should take account of the speed limit and the containment rating (N1, N2 or otherwise) of the kerbs.

| Paragraph No. in Safety Audit Report | Problem accepted (yes/no) | Recommended measure accepted (yes/no) | Alternative measures (describe) | Alternative measures accepted by Auditors (Yes/No) |
|---|---|---|---|--|
| 3.4 | Yes | No | The proposed greenway will create more protection from potential errant vehicle entering the river bed than the existing layout. The scheme proposes a 4m wide boardwalk with kerbs and fencing along this point. The boardwalk will be able to cater for vehicular loads, for emergency access. Therefore, the boardwalk will create an additional 4m clear zone. | Yes |

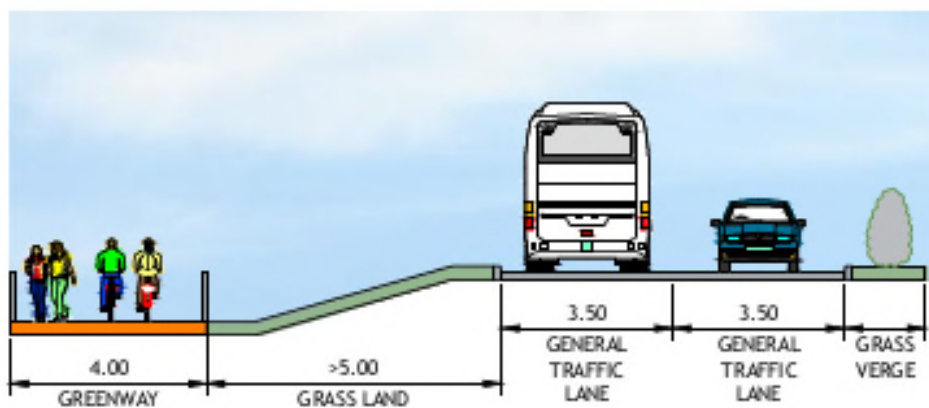
General, possibility of flooding.

It was observed during the site visit that there are warning signs that some areas are prone to flooding. There is a risk that some users of the greenway may not know where to walk/cycle if the area is flooded. This could lead them to enter the carriageway or fall in areas where they cannot see trip hazards due to flooding. It is unclear if allowance has been made for recent extreme rainfall events combined with high tides and the possible implications of climate change.

It is recommended where possible the levels of the greenway should be above flood levels and that a regime of warning users of potential flooding be devised at detailed design stage.

| Paragraph No. in Safety Audit Report | Problem accepted (yes/no) | Recommended measure accepted (yes/no) | Alternative measures (describe) | Alternative measures accepted by Auditors (Yes/No) |
|---|---|---|---|--|
| 3.5 | Yes | No | <p>The greenway would only be in Flood Zone A when alongside the road, and therefore constrained by existing road infrastructure, raising the greenway significantly (as much as 1.2 metres above road level in places) would be impractical, commercially restrictive, and visually obtrusive.</p> <p>It is the intention of Meath County Council that permanent warning signage (variable message) be put in place notifying both road and greenway users of the flood levels and directing them to an alternative route. The sign information will be switched by way of automatic level monitoring within Drogheda Port</p> | Yes |

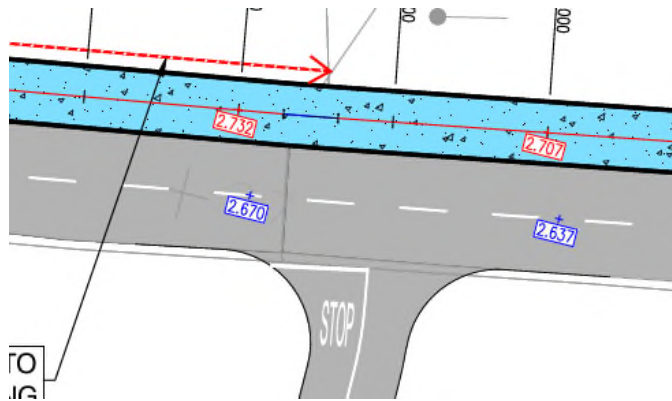
Drawing 170029-2205 Rev P2, Sideroad at Chainage 630.

There is a proposed sideroad at Ch 630 on the opposite side of the R150 to the greenway. No means of accessing the greenway is shown on the drawings. Without an access point, vulnerable road users may have to stay on the carriageway where they would be at greater risk of being struck by passing traffic.

It is recommended that a suitable crossing/access to the Greenway be provided.

| Paragraph No. in Safety Audit Report | Problem accepted (yes/no) | Recommended measure accepted (yes/no) | Alternative measures (describe) | Alternative measures accepted by Auditors (Yes/No) |
|--|---|--|---|--|
| 3.7 | Yes | No | This sideroad is a future private development. When the road/development is further progressed, discussions between the development and the Roads Authority will be undertaken to determine a suitable safe crossing facility. | Yes |

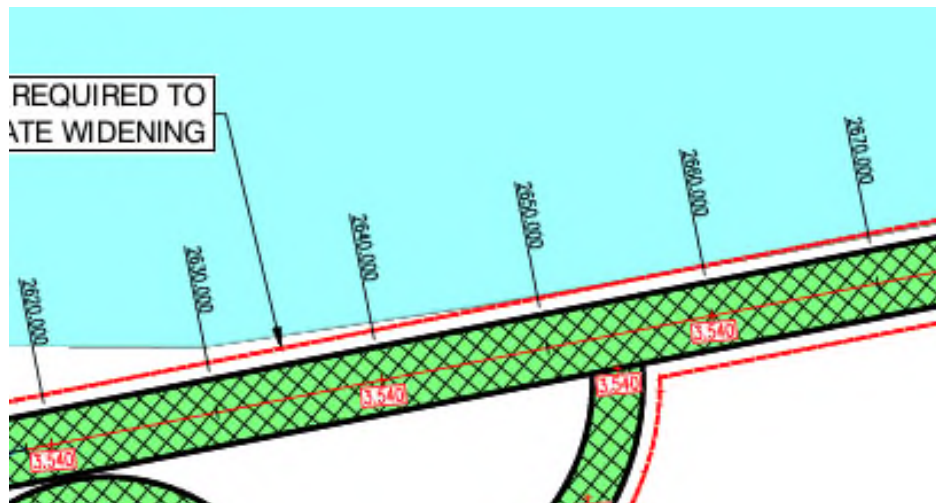
Drawing 170029-2218 Rev P5, Access to Marsh Road/Mill Road Junction.

It is proposed to provide a spur from the boardwalk element of the greenway to the signalised crossing of Marsh Road to the East of the Mill Road junction. The turn into the spur from the main greenway may be difficult for cyclists given its width and the presence of the railings. This could lead to collisions with the railings or collisions with other cyclists or pedestrians.

It is recommended that the junction with the greenway spur be widened locally to facilitate cyclists turning movements.

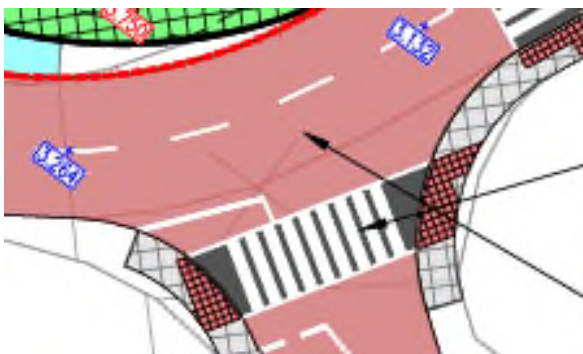
Drawing 170029-2226 Rev P2, Zebra Crossing on R150 Church Road.

The proposed zebra crossing at R150 Church Road is very close to the stop line. Drivers waiting to turn onto the R151/R150 will have to wait on the crossing. This may block the path of vulnerable road users.

It is recommended that the zebra crossing be set back at least one car length or that the entire junction be signalised.

| Paragraph No. in Safety Audit Report | Problem accepted (yes/no) | Recommended measure accepted (yes/no) | Alternative measures (describe) | Alternative measures accepted by Auditors (Yes/No) |
|--|---|--|---|--|
| 3.9 | Yes | No | It is proposed to replace the zebra crossing with an uncontrolled crossing, as there no desire line or footpath on the opposite side of Church Road at present. This crossing may be updated as part of future developments along Church Road. | Yes |

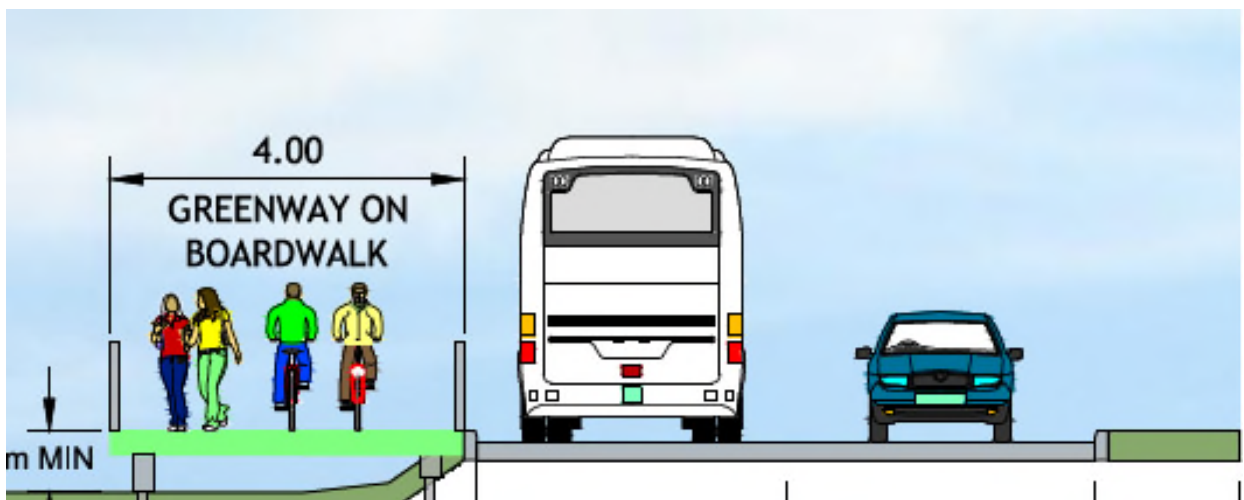
Drawing 170029-2227 Rev P2, Typical cross section.

The typical cross section East of the R150 Church Road junction shows the boardwalk and carriageway separated by a pedestrian railing and a kerb. There is a risk that the railing will be damaged by a large vehicle given how small of an offset it has from the edge of the carriageway. This could also lead to injury to pedestrians or cyclists.

It is recommended that the railing of the boardwalk be set back further from the edge of carriageway.

| Paragraph No. in Safety Audit Report | Problem accepted (yes/no) | Recommended measure accepted (yes/no) | Alternative measures (describe) | Alternative measures accepted by Auditors (Yes/No) |
|--|---|--|---|--|
| 3.10 | Yes | No | 450mm buffer will be provided between the carriageway edge and the boardwalk railing. The timber rails will be placed on the boardwalk/greenway side of the posts. | Yes |

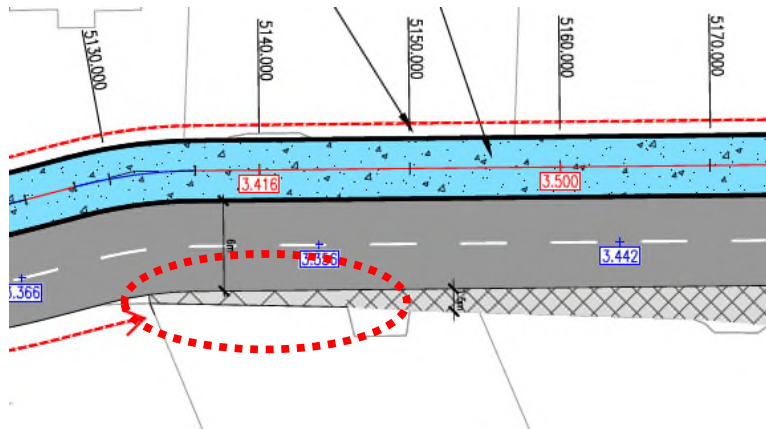
Drawing 170029-2235 Rev P3, Footpath on Southern side of R151.

It is unclear where the footpath will terminate on the southern side of the R151 but it is expected at approximately Ch 5140. There is a risk that pedestrians may continue their journey towards Drogheda on the carriageway if there is no facility for them to cross to the greenway on the opposite side. This would lead to an increased risk of those pedestrians being struck by passing vehicles.

It is recommended that an uncontrolled crossing point be provided at the terminal of the footpath at a location where suitable inter-visibility is provided between pedestrians and drivers.

| Paragraph No. in Safety Audit Report | Problem accepted (yes/no) | Recommended measure accepted (yes/no) | Alternative measures (describe) | Alternative measures accepted by Auditors (Yes/No) |
|--|---|--|---|--|
| 3.11 | Yes | No | A zebra crossing to the greenway is provided at the Mornington Court access. Providing a pedestrian crossing at the location mentioned will encourage the two residential properties on the southern side of the R151 to cross at a location where vehicle speeds have not | Yes |

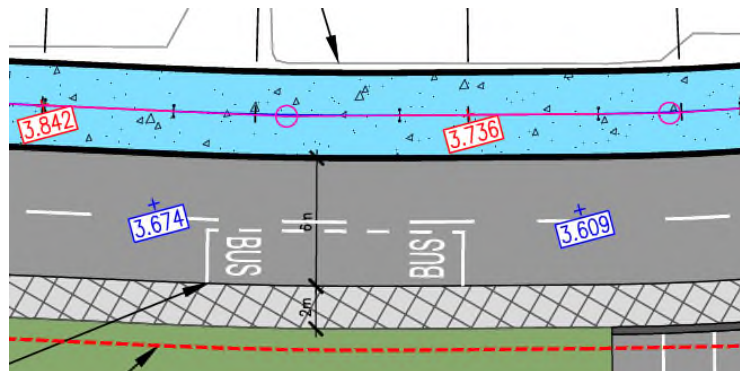
Drawing 170029-2237 Rev P4, Bus stop facilities.

It is unclear if a pedestrian crossing point is to be provided between the greenway and the Drogheda bound bus stop at Ch 5450. Without suitable crossing facilities the bus may not be accessed by all.

It is recommended that a pedestrian crossing be provided adjacent to bus stop.

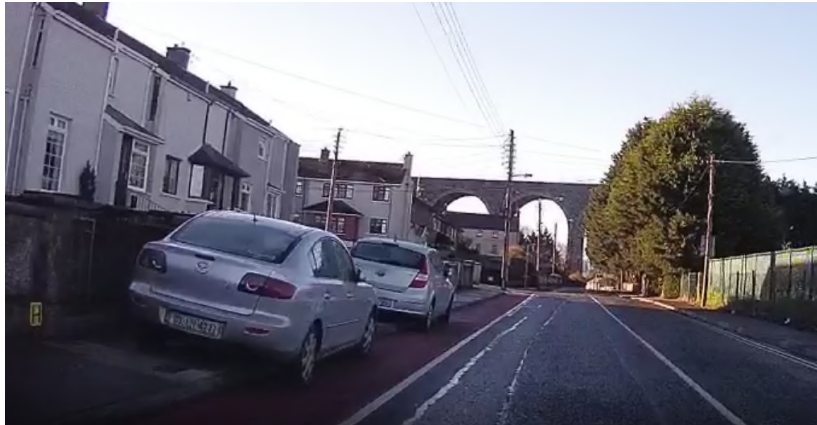
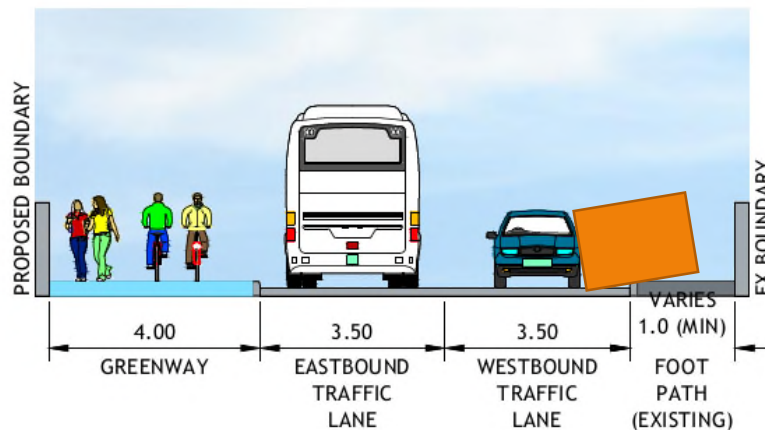
Drawing 170029-2202 and Site Observation.

It was observed during the site visit that on-road parking takes place on the Marsh Road outside the houses adjacent to Weir Hope. There are no on-curtilage parking facilities at some of those houses. It is unclear if the carriageway will be narrowed at this location as a result of the greenway or will remain the same. A lack of parking provision may lead to parking on the footpath resulting in hazards for pedestrians.

It is recommended that the scheme design takes account of this parking and that provision be made for it.

| Paragraph No. in Safety Audit Report | Problem accepted (yes/no) | Recommended measure accepted (yes/no) | Alternative measures (describe) | Alternative measures accepted by Auditors (Yes/No) |
|--|---|--|--|--|
| 3.13 | Yes | No | Prior to providing the exiting cycle facilities there were yellow lines (parking restriction) on both sides of the carriage at this location. Residents at this location have existing parking spaces at the rear of their properties. | Yes |

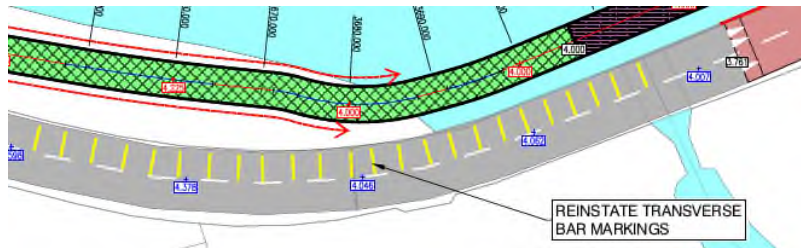
The use of transverse bar markings is currently only permitted on dual carriageway approaches to roundabouts. Alternative forms of traffic calming may be required on approach to the R150/R151 junction.
