**BUVINDA HOUSE COUNCIL CHAMBER EXTENSION, Co. Meath**  
Athlumney townland

**Desk Based Review and Assessment**

Niall Roycroft  
1<sup>st</sup> December 2022

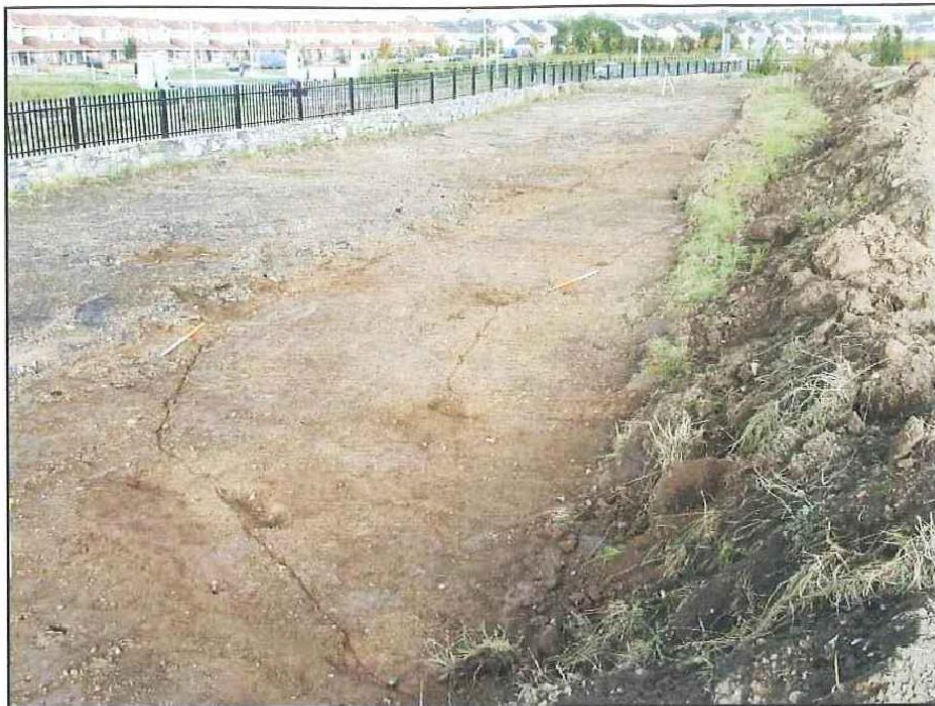
Plate 1 Topsoil removal along Area A. Ditch C295. Looking northeast  
Topsoil stripping in advance of the haul road along the northern side of the site

Ditch C295 referred to in Plate 1 can be seen to be curving around to the east and this curve is not reflected in the Final Report plan, presumably because it was under the haul road area. By overlay the Haul Road works seem to be around 8.5m wide from the northern boundary, flaring to 15m wide at the western end.

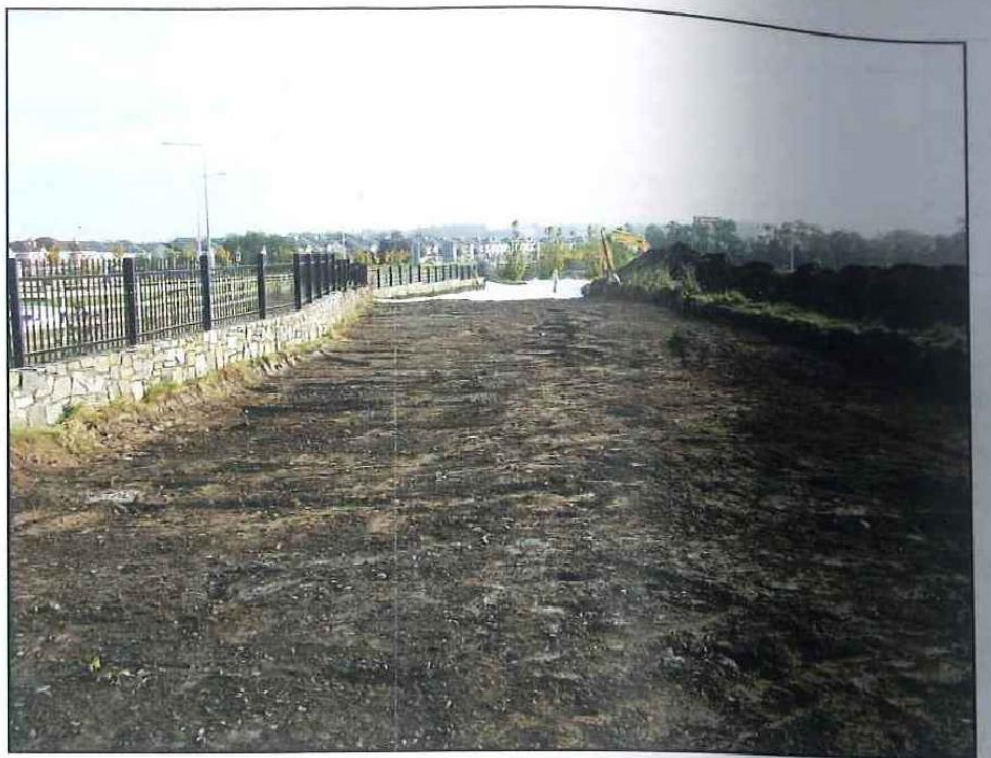
**Plate 2** Placing of terram over stripped area prior to importation of stone

The geotextile is the white mass in the distance. This shows the haul road to be around 15-20m wide
