# **Arboricultural Assessment, Arboricultural Impact and Tree Protection Strategy Report**

**Boyne Greenway -  
Drogheda to Mornington,  
Co. Meath/Co. Louth**

| <b>Project No.</b> | TBOY001 | <b>Date</b> | 13/07/20 |
| <b>Project Name</b> | Boyne Greenway - Drogheda to Mornington | <b>Revision</b> | A |

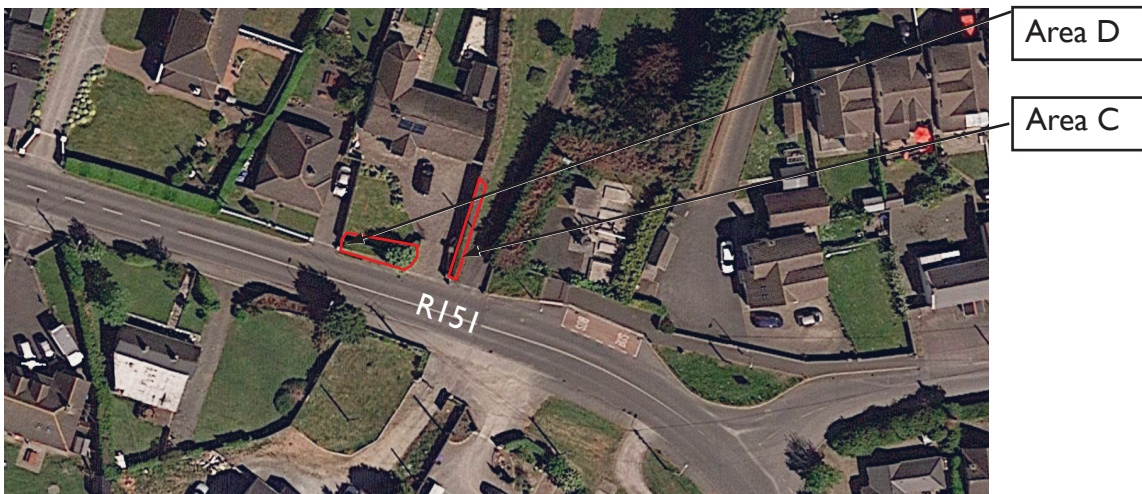
Image 10: Area D; Griselinia hedge 1.5 metre high behind a brick wall. Well maintained and vigorous. 9 metre long. Early mature Swedish whitebeam (#693) shown left.

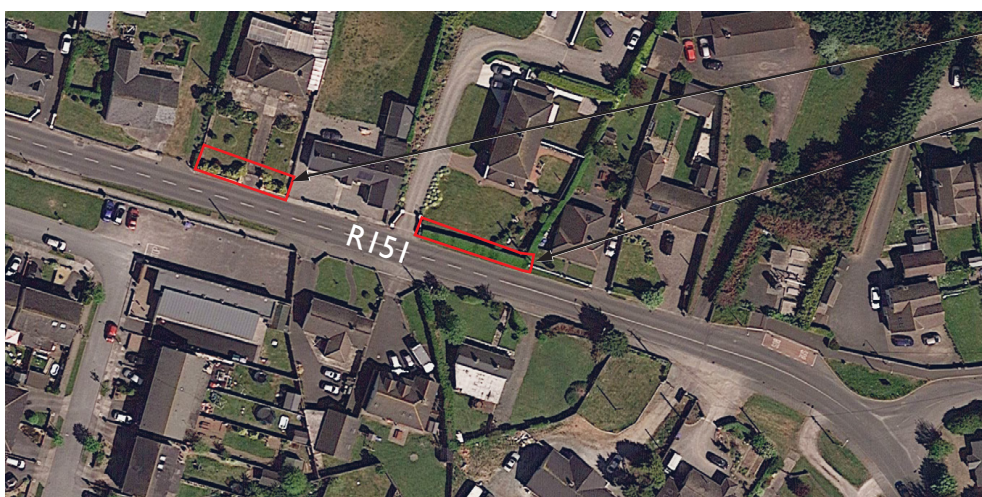
Area F

Image 12: Area F; Golden cypress (*Cupressus cv*) hedge topped to 1.75 metre high behind a low brick wall. Well maintained with no visible defects.

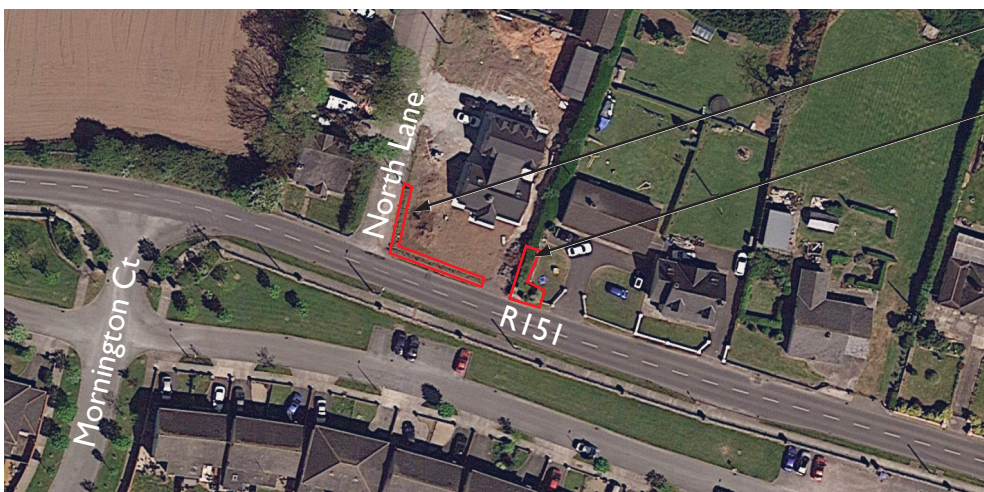
Area H

Image 13: Area H. Juvenile griselinia 0.5 high metre hedge. Recently planted for screening to residential property.

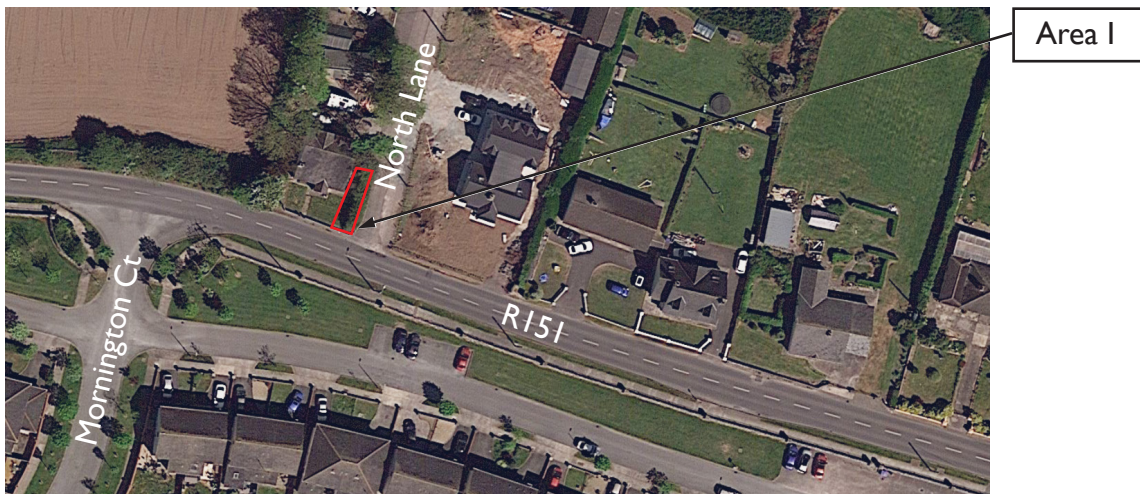
Image 14: Area I; Bramble hedgerow located on property on corner of R150 and North Lane. 2.25 metre high in a line perpendicular to R150. Well maintained.

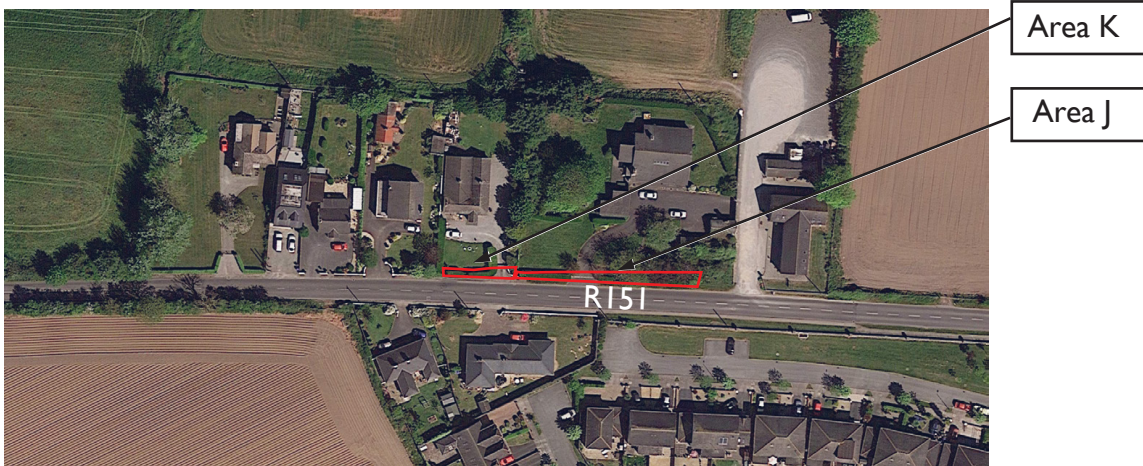
Image 16: Area K. Privet hedge 1.7m high behind a low stone wall. Gappy in places but well maintained.

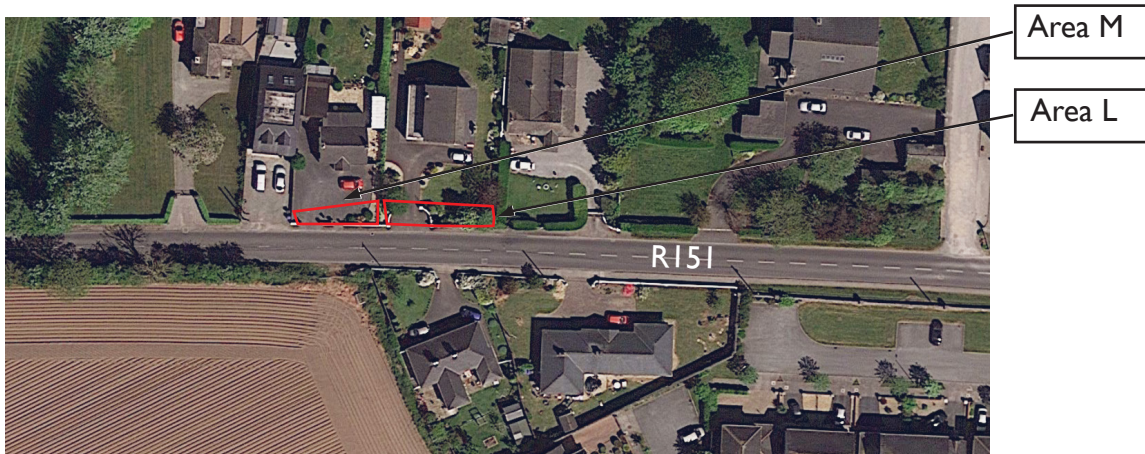
Image 18: Area M; Mix of shrubs (New Zealand Flax *Phormium* cv, *Euonymus* cv, Rose of Sharon) behind a low concrete wall.

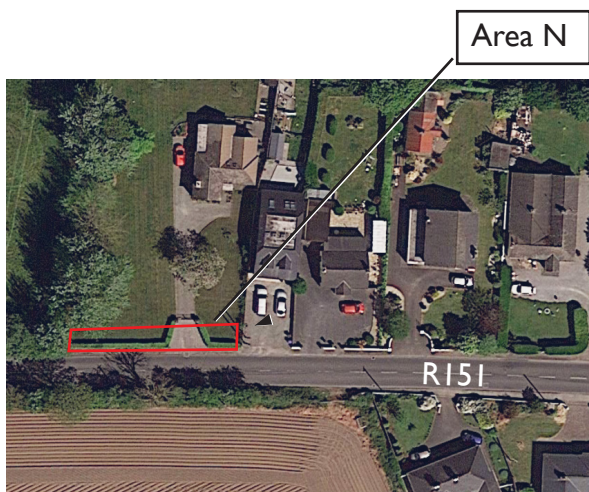
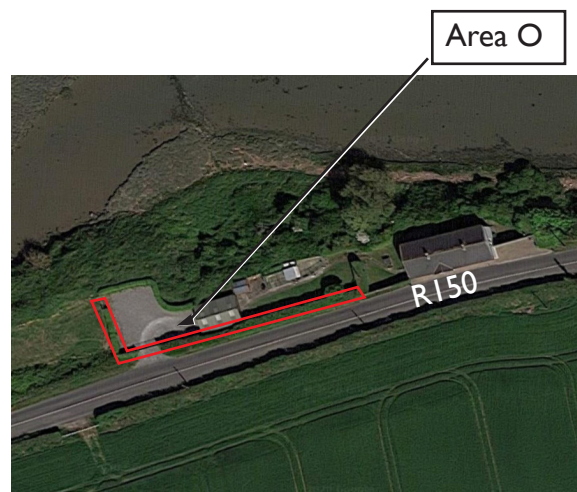
Image 20: Area O; Privet hedge 1.75m high and griselinia hedge 1.25m high. Well maintained.

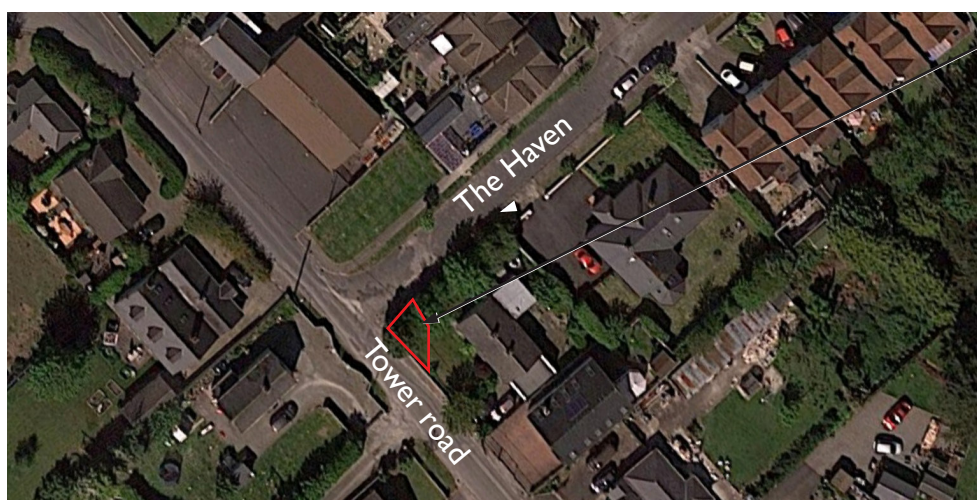
Area P

Image 21: Area P; A young sycamore inside private land at the intersection of Tower road and The Haven.
