energy efficiency

IN TRADITIONAL BUILDINGS

Comhshaol, Oidhreacht agus Rialtas Áitiúil
Environment, Heritage and Local Government

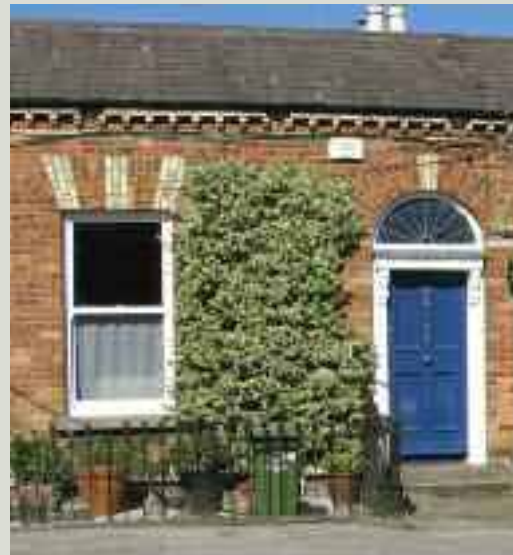
A typical brick-fronted, nineteenth-century house with solid masonry walls, single-glazed sash windows and slate roof

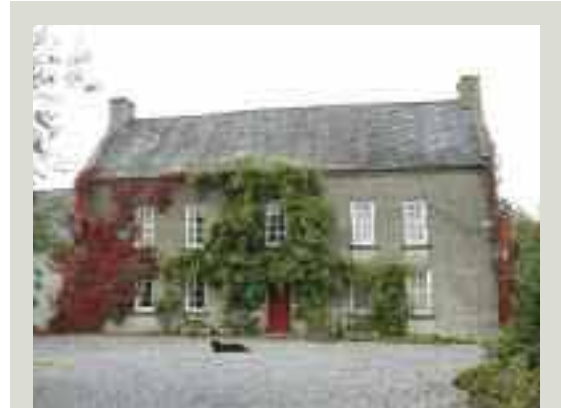
A typical traditional farmhouse, built of stone and finished in lime render, with a slate roof and timber windows

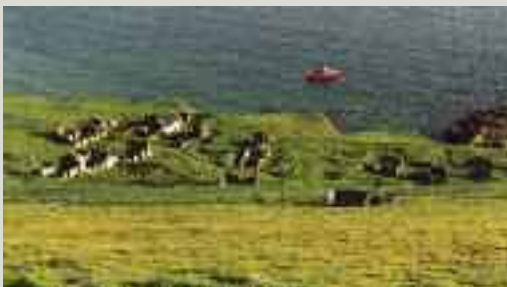
Houses on Great Blasket Island in lee of the hill with their gables turned towards the direction of the prevailing wind

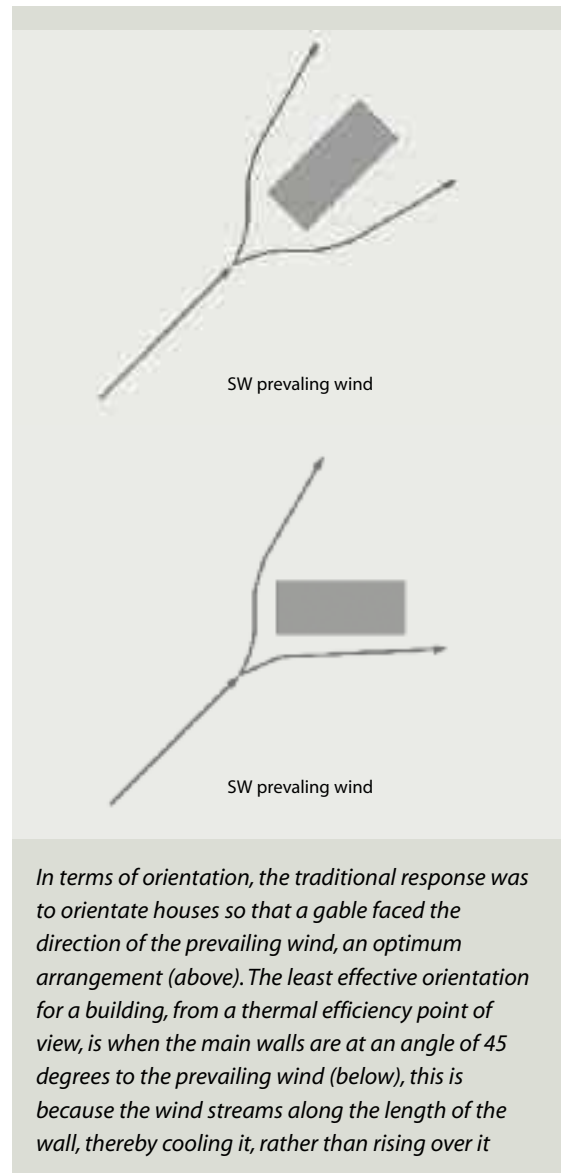
In terms of orientation, the traditional response was to orientate houses so that a gable faced the direction of the prevailing wind, an optimum arrangement (above). The least effective orientation for a building, from a thermal efficiency point of view, is when the main walls are at an angle of 45 degrees to the prevailing wind (below), this is because the wind streams along the length of the wall, thereby cooling it, rather than rising over it

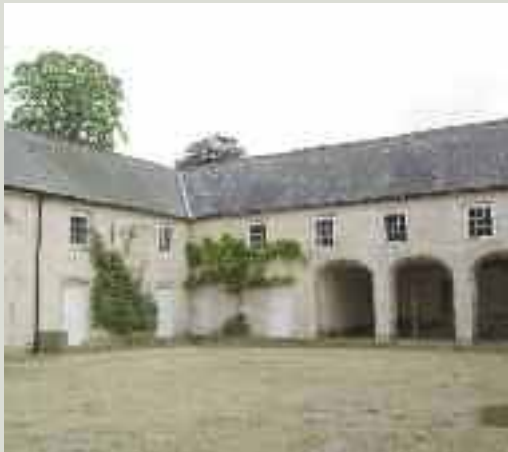
Traditional farm complexes were arranged so that the buildings provided shelter, not only to each other, but also to the outdoor working areas

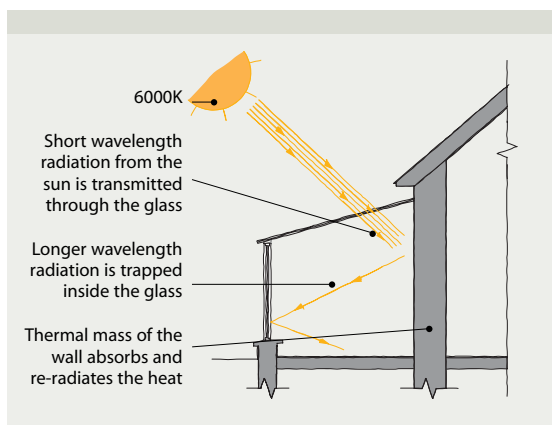
Solar gain: the 'greenhouse' effect. Traditionally, conservatories and greenhouses were built to maximise the advantages of the heat from the sun; sunlight entering through the glass warmed the air inside allowing for the cultivation of exotic flowers and fruits. The conservatory also provided a room for entertaining which was a place of transition between the house and garden

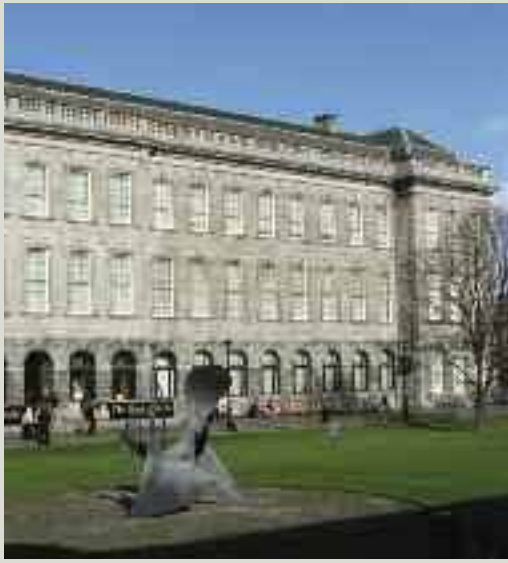
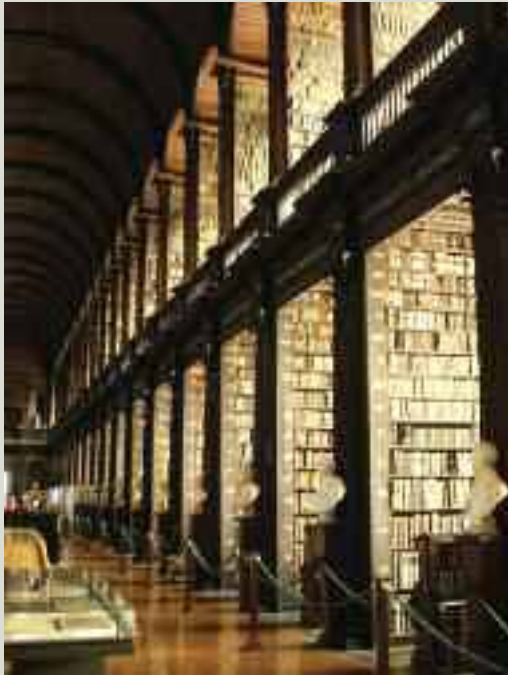
Trinity College Library, Dublin. There were never fireplaces in the library, to avoid the risk of fire breaking out. Sunlight streams in through large single-glazed south-facing windows, maximising solar gain. Appropriate steps should be taken to protect light-sensitive historic furnishings and contents from damage caused by both ultra-violet light and visible sunlight

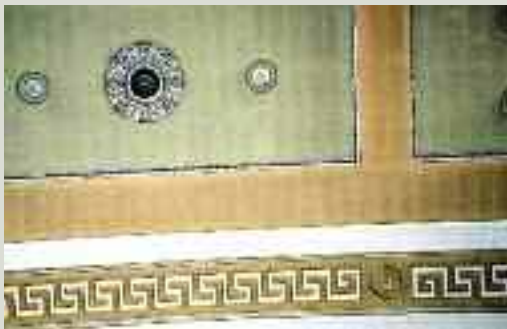
This plastered ceiling has no insulation above it. Discolouration can be seen on the plasterwork between the timber joists located above, as the timber is slower to transfer heat to the cold roof space than the plaster alone. Dust particles in the warm air passing through the plaster remain trapped on the surface causing the discolouration

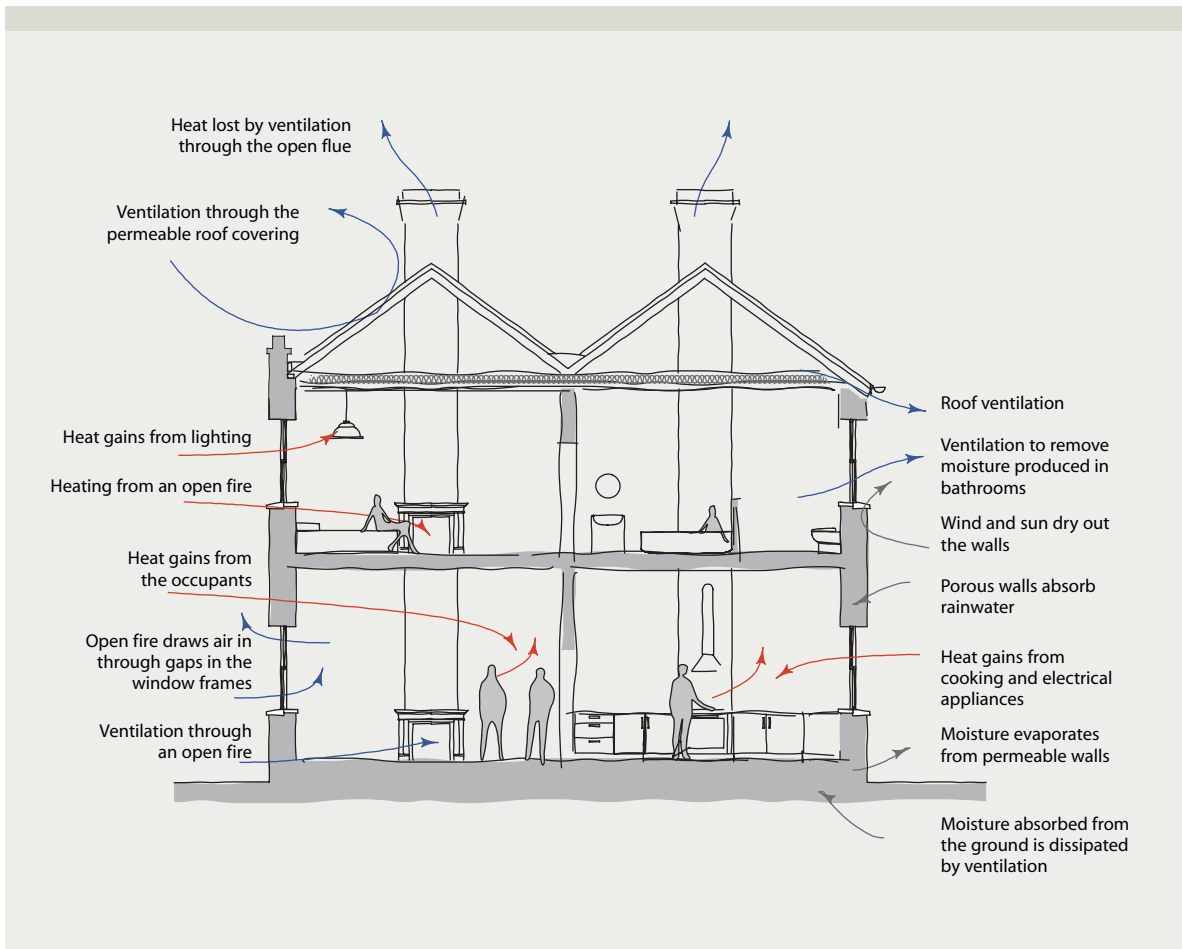
A comparison of the ventilation and heating requirements for a traditional building (above) and a modern building (below)

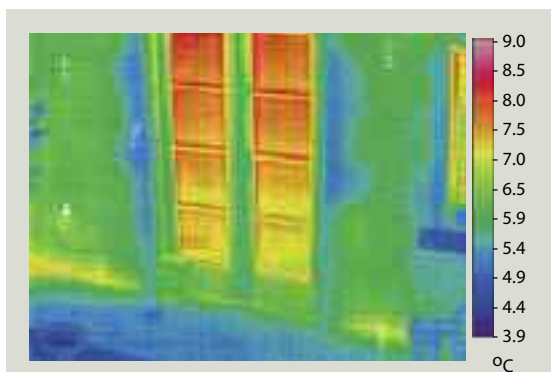
A thermographic image of a double-glazed door at semi-basement level in a nineteenth-century terraced house; note how the yellow patches at the base of the wall, which are damper, indicate that these areas are emitting heat at a higher rate than the rest of the wall

Thermal imaging can be used to identify potential problems with a building's fabric. When looking at traditional buildings, thermal imaging might be used to identify areas of dampness and to locate thinner depths of wall, cracking and voids. Expertise is required both in deciding how and when to take IR images and later in interpreting the information. For example, objects which have high or low emissivity such as metal do not give an accurate temperature reading. Weather conditions, orientation and the time of day when the image was taken all have the potential to affect the reading. The information gathered from thermal images can be properly assessed only in conjunction with data gathered as part of a comprehensive condition survey.

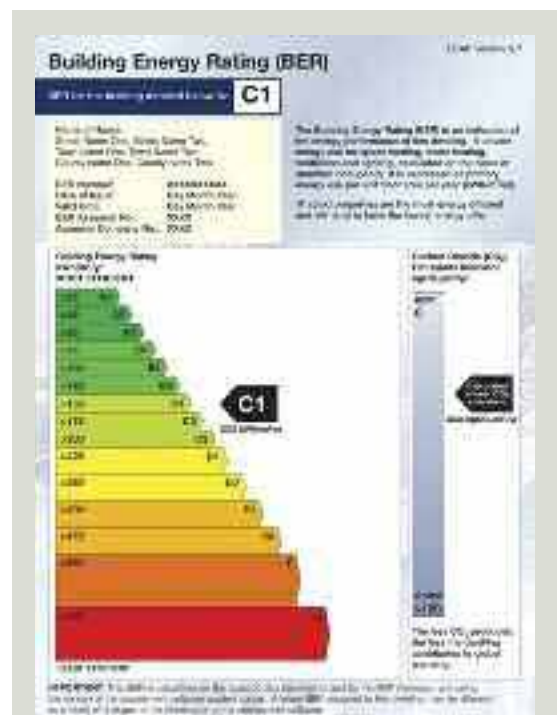
Sample Building Energy Rating Certificate for dwellings. The most energy efficient rating is 'A1' (green) down to the least efficient is 'G' (red)

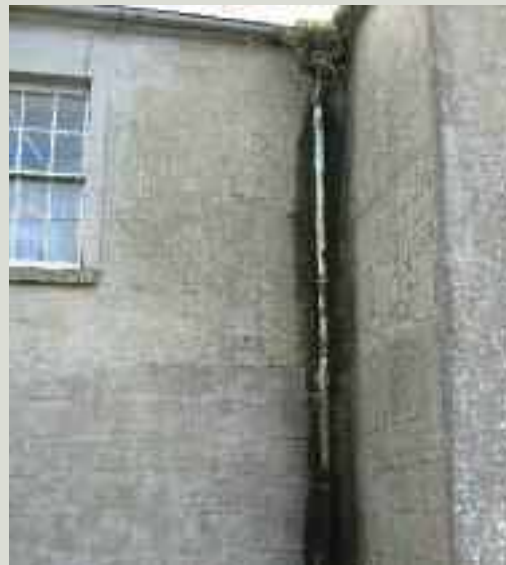
The importance of maintaining rainwater goods in good working order cannot be over-emphasised. Not only will the water running down this wall cause rotting of the building fabric and damage to the interior in the short to medium term; the dampness in the wall will also cause it to transmit heat more quickly from the inside of the building making it colder and less thermally efficient

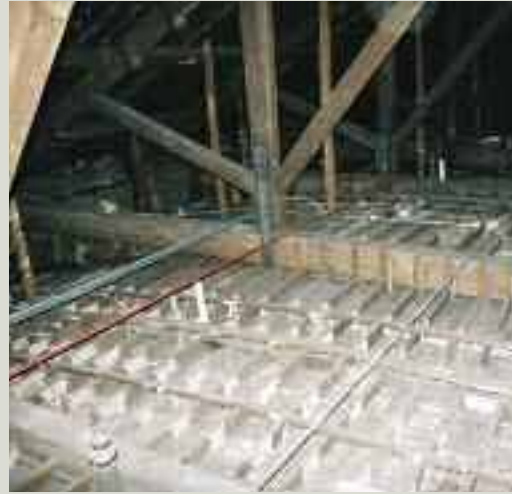
A large roof space with no insulation above the ceiling; while the heat rising from the building interior may benefit the timber and other building materials in the roof space, a lot of energy is wasted in this way

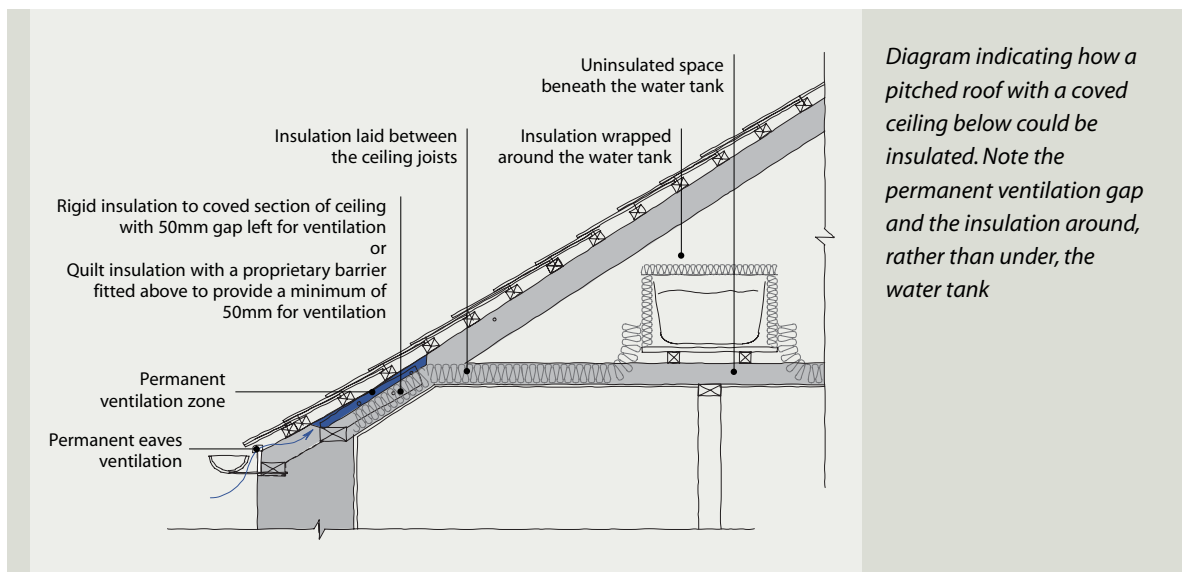
Where a roof is currently ventilated at eaves level, a gap of adequate dimension should be left to allow a continuous 50 mm passageway for air flow. It is common to find covered ceilings with a collar-tie roof structure in older buildings. Where this is the case, it is probably most appropriate to use a rigid form of insulation for the covered section of the roof, allowing a 50 mm ventilation gap over the insulation for the full length of the covered area. The horizontal ceiling joists can then be fitted with any of the insulation products discussed above.

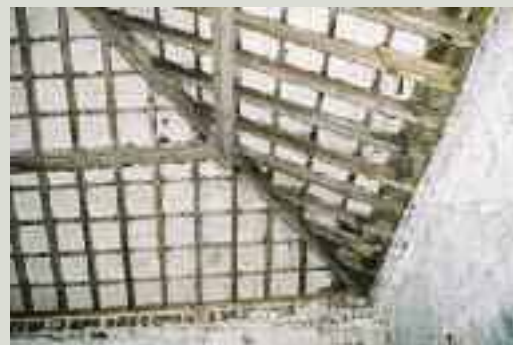
A roof with largely intact lime mortar parging applied to the underside of the slates. Parging has an insulation value in itself and helps to reduce air-blown water infiltration

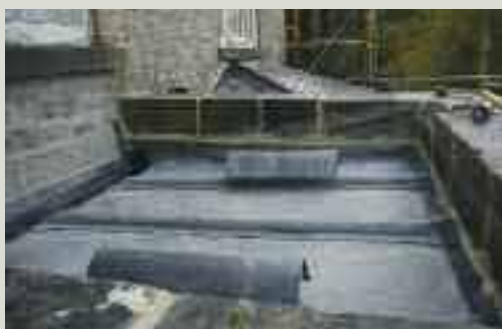
A recently re-covered lead flat roof. These modern lead roof vents were introduced as, previously, poor ventilation had caused moisture to build up within the roof space leading to timber decay

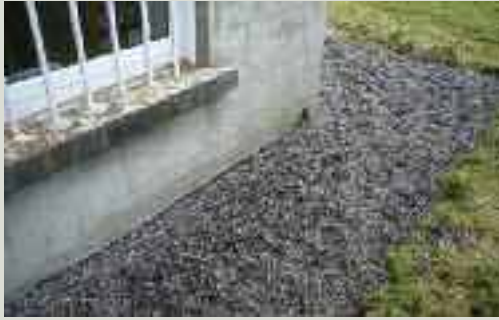
Where there are persistent problems with damp, it is important to ensure that the external ground level is lower than the internal floor level and, if necessary, consider installing a French drain below ground level with a gravel finish. Water percolates through the gravel finish to a perforated drain below, following which it drains to a soakaway at a distance from the building. The rendered wall finish will generally require repair following the lowering of the ground level. The installation of a French drain around buildings in sites of archaeological potential, such as churchyards, will require careful prior assessment and consultation with the relevant authorities

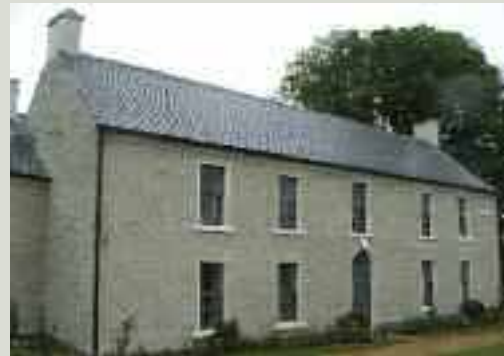
A lime-rendered façade, in good condition, improves the insulating value of a wall and prevents damp penetration to the inside of the building

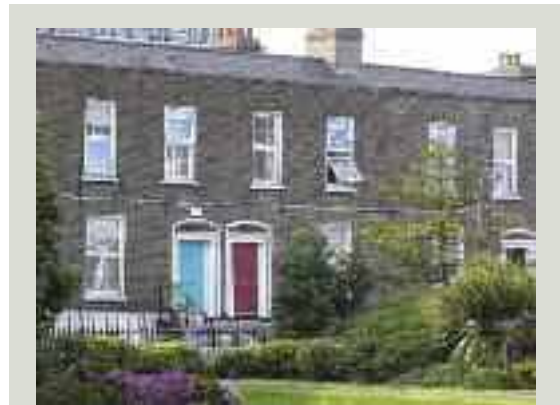
Terraced houses with replacement uPVC-framed windows. These windows are unsympathetic to the character of the houses; opening outward instead of sliding up and down, they disrupt the streetscape; the modern glass creates jarring reflections; while the thick frames contrast poorly with the elegant timber sections of the original sash windows

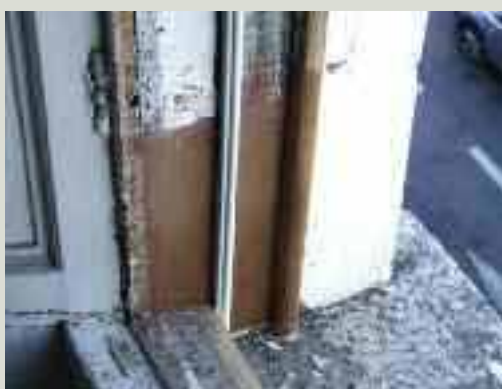
A repaired window frame with a replaced style and new parting bead. The timber sash frames have been temporarily removed

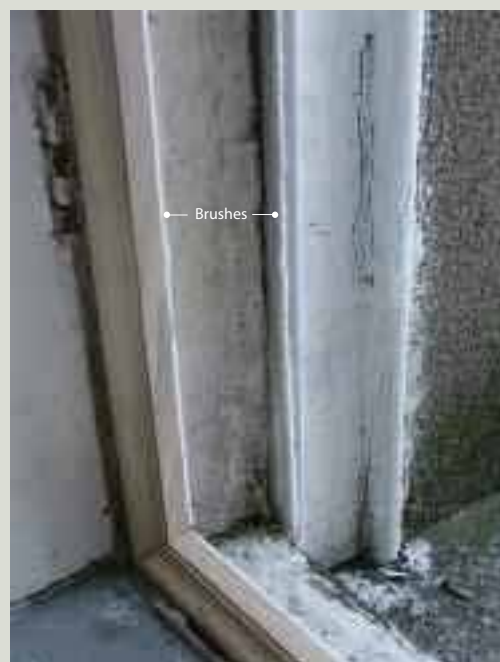
Draught-proofed window frame: brushes are visible on the staff and parting beads, both of which have had to be replaced in order to draught proof. For the brushes to work properly it is important that they are not painted over

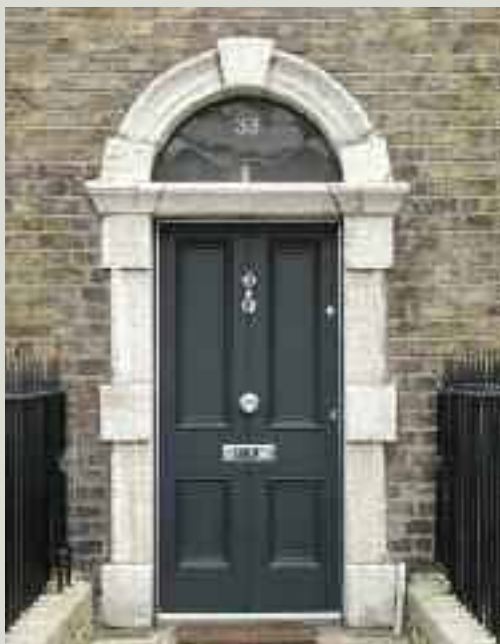
Aluminium draught strips can be seen to all sides of this door. The metal part of these strips, unfortunately visible, can be painted (although it is difficult to achieve successfully) but it is important that the flexible sealant strip is not

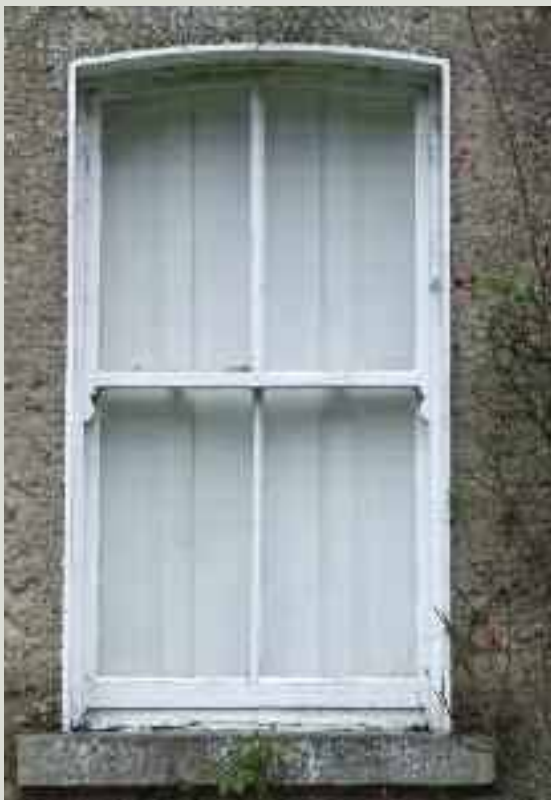
Working timber shutters: the interior of the shutter boxes could be lined and sealed to reduce air leakage. Any new linings should not prevent the shutters from folding back into the shutter box when not in use

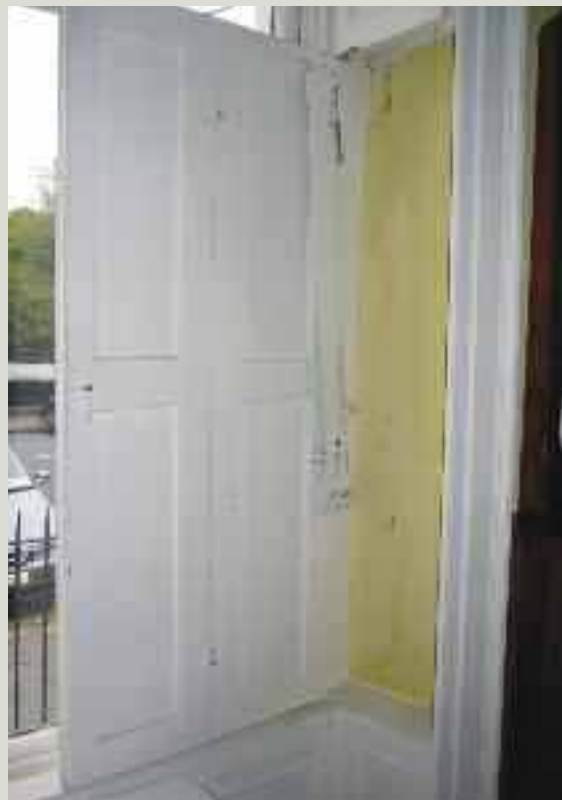
A well-sealed shutter lining

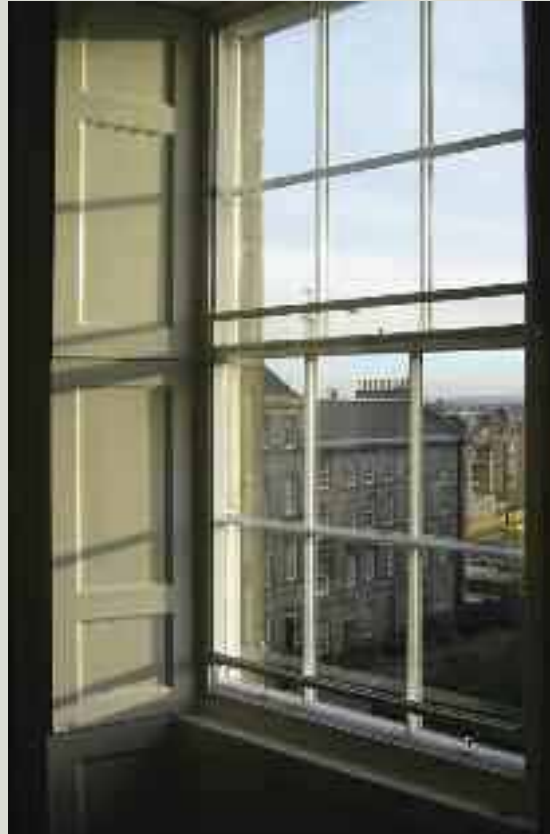
Carefully designed bespoke secondary glazing installed as part of Changeworks' Energy Heritage project (Image © Changeworks)

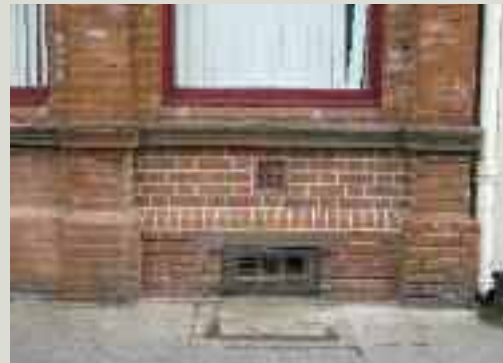
A floor vent to ventilate the ground floor was built into the wall between the cellar and ground floor windows as part of the original design

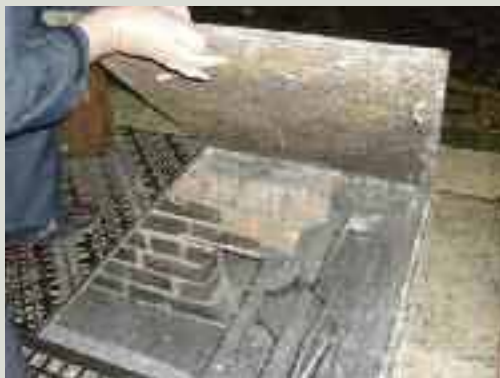
Hot-water heating pipes in a typical nineteenth-century floor duct

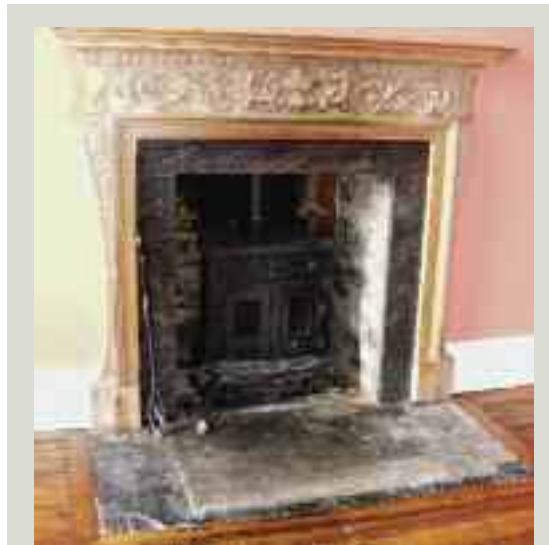
Wood-burning stoves can be efficient but in a traditional building they should generally only be fitted into non-decorative fireplaces. Historic grates and fire surrounds should not be damaged or removed in order to fit a stove

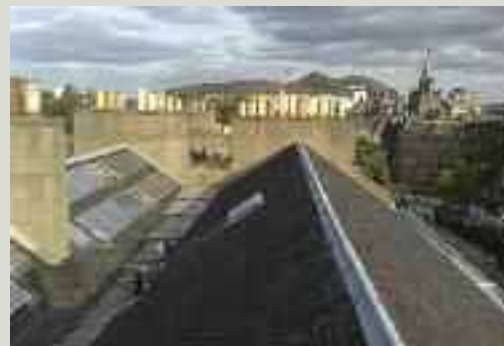
A roof valley may be an appropriate place to locate solar thermal or photovoltaic panels provided that the orientation of the roof is appropriate. This image shows solar panels installed in hidden roof valley as part of Changeworks' Renewable Heritage project (Image © Changeworks)

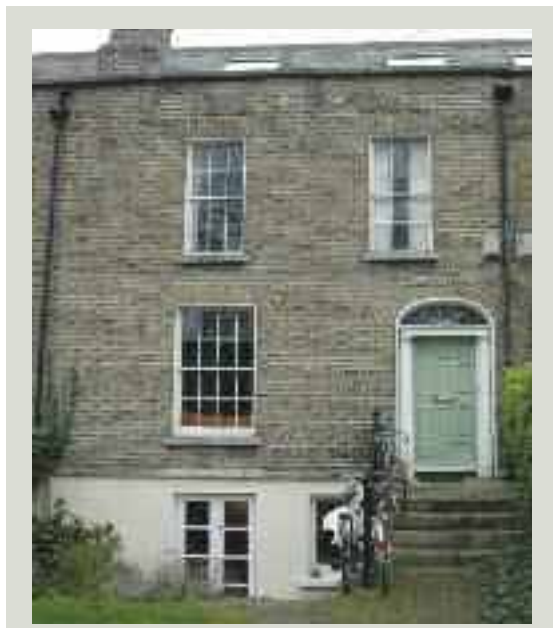
The brick façade from 1821 was later repointed using a sand and cement mortar. While the removal of this pointing and its replacement with a vapour-permeable lime-based mortar would benefit the building, it is likely that the process of removal of the pointing would cause unacceptable damage to the brickwork

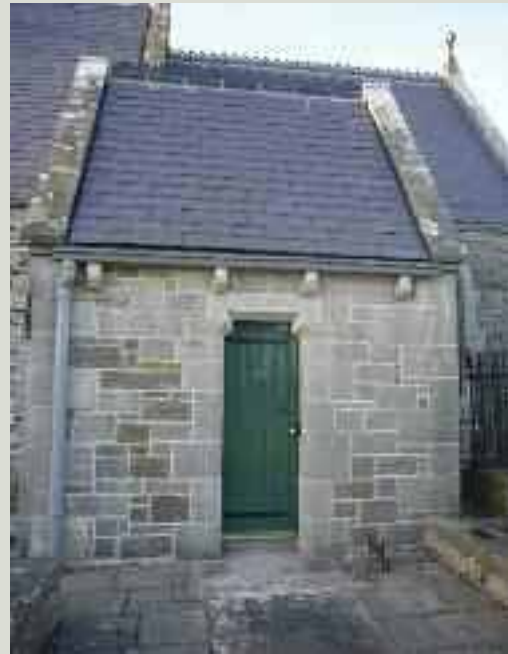
A special detail was used to deal with the small additional height that resulted from adding insulation to the roof build-up; stone blocks were added under the reinstated cast-iron gutter
