advice series

THE CONSERVATION AND REPAIR OF MASONRY RUINS

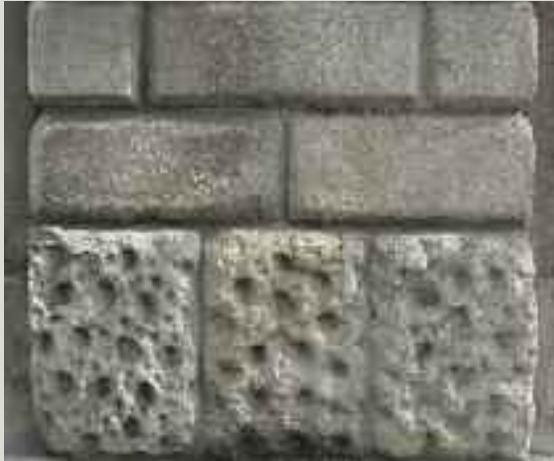
Granite ashlar with vermiculation to the lower course

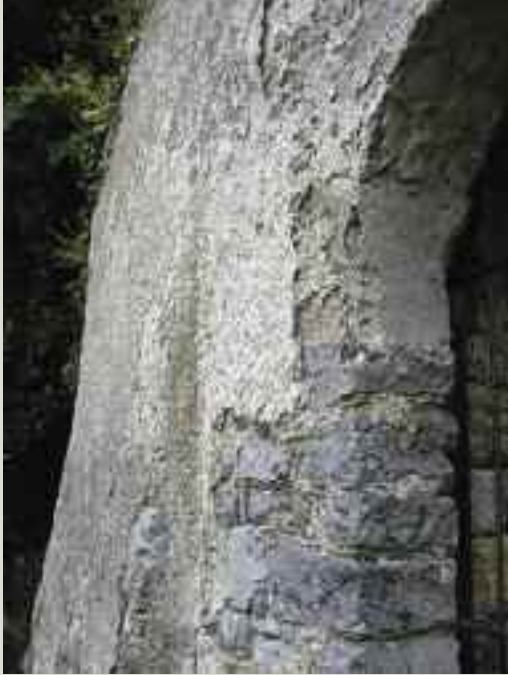
A wall showing surviving traces of external lime render. Most rubble-walled buildings were originally rendered to keep rainwater from penetrating into the interior

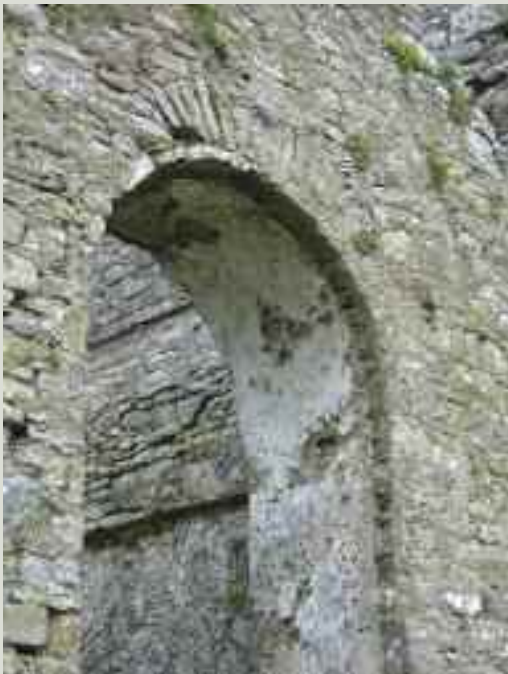
Even buildings which have stood as ruins for centuries can retain traces of internal plaster. These are most often found in sheltered parts of the building such as here on the intrados of an archway

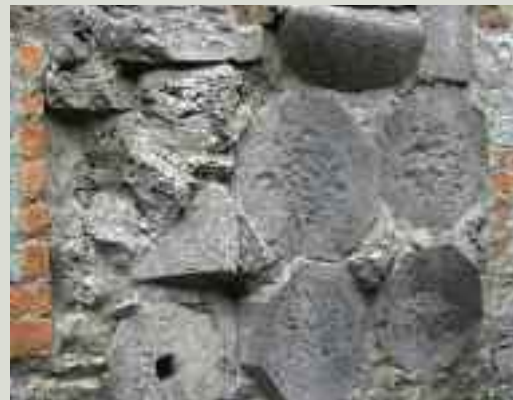
Earlier carved stone was often reused in the construction of later masonry walls. In this example an opening was blocked up using parts of a disassembled column from the adjacent ruined friary

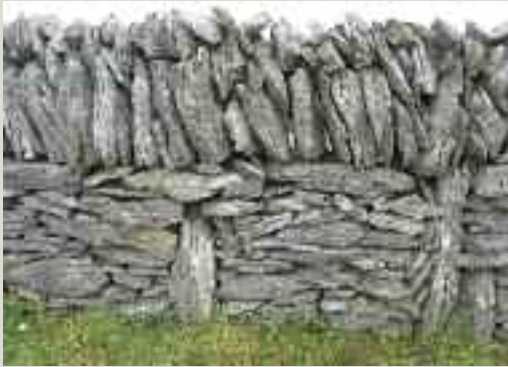
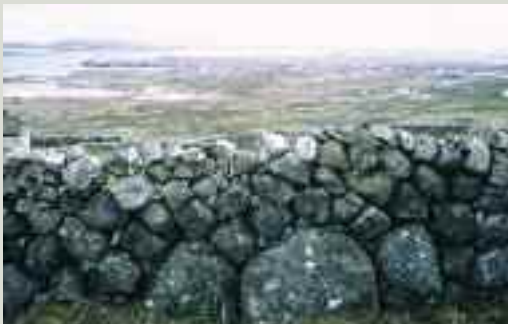
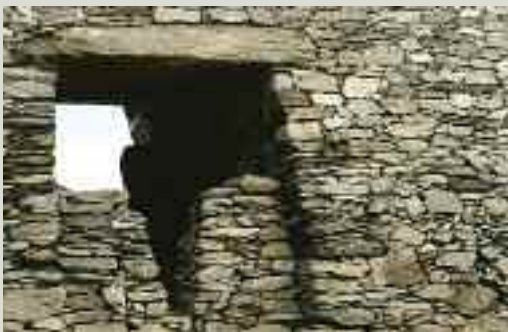
Drystone walls show regional variations and styles, dictated by the type and size of field stone locally available (Top and middle images courtesy of Patrick McAfee)

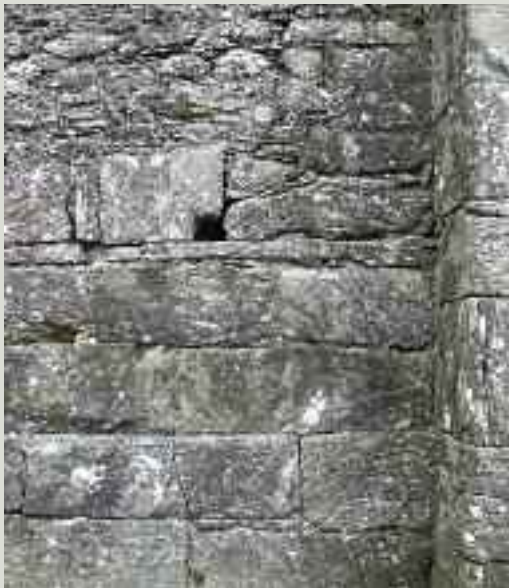
Large blocks of cyclopean masonry can be seen to the lower courses of this wall

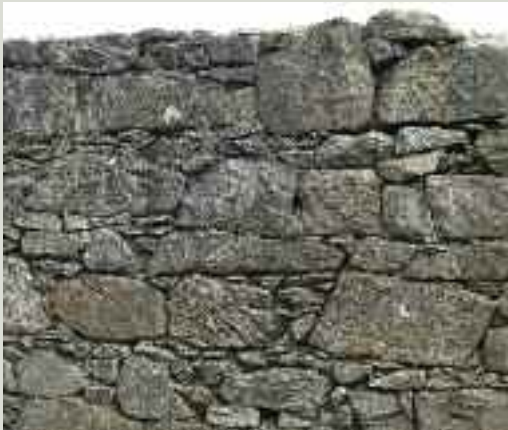
The small stones used as pinnings can be easily lost as the mortar holding them in place erodes over time. When repairing a wall, it is important to collect any fallen pinnings and reincorporate them into the joints as they are an essential characteristic of the wall

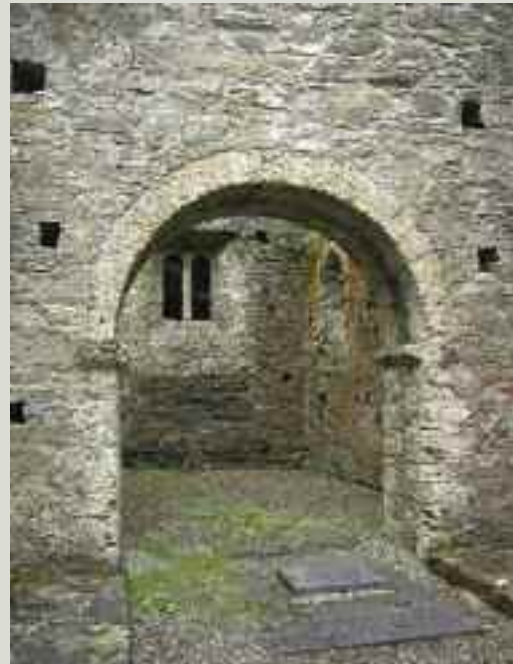
Putlog holes, literally holes in a masonry wall where timbers were put, are a common feature of mediaeval buildings

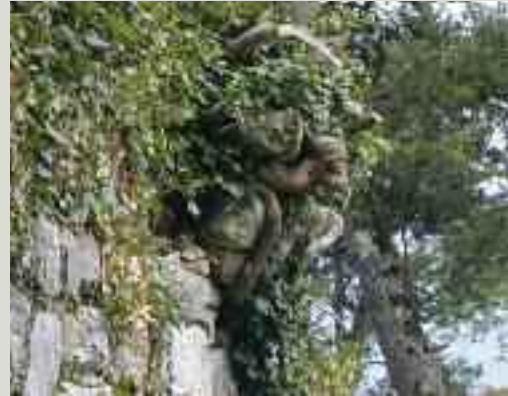
Ivy will displace stones as its stems thicken and can become part of the structure, holding up the stones it has dislodged

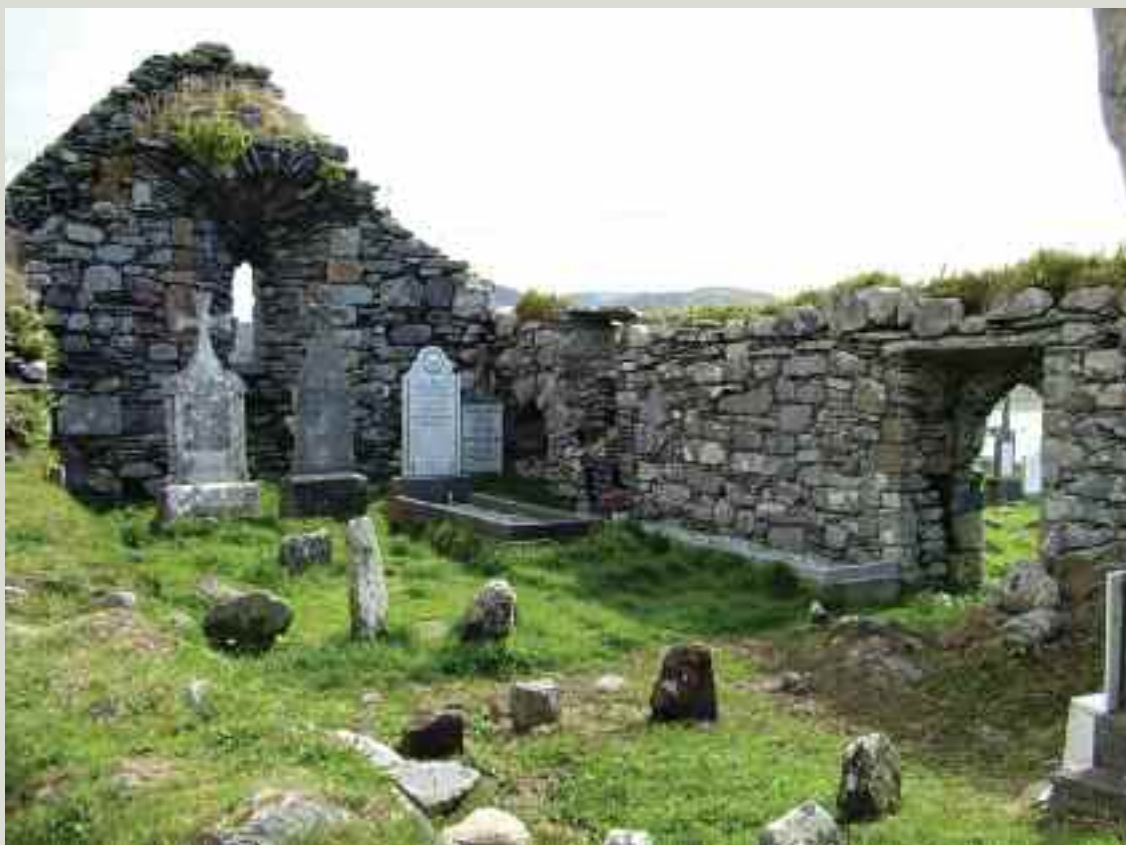
Graves close to a ruined church wall can damage the masonry foundation itself and undermine the earth supporting the foundation

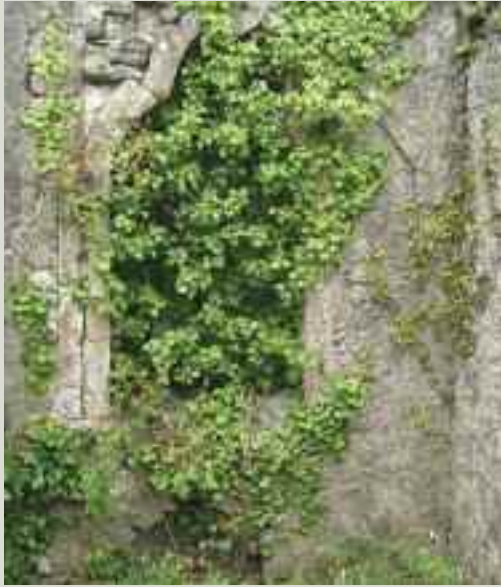
Ivy can become established within a masonry wall, growing unchecked through the joints and re-emerging in other parts of the structure

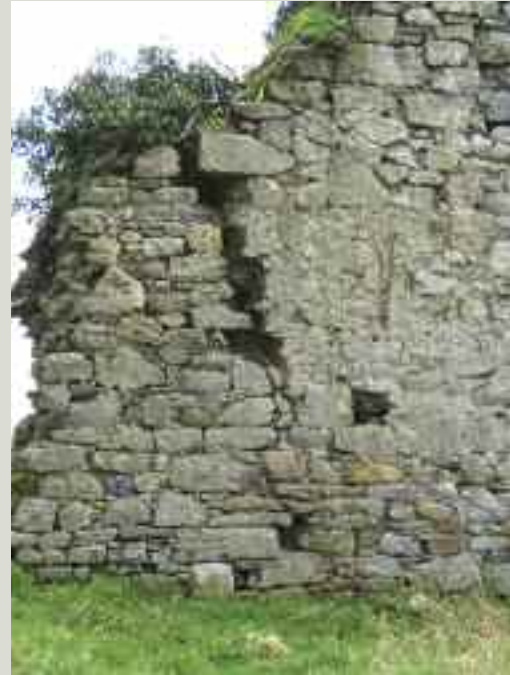
Tapering cracks can result from subsidence. As the crack widens the smaller stones fall out or drop inside the wall creating a wedge effect and increasing the damage

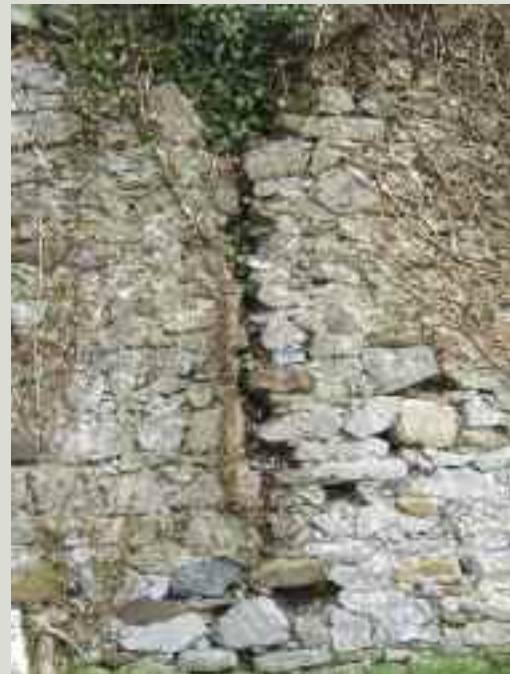
Vertical cracks can be more common in walls where few long facing stones were used. Longer stones create a stronger bond than smaller stones

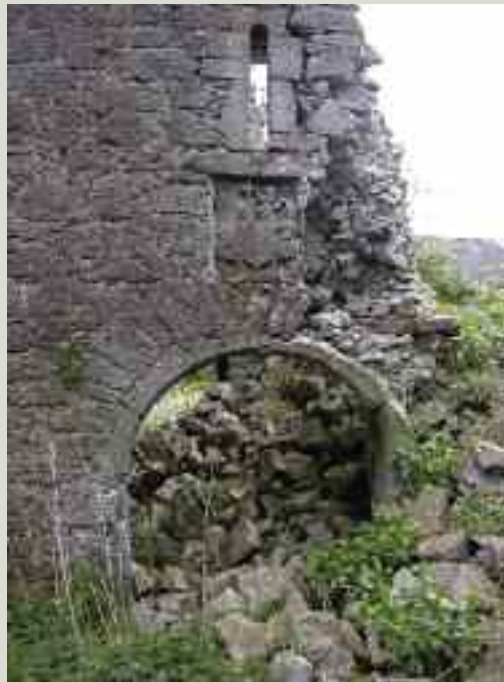
Partial collapse of this church tower occurred suddenly, taking down a portion of the nave wall

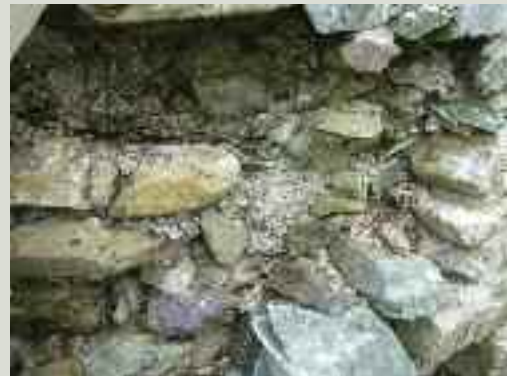
Wall with its outer face lost exposing the construction of the wall core

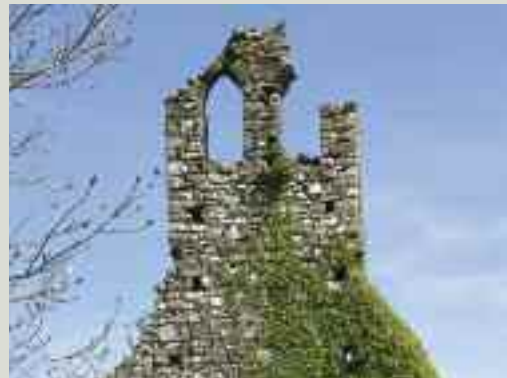
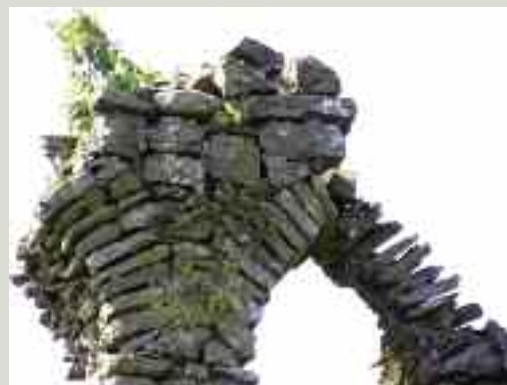
One arch on this double bell-cote has already failed. The other is on the point of collapse due to loss of mortar through erosion and exposure

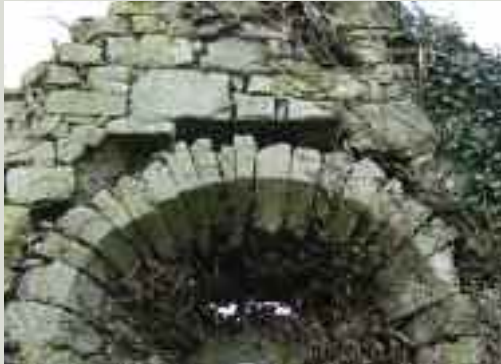
Arch over a window. Note the damage done by the improper removal of ivy which pulled out the smaller packing stones and has left the arch vulnerable

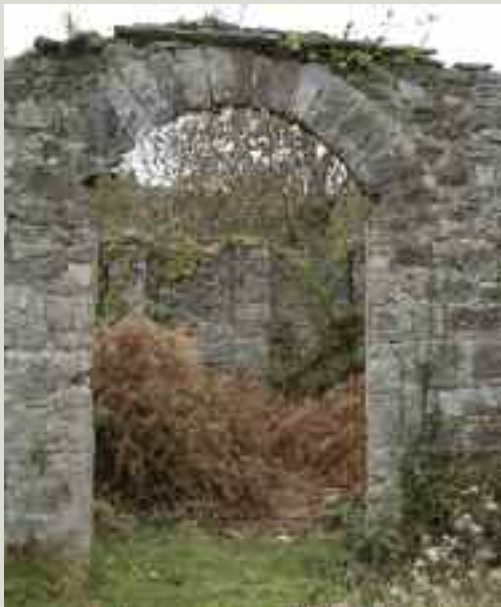
Arch over a door opening. This arch is also vulnerable because the wall over the arch has been lost

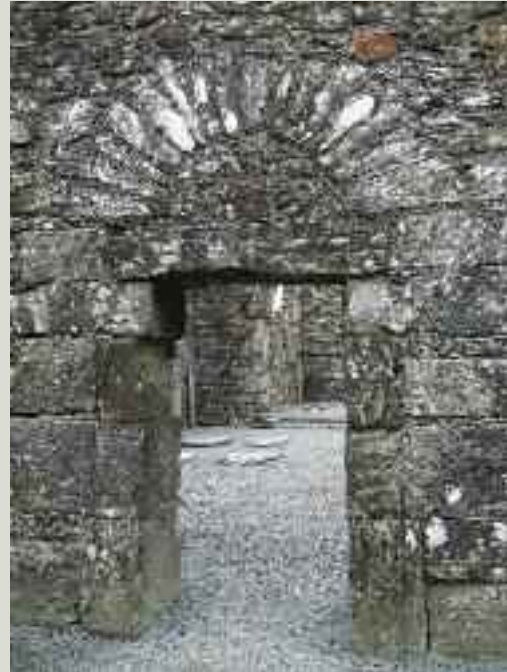
Relieving arch over a flat door lintel

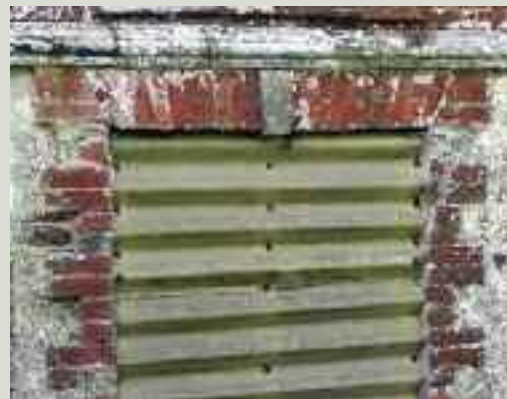
A flat arch constructed of brick with a limestone keystone

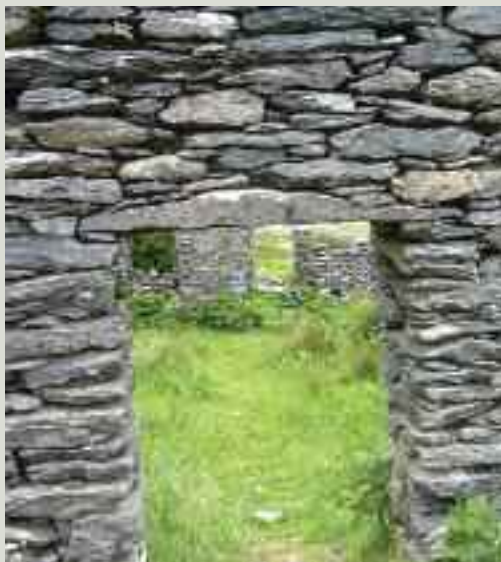
Stone lintel over a narrow opening. The thinness of the lintel, particularly at the right-hand end, makes it vulnerable to cracking

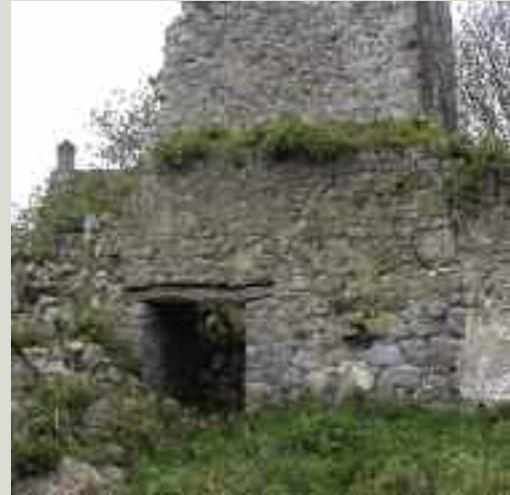
The condition of the surrounding masonry is important in the survival of timber lintels. If the wall top or pointing is poor, water will lodge on top of the timber lintel and cause decay

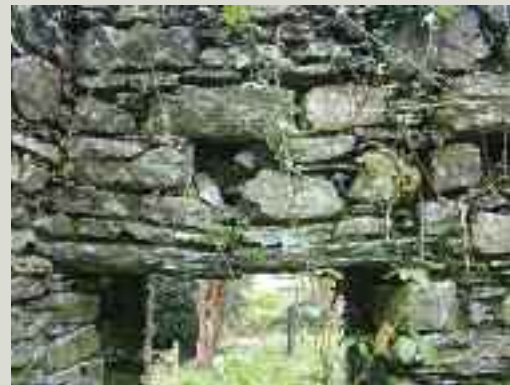
Lintel failure in this case was probably the result of the loss of mortar and stone from the wall above the lintel which damaged the natural self-arching tendency of the masonry placing excessive loading onto the lintel

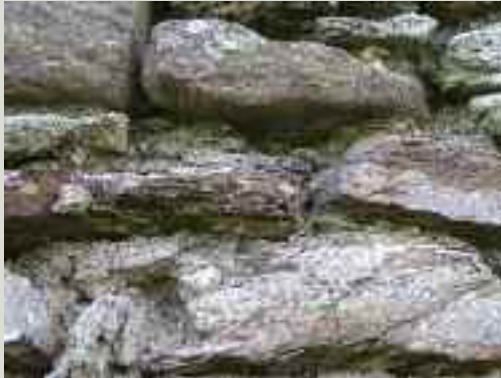
Decayed/weathered lime mortar

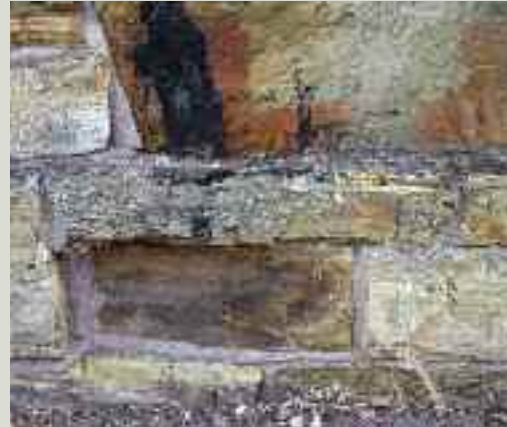
Delaminating stone, bedded vertically

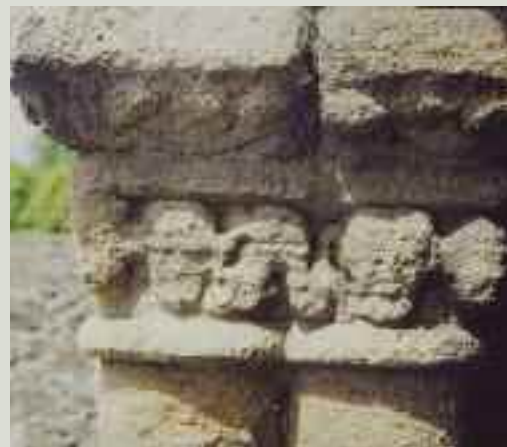
Carved sandstone, showing weathering. Sandstone was widely used for carving because it was relatively soft and easily worked. Some high crosses and Romanesque detailing were carved in sandstone

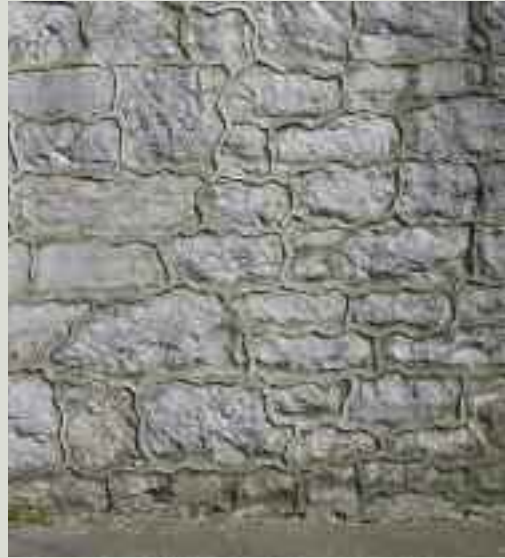
Strap pointing is a style of pointing which must be avoided on historic masonry structures. Unfortunately, it is quite a common intervention and was often used where the original joints were very fine. Unsightly and damaging to the stone, the pointing is proud of the stone surface and traps water on the ledges formed. It also partially adheres to the face of the stone and is almost always cement-based

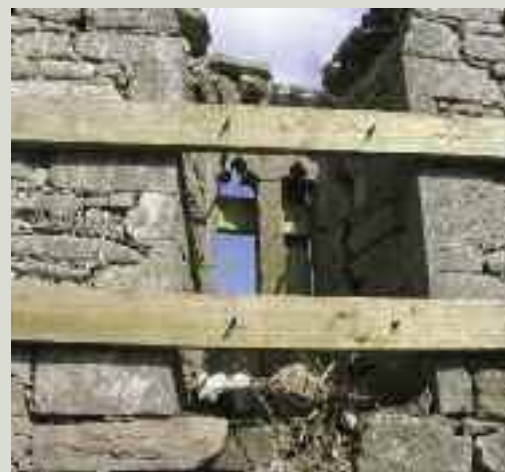
Timber bracing in the vertical plane to secure a window opening where a collapse outwards was imminent. The temporary work consisted of planks bolted through the opening

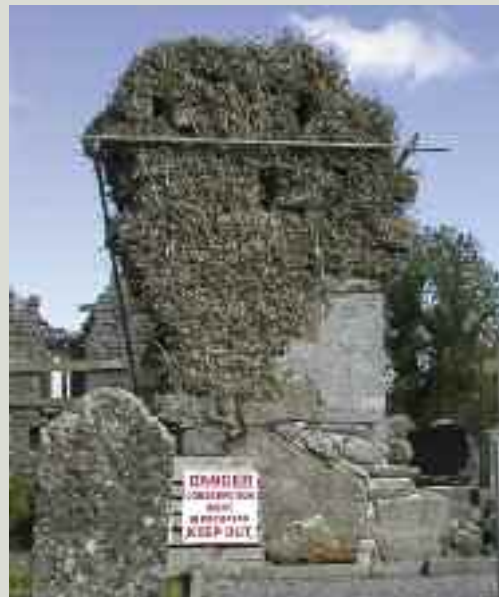
A clear sign warns of conservation works in progress. The temporary works to the wall in the background include scaffolding poles to provide restraint. The concrete blockwork on the right hand side provides temporary propping pending reinstatement of the wall core

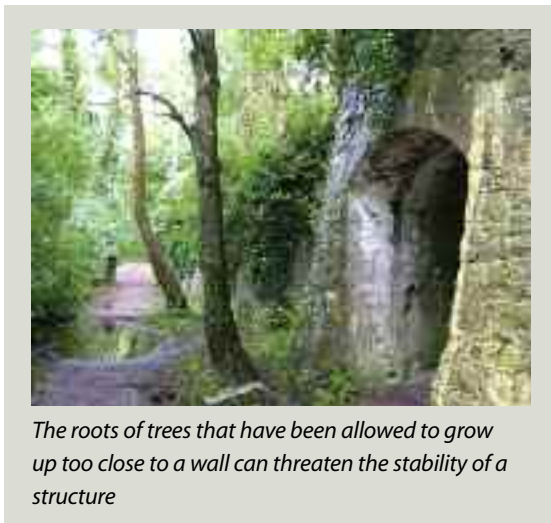
The roots of trees that have been allowed to grow up too close to a wall can threaten the stability of a structure

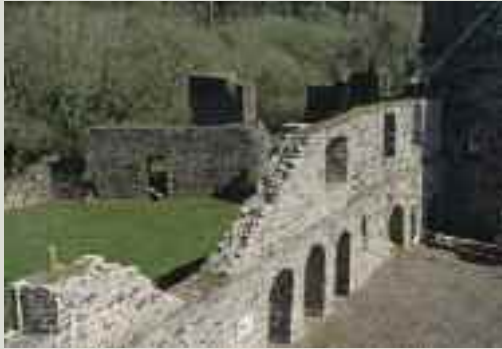
Flaunching, a sloping area of mortar, has been applied to the raking surface and also to the upper surface of this wall on which a mat of vegetation is beginning to grow

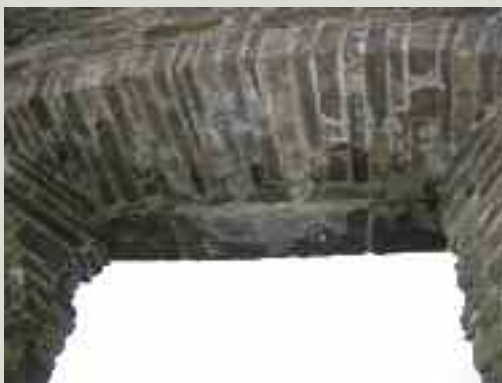
Failed lintel with stainless steel rods used to carry out a stitch repair

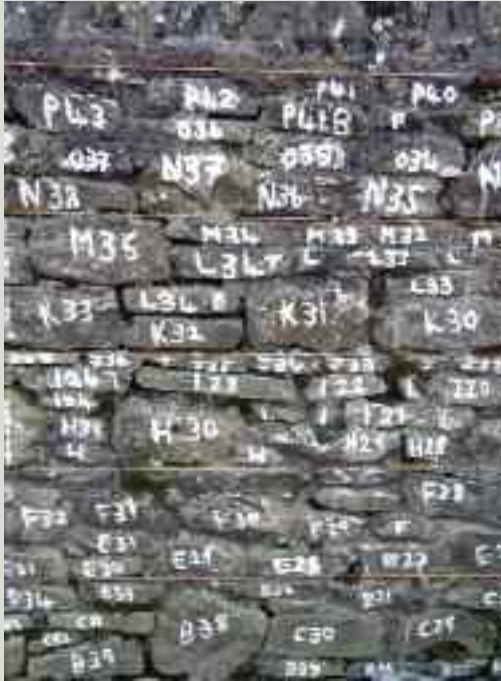
Masonry wall with stones numbered to allow for accurate rebuilding. The strings are stretched across the length of the wall to mark the wall at vertical intervals to ensure joints are kept at original thickness when rebuilding

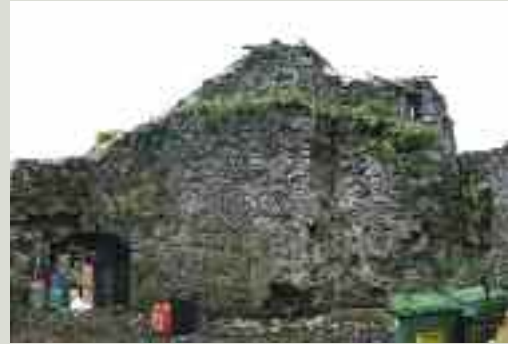
A repair to a town wall using new stone where the wall had been damaged or robbed. In this case, the new stone was sourced from a quarry 8 km away and, in the course of time, will weather in

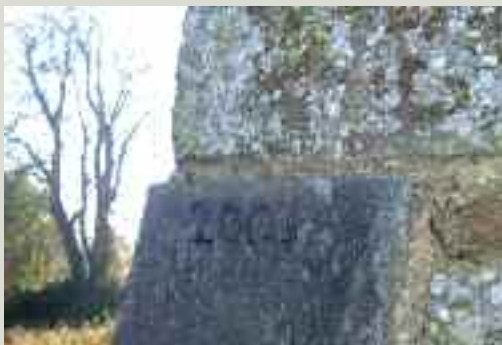
A date has been etched into the stone to distinguish the new stone from the original

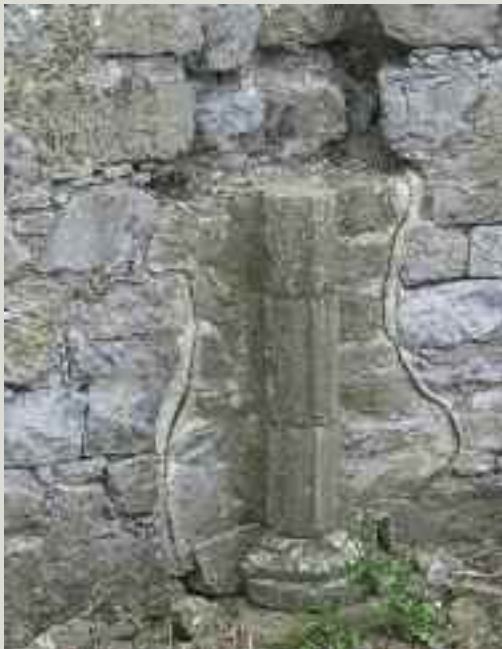
A method of distinguishing between old and new masonry in repair work was used by the Office of Public Works in the mid-twentieth century and can still be seen on many national monuments today. The technique involved separating the new from the original by the insertion of a strip of felt. This technique is no longer used today

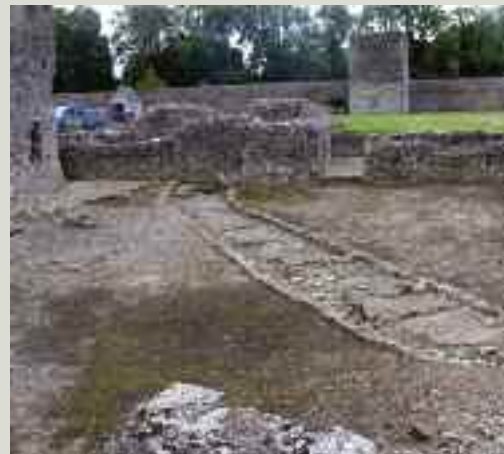
Archaeological investigation revealed the existence of a stone-covered subsurface drain running beneath this mediaeval priory complex (Image courtesy of the Office of Public Works)

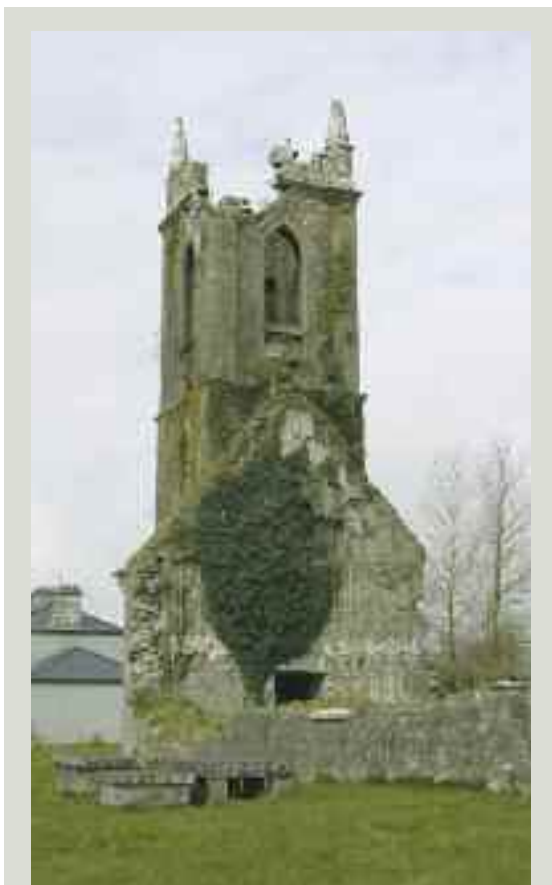
Ruins are often found in isolated areas and a structure such as a tower may be the tallest in its locality making it vulnerable to lightning strike. The tower of this ruined church was struck by lightning which destroyed the corner pinnacle

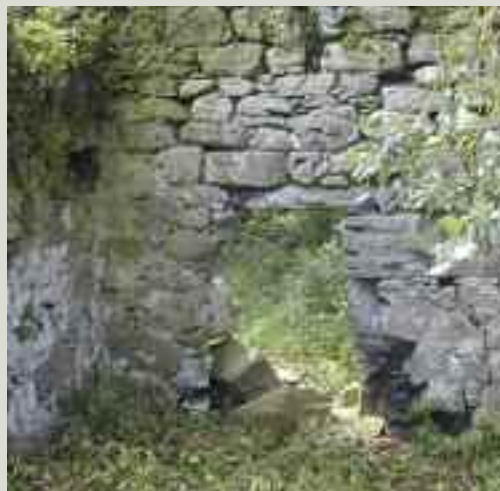
The stones that formed the jambs to this doorway have become dislodged because of cattle pushing through the narrow opening
